**NS 2 FRESHWATER PEARL MUSSEL SUB-BASIN
MANAGEMENT PLANS**

**REPORT ON MORPHOLOGICAL MONITORING AND
CATCHMENT WALKOVER RISK ASSESSMENTS IN THE
CLADY CATCHMENT**

September 2009

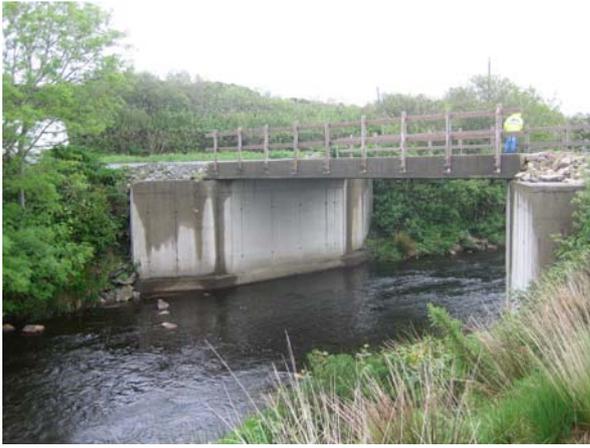
<p>RHAT 1-3 Photo 12 along end section of survey stretch new bridge within SAC boundary</p>

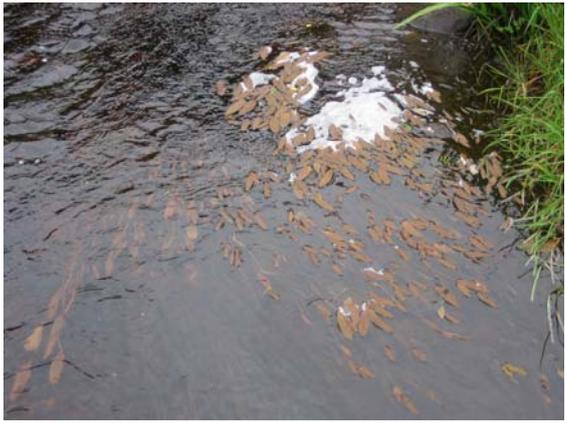
<p>RHAT 1-3 Photo 14 along end section of survey stretch, excessive <i>potamogetan</i> growth</p>

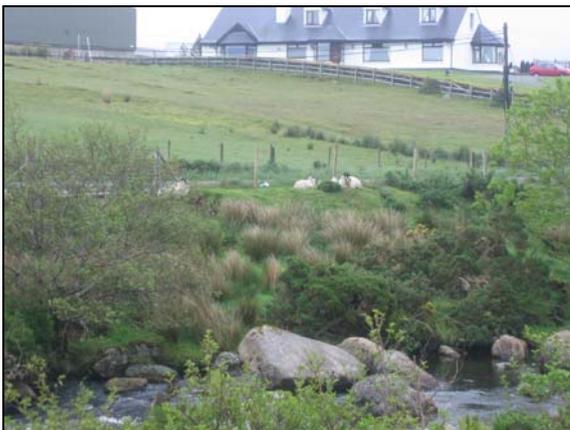
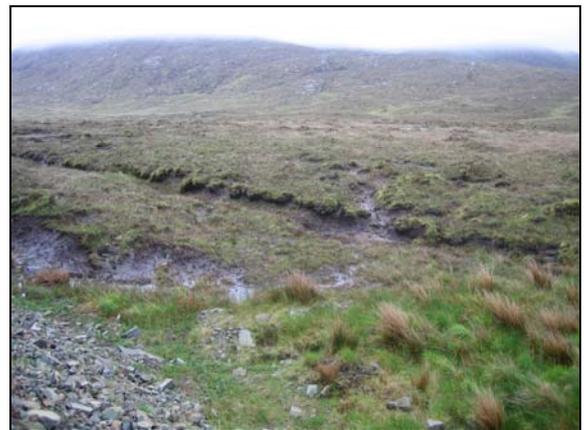
Plate 3.2 & 3.3 are sites which were surveyed as part of the catchment walkover risk assessments. These images provide an indication of the overgrazing on peat soils and animal access to the river channel in the vicinity of the pearl mussel populations.

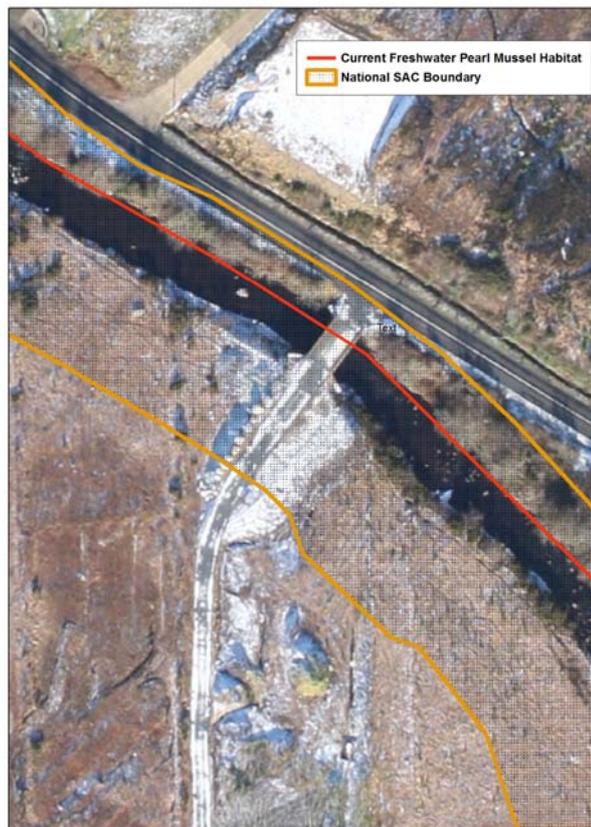
The construction of an access road, associated embankment and bridge crossing, within the vicinity of pearl mussels is evident as shown by **Plate 3.4**. This site was investigated further through the catchment walkover risk assessment where the bridge and road embankment was found to be constructed from loose hardcore material. The risk of material reaching the river is significant at this location.

Plate 3.4 Detailed aerial imagery showing extensive construction both in and adjacent to the river within the Fawnboy Bog/Lough Nacung SAC

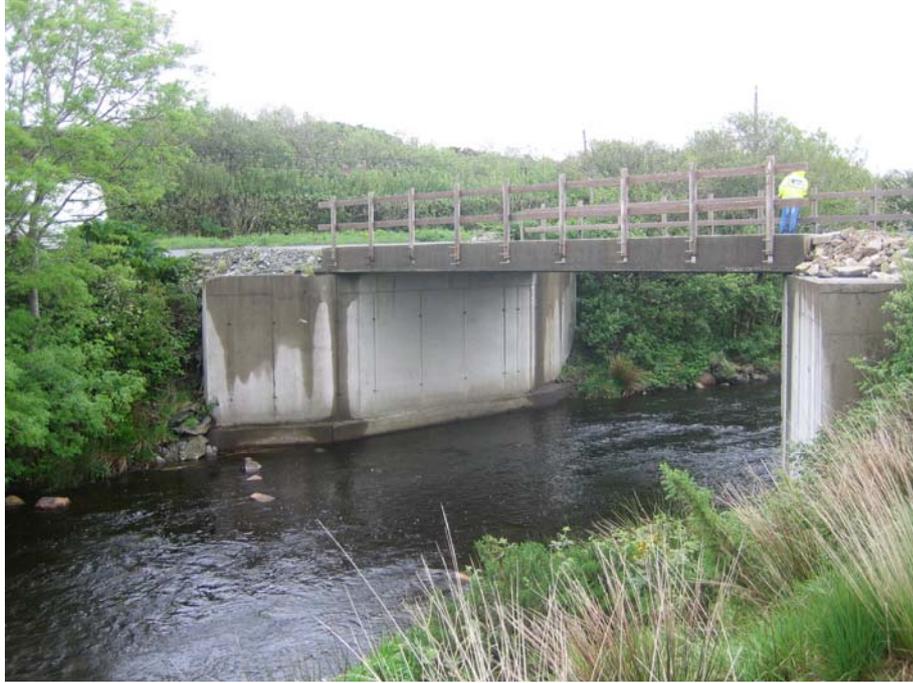
Plate 3.5 New bridge construction within the Clady catchment

Damage to mussel habitat is already evident from erosion and ponding below the bridge due to scour at the pier which does not clear span the river bank habitat. Excessive macrophyte growth together with dead mussels was found at this point along the survey stretch. This bridge and access road was constructed within the Fawnboy Bog/Lough Nacung SAC without prior consent from NPWS. Planning permission was granted for the construction of the dwelling house, septic tank together with the construction of the bridge as part of the new road at Dore by Donegal CoCo.
