**NS 2 FRESHWATER PEARL MUSSEL SUB-BASIN
MANAGEMENT PLANS**

**REPORT ON MORPHOLOGICAL MONITORING AND
CATCHMENT WALKOVER RISK ASSESSMENTS IN THE
CLODIAGH CATCHMENT**

September 2009

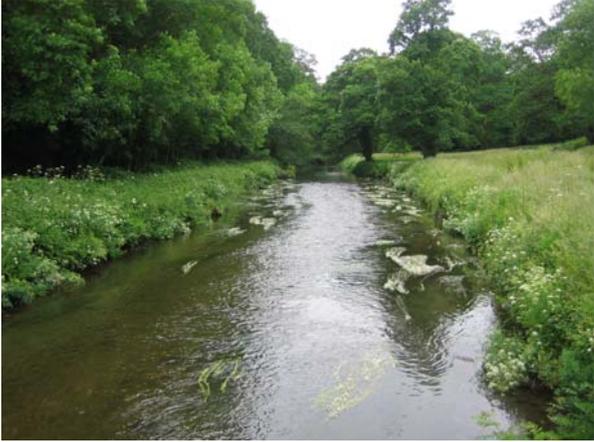
<p>RHAT 3 Site 3 Photo 1</p>

RHAT number 3 was also carried out in Curraghmore Estate over a 390m survey stretch. Excessive resectioning on the left bank together with resectioning on the right bank and reinforcement on both banks were recorded. As a result the channel form and flow type only scored one out of four based on the observation that approximately >80% of the left bank was reinforced and/or resectioned. The bank structure and stability together with the bank vegetation and floodplain connectivity all scored low also.

For a channel of this type significantly more macrophyte growth than would be expected for a channel of this type was recorded in particular *Ranunculus*. Overall this stretch was classified as being at good status.

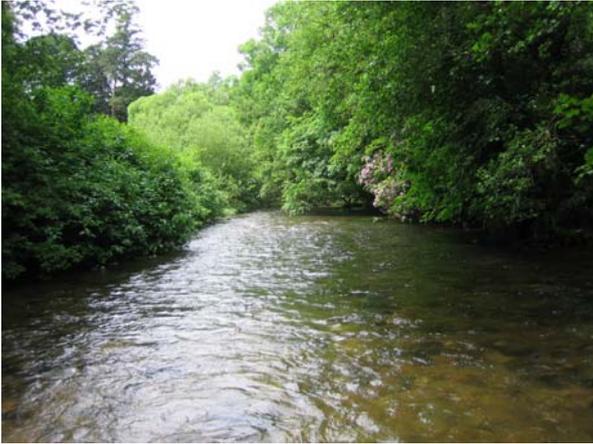
<p>RHAT 4 Site 4 Photo 9</p>

RHAT number 4 was carried out farther up the catchment over a 451m stretch of a pool-riffle-glide channel. Overall this stretch was found to be in good condition from a morphological point of view with only the substrate condition and channel vegetation scoring quite low due to the presence of fine silts in the channel and greater than expected levels of macrophyte growth in particular *Ranunculus*. Overall this stretch was classified as being at good status.

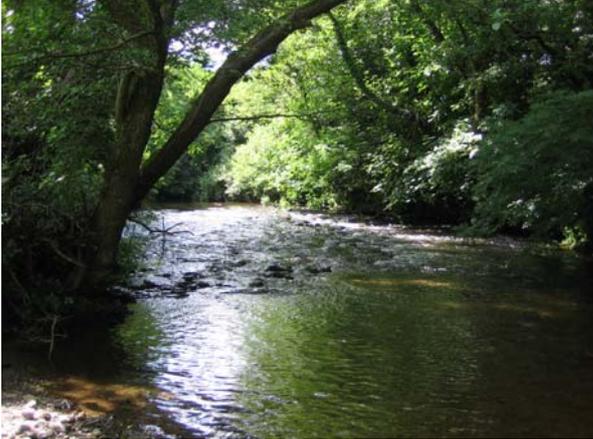
<p>RHAT 5 Site 5 Photo 5</p>

The final RHAT survey carried out within the catchment was RHAT number 5 this was carried out at Glenstown Bridge. This is a pool-riffle-channel with very little morphological alterations. Only the substrate condition scored low together with the

channel vegetation. This is again due to the presence of fine silts and greater than expected amounts of macrophytes including *Ranunculus* and filamentous algae. Some poaching has occurred in the past but this is largely localised and not an on-going issue. Overall this stretch was classified as being at high status.
