**NS 2 FRESHWATER PEARL MUSSEL SUB-BASIN
MANAGEMENT PLANS**

**REPORT ON MORPHOLOGICAL MONITORING AND
CATCHMENT WALKOVER RISK ASSESSMENTS IN THE
CURRANE CATCHMENT**

September 2009

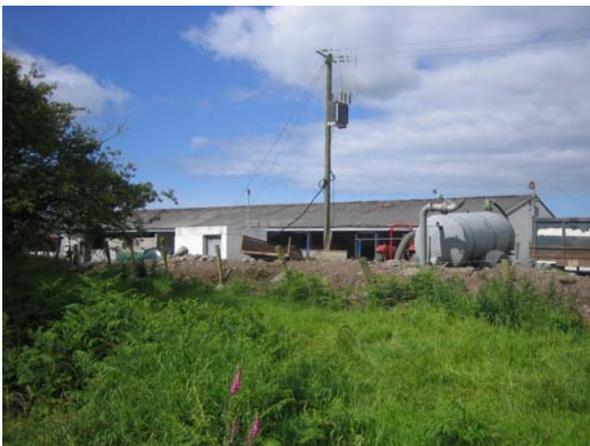
RHAT 1, Site 1 Photo 6

RHAT Number 1 was carried out at the downstream end of the catchment before the Cumberagh flows into Lough Currane. This stretch began at Dromkeare Bridge where the road and the bridge were subsiding. The left bank has been reinforced to give support to the bridge which is leading to a loss of habitat for the pearl mussels which have been recorded at this location. Towards the end of the survey stretch a mink farm, **Willow Herb Ltd.** is located on the left bank with very little buffer zone between the facility and the river. Numerous dead mussels were found along this stretch, with the substrate in a very poor condition. Filamentous algae was found to have <50% coverage, trucks were being washed in the yard adjacent to the main river channel while the survey was being undertaken with a foul smell coming from the facility. Animal

trampling and siltation was also an issue along the stretch. Both solid and liquid waste from the mink farm is spread on lands within the Waterville area.
