**NS 2 FRESHWATER PEARL MUSSEL SUB-BASIN
MANAGEMENT PLANS**

**REPORT ON MORPHOLOGICAL MONITORING AND
CATCHMENT WALKOVER RISK ASSESSMENTS IN THE
ALLOW CATCHMENT**

September 2009

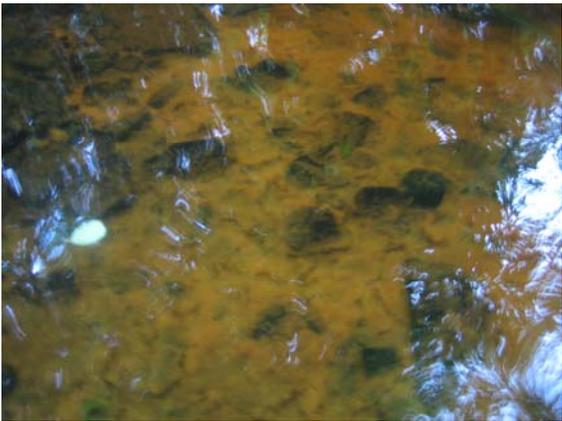
<p>RHAT 87 Site 87 Photo 13</p>

Due to the single location of pearl mussels within the Allow catchment only one RHAT surveys were carried out. The results of this survey can be found in the electronic appendix. This site was deemed to be at high status scoring 0.83 despite the presence of abundant *Ranunculus* growth at the beginning of the survey at John's Bridge. At this point suspended solids were also noted. It is a lowland meandering channel with occasional pool/riffle sections. The lowest scoring attributes along this stretch were the channel vegetation, substrate condition, riparian landcover and bank vegetation. The two lowest scoring attributes were the substrate condition and the riparian landcover both scoring two out of four. This was largely due to the presence of fine sediment at the beginning of the survey stretch together with a bacterial floc which was found covering

the substrate also at the beginning of the survey stretch. (See Photo 13). The Riaprian Landcover attribute was also marked down due to the presence of cattle access with noted trampling and/or poaching along on of the banks. Along some of the survey stretch there was also a very poor buffer zone. (See photo 15). Although these attributes scored low the overall stretch was still classified as being at high status as the pressures recorded were quite localised.

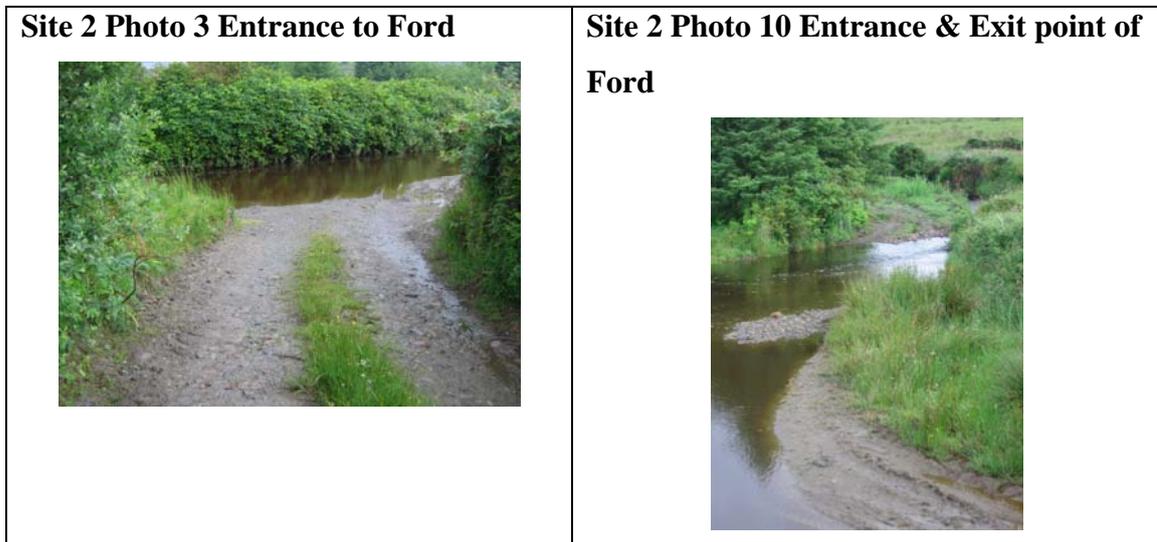
Two Fords were located within the Allow catchment during the course of the catchment walkover risk assessments. The first was located at Site 2 – Doctor’s Hill Bridge. This is a significant vehicular ford crossing with tyre marks present leading up to and into the channel.

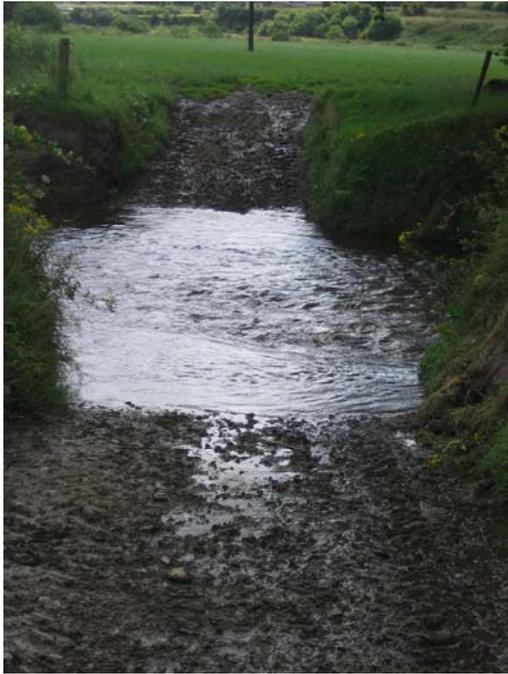
Site 4 Ford Crossing

A second ford was found just downstream of Kiskeem Bridge at site 4. Again this Ford appears to have both vehicular and animal access across the channel.

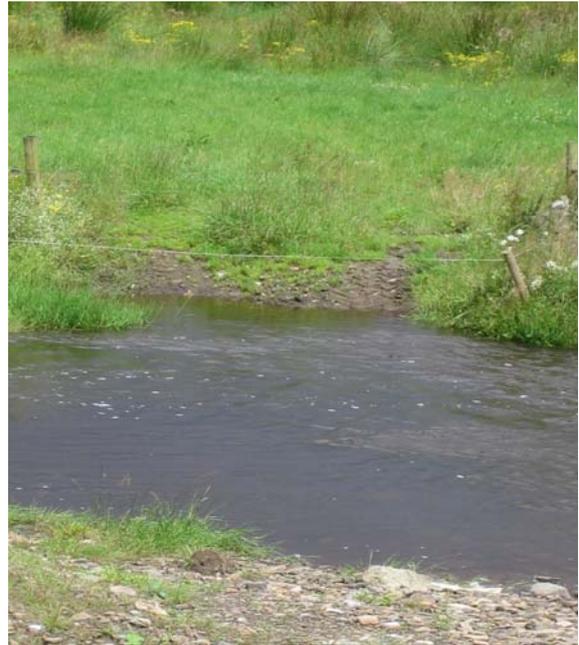
Site 5 Photo 7

The third ford was found at site 5 just upstream of Clamper Bridge. It doesn't appear to be used as frequently as the fords which were found at Site 2 and 4, however, it does still appear to have vehicular access on some occasions.
