**NS 2 FRESHWATER PEARL MUSSEL SUB-BASIN
MANAGEMENT PLANS**

**REPORT ON MORPHOLOGICAL MONITORING AND
CATCHMENT WALKOVER RISK ASSESSMENTS IN THE
ESKE CATCHMENT**

September 2009

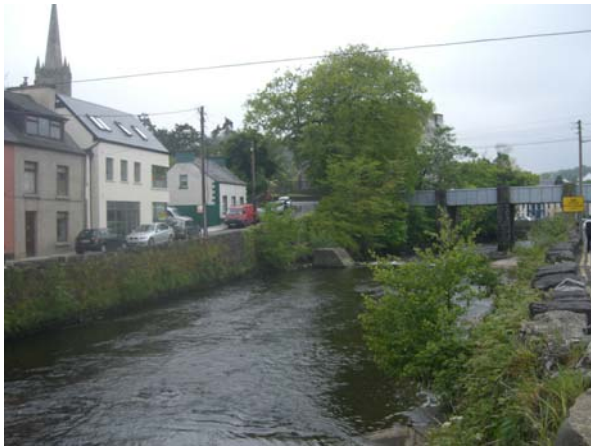
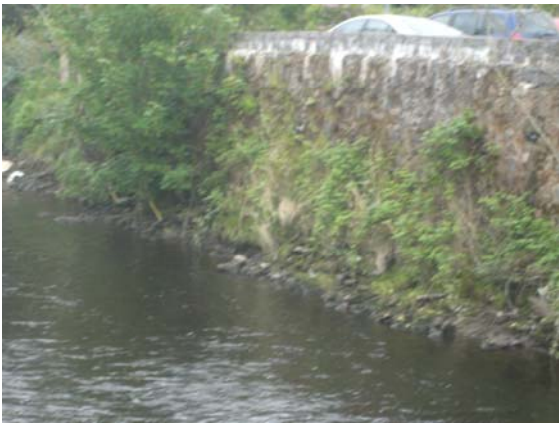
Three RHAT surveys were carried out throughout the Eske catchment. The results of these surveys can be found in the electronic appendix. One each at moderate, poor and bad status. RHAT number 1 was carried out in the vicinity of Donegal Town at the lower end of the catchment and was classified as being at Poor status. These stretch is largely urbanised with flood walls, culverts/outfalls and some resectioning, reinforcement and embankments found along both banks and in excessive lengths (i.e. >30%). All attributes scored low except for barriers to migration which scored three out of four. Due to the extensive artificial banks which have altered the flow and channel form and led to the removal of the bank side vegetation these attributes all scored one out of four. The Bank structure and stability together with the floodplain connectivity

scored zero (bad) again due to the total artificial nature. Overall, this stretch is in poor condition from a morphological point of view with three major bridges, mid-channel bars, deflectors, storm water outfalls and culverts along the stretch.

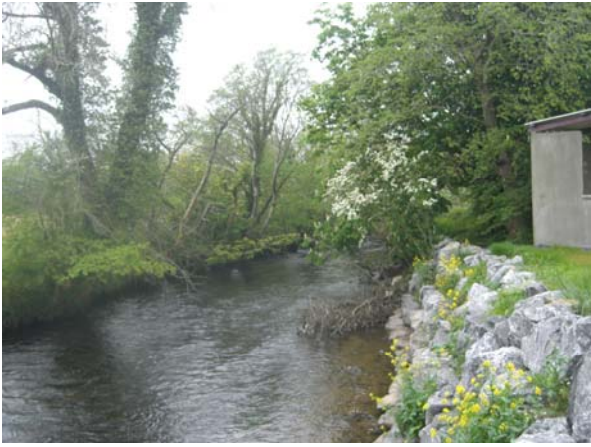
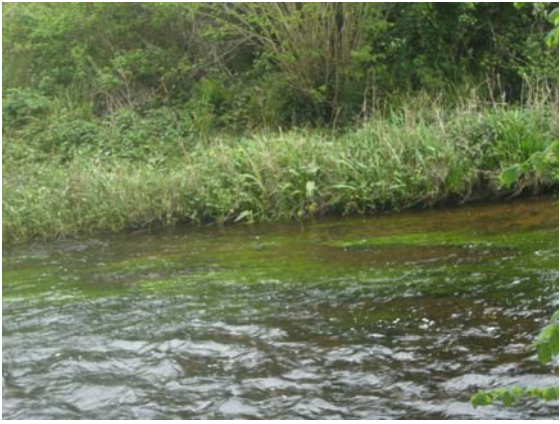
RHAT Number 2 was carried out further upstream from RHAT number 1. Drainage works, land improvement together with re-seeding and associated fertilisation coincided with extensive *Ranunculus* growth in the channel. Some resectioning and excessive reinforcement (>30%) was recorded on the left bank. The Channel vegetation, substrate condition, bank vegetation, riparian landcover and floodplain connectivity all scored two out of four. It is a lowland meandering channel and while it is classified as being at “Good” status this is a borderline score and it could well be downgraded to moderate status.

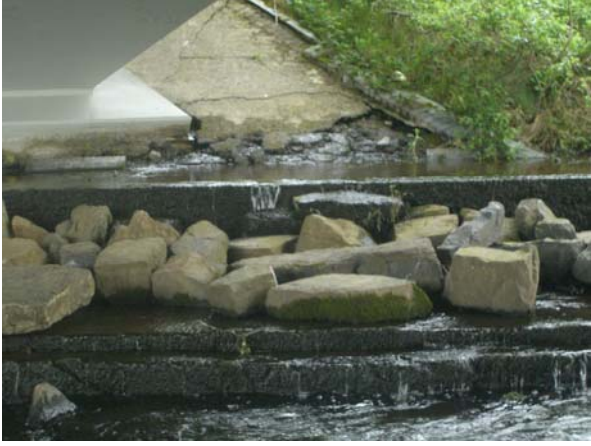
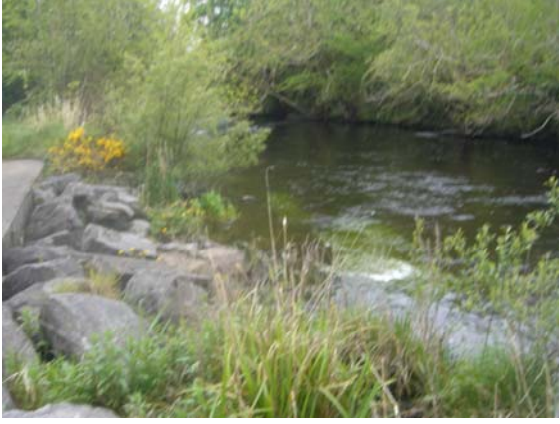
RHAT number 3 scored well on all attributes except substrate condition, bank vegetation and riparian landcover. This is also as a result of the adjacent forestry plantation which has led to tunnelling and a build up of pine needles on the substrate which is blocking out light and leading to a growth of filamentous algae.

RHAT number 3 (Site 13) was carried out further upstream of Donegal Town at Eske Bridge on the N59. This is a major bridge structure with large artificial boulders placed in channel along the verges of the bridge piers. There are insufficient sustainable natural banks on either side of this bridge and as such it has led to a significant loss of habitat. The substrate has been highly altered by the bridge structure with high levels of *Ranunculus* recorded in channel. All attributes scored low except for barriers to migration which scored three out of four. Channel vegetation, substrate condition, bank structure and stability and bank vegetation all scored only one out of a possible four. Overall this stretch was classified as being at “moderate” status again as with RHAT number 2 it was only 0.02 above the hydromorph score for moderate and could be downgraded to poor status.
