**NS 2 FRESHWATER PEARL MUSSEL SUB-BASIN  
MANAGEMENT PLANS**

**REPORT ON MORPHOLOGICAL MONITORING AND  
CATCHMENT WALKOVER RISK ASSESSMENTS IN THE  
KERRY BLACKWATER CATCHMENT**

**September 2009**

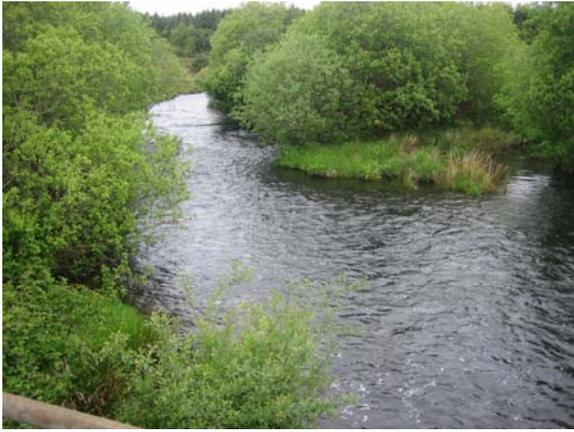
**RHAT 3**

RHAT number 3 scored well on all attributes except riparian landcover. This is largely due to over grazing and trampling along the right bank downstream of the bridge together with the associated site works which have taken place upstream of the bridge on the left bank.

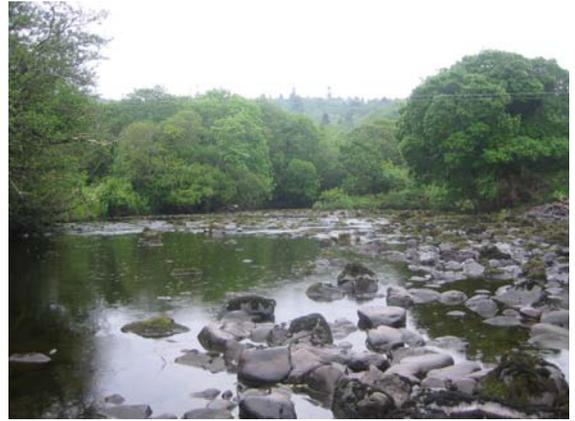
**RHAT 5**

For RHAT number 5 channel vegetation scored low due to the excessive substrate coverage of filamentous green algae. Numerous dead mussels were found along this stretch both in channel and along the banks. RHAT number 6 scored highest of all the sites in the Kerry Blackwater with both dead and live mussels found in the channel. Despite this some of the attributes did not score 4 due to the large amount of silt deposition and filamentous algae attached the mussels themselves.
