**NS 2 FRESHWATER PEARL MUSSEL SUB-BASIN
MANAGEMENT PLANS**

**REPORT ON MORPHOLOGICAL MONITORING AND
CATCHMENT WALKOVER RISK ASSESSMENTS IN THE
OWENAGAPPUL CATCHMENT**

September 2009

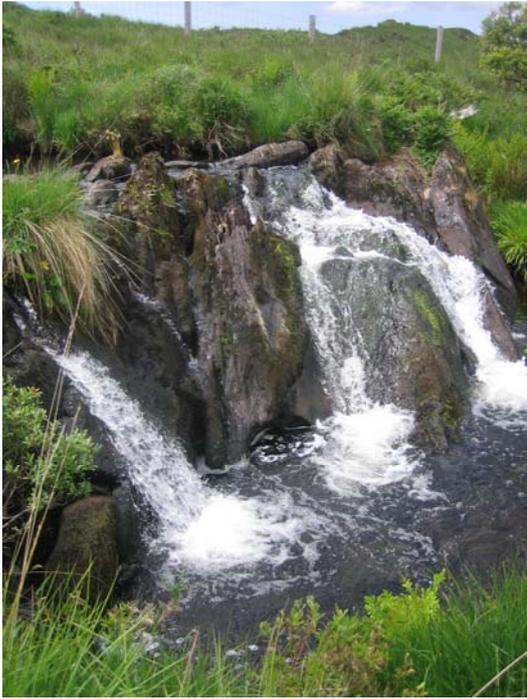
RHAT 7 Site 7 Photo 8

RHAT number 7 was carried out further upstream on the Ownagappul along an area surrounding by peat substrate. This is a very remote stretch of the river which is a Step-pool cascade channel. All attributes scored well along this survey stretch with only the riparian land cover and the channel vegetation downgraded to 3.5 and 3 respectively. This is due to the lack of bankside vegetation due to the peat setting together with the presence of some fine silts and filamentous algae on the river substrate. Overall this stretch was found to be in good condition with adults pearl mussels noted in the channel.
