**NS 2 FRESHWATER PEARL MUSSEL SUB-BASIN
MANAGEMENT PLANS**

**REPORT ON MORPHOLOGICAL MONITORING AND
CATCHMENT WALKOVER RISK ASSESSMENTS IN THE
MUNSTER BLACKWATER CATCHMENT**

September 2009

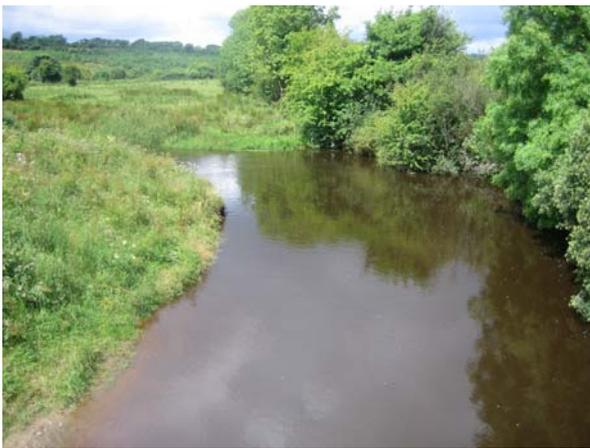
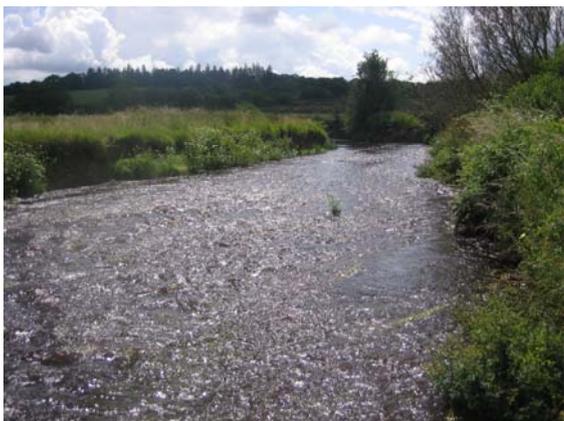
Eleven RHAT surveys were carried out throughout the Munster Blackwater catchment. The results of these surveys can be found in the electronic appendix and are also shown in Figure 1 above. Eight were deemed to be at good status. The RHAT surveys were carried out in the vicinity of the pearl mussel populations. The “Good” status sites were found throughout the catchment from Ballyduff to Ballydesmond. The three moderate sites were located in Mallow, Millstreet and Knocknagree to the west of the catchment. Going from West to east across the catchment RHAT number 42 which was surveyed at Farankeal bridge scored 0.59 and was classified as being at moderate status. This stretch contained high banks on both sides downstream of the bridge. Erosion and bare banks with a lack of buffer zone was present. On meeting the landowner he indicated that he is in REPS and has undertaken works in line with the REPS guidelines. New fencing has been erected as a result the conditions downstream may improve in the future as an adequate buffer zone has also been left. High levels of silt were recorded in the channel with the underneath of one bridge arch containing a mound of silt.

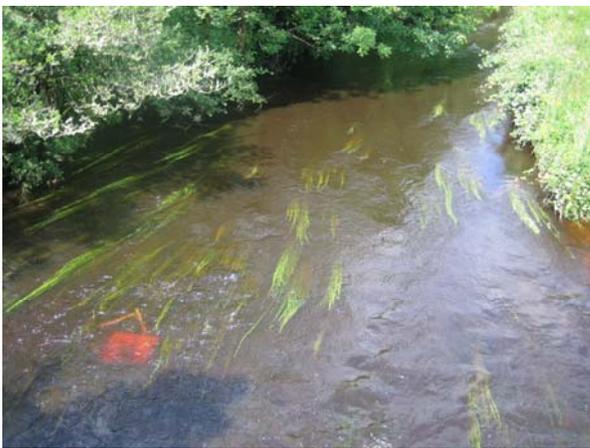
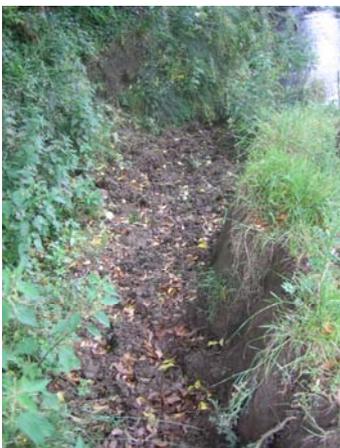
RHAT number 41 at Novona bridge scored 0.65 and was classified as “Good” status. The river was in high flow on the day of surveying and was very silty and peat stained. A lot of cattle poaching has and is occurring along this river stretch which has led to slumping of the river banks and subsequently an increase in silt.

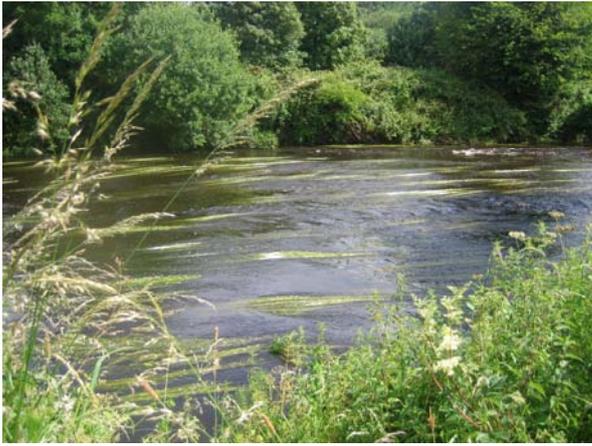
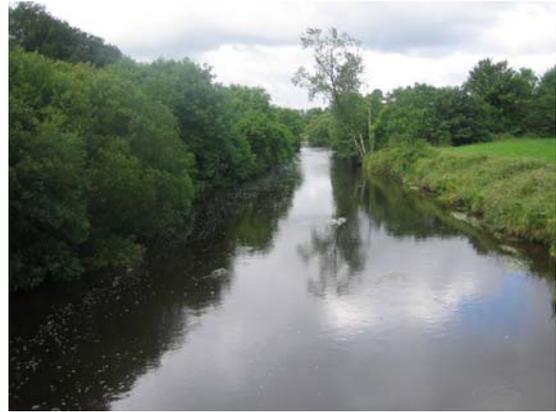
Moving upstream RHAT number 39 at Charles Bridge on the main river Blackwater was also classified as being at “Good” status. The channel vegetation attribute scored low over this stretch as the macrophyte growth was more than would be expected for a river of this typology. The substrate condition was not visible due to the high flows but the excessive *Ranunculus* growth along the survey stretch would indicate a nutrient and/or siltation issue. A v-notch weir and a hydrometric gauging station were also recorded along this stretch. The high banks which were recorded appear to have undergone some disturbance and therefore the bank vegetation was downgraded together with the floodplain connectivity.

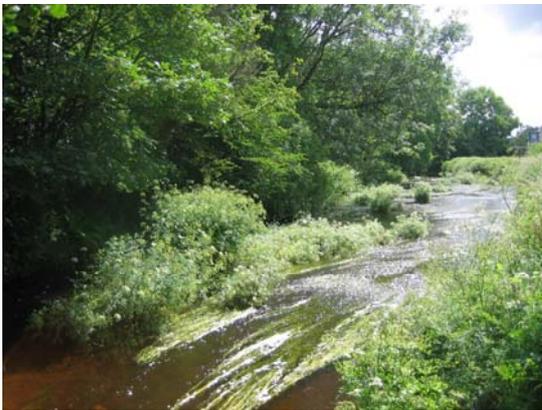
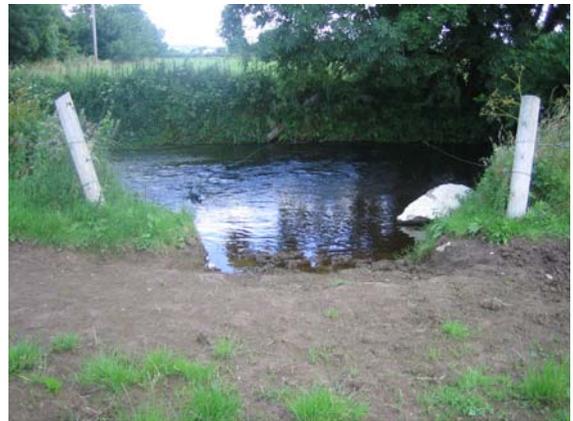
RHAT number 40 scored 0.59 and was classified as moderate. This survey was carried out on the Finnow River just outside Millstreet over a 278m stretch. Cattle access and poaching were significant pressures along this stretch. Peat staining, urbanisation associated with Millstreet and vegetated islands were all noted along this stretch and

impacting on the channel. Extensive lengths of the channel contained excessive macrophyte and in particular *Ranunculus* growth. As a result the channel vegetation attribute was downgraded and only scored one out of four. The substrate condition, bank structure, bank vegetation, riparian landcover and floodplain connectivity all scored quite low also due to the impact from the pressures listed above.

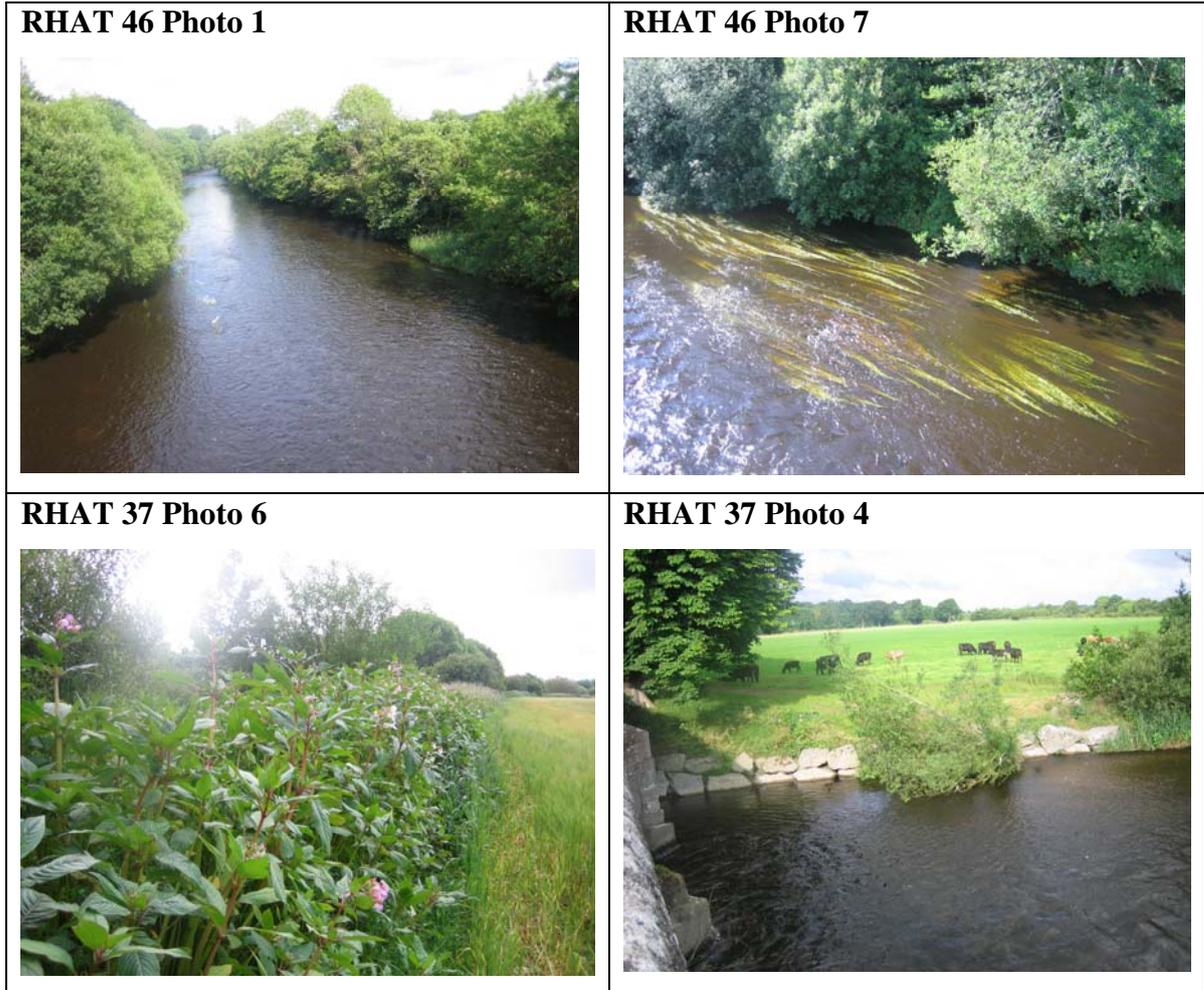
RHAT Number 46 was carried out at Keale bridge and scored 0.71 and was classified as being at “Good” Status. The channel was very heavily stained and carrying suspended solids downstream which were also seen farther upstream in Owentaraglin. It is a lowland meandering channel with all attributes scoring three out of four except the substrate condition which scored two out of four. Although the substrate was not visible at the time of survey, the level of suspended solids and macrophyte growth would indicate its poor condition. A ford or entrance point was noted just upstream of the road bridge. RHAT Number 37 was carried at Roskeen bridge, this is a lowland meandering channel which has been altered in the past. (See RHAT 37 Photo 6) The presence of *Himalayan Balsam* along most of the survey stretch is a clear indication of disturbance and alteration. The landuse along this stretch is quite intensive, with large arable fields downstream of the bridge and improved grassland with cattle grazing upstream of the bridge. The river was in spate on the day in which the survey took place overall this stretch was classified as being at “good” status.

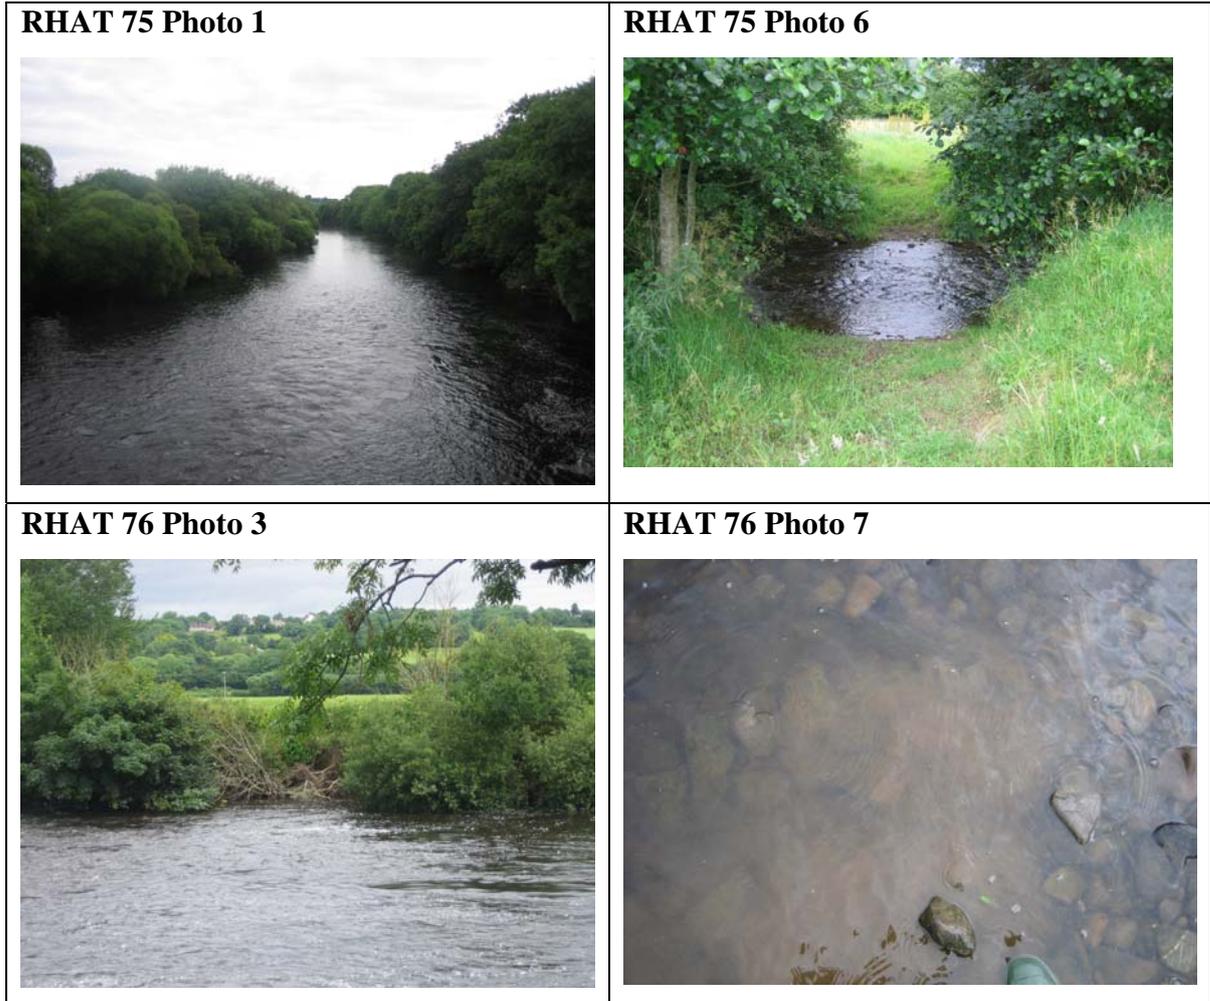
RHAT numbers 75, 76 and 77 were all carried out in Lombardstown, Clyda and Mallow respectively. At Lombardstown again *Himalayan Balsam* and *Japanese Knotweed* were recorded indicating disturbance in the past. The survey commenced on the Blackwater main channel and then continued on the Duvglasha tributary. The substrate was not visible along most of the Munster Blackwater stretch however it was heavily peat stained. One small ford was recorded on the Duvglasha tributary. This stretch scored 0.69 and was classified as being at “Good” status. The second RHAT survey along this stretch was carried out at Longfields Bridge again along the Blackwater Main channel. This stretch is a lowland meandering channel and where the substrate was visible silt and filamentous green algae was excessive. Both the bank structure and the bank vegetation scored 2.5 with the right bank scoring lower than the left bank for both attributes. This was due to the presence of some erosion and exposed tree roots recorded along the survey stretch.

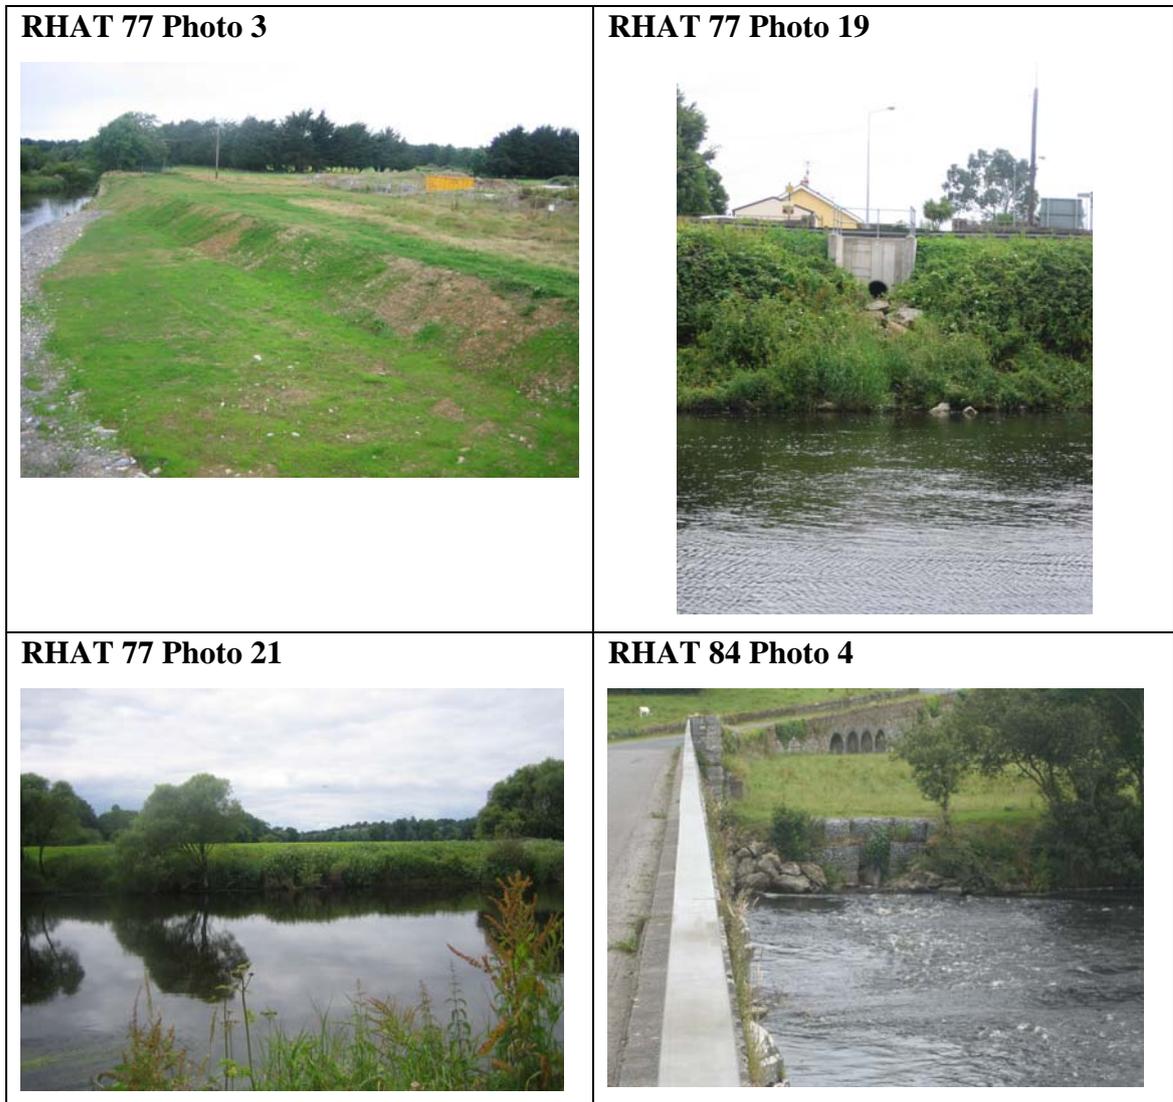
The third RHAT survey within this region was in Mallow itself. The survey commenced in Mallow Town at Mallow Bridge and continued upstream for over a kilometre. This stretch has been subject to OPW Drainage works which were been under taken at the time the survey took place. The stretch within the vicinity of Mallow Town has been newly sectioned and widened and an embankment put in place. The channel form and flow types only scored 1 out of four as a result. The tributary entering from the town appears to have very poor water quality. The substrate condition, bank structure & stability, bank vegetation and riparian landcover all scored 2 out of four as along the entire stretch outfalls, slumping, removal of bankside vegetation and reinforced toe line were recorded. A uniform bank vegetation of *Himalayan Balsam* was recorded at the lower end of the survey stretch past the motorway and railway line. This was associated with an intensely farmed arable field indicating disturbance and removal of the bank side vegetation. The floodplain connectivity attribute scored the lowest of all the

attributes – 1.5. This is largely due to the confinement of the channel and 4m high banks in the vicinity of Mallow.

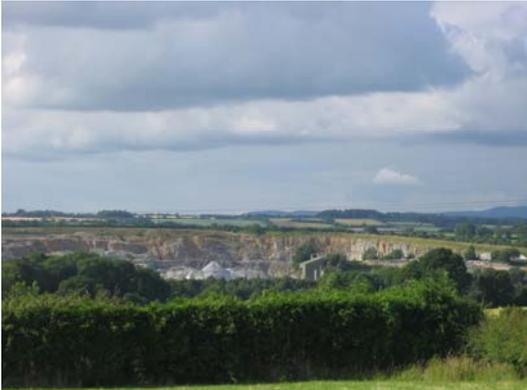
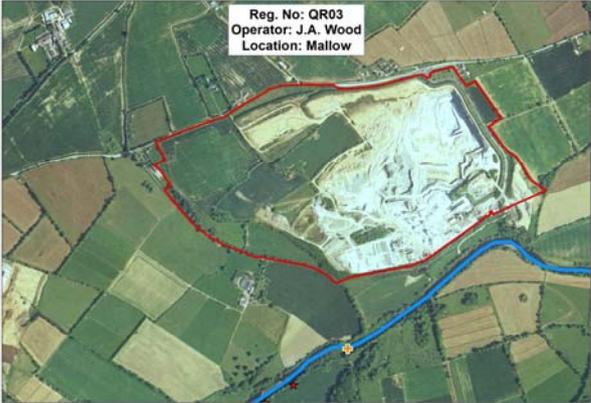
<p>J.A.Woods Quarry – Munster Blackwater Lacknamona Mallow</p>

The significant number of fords, quarries and crossing points are also cause for concern and a major source of silt to the channel and the freshwater pearl mussel habitat.

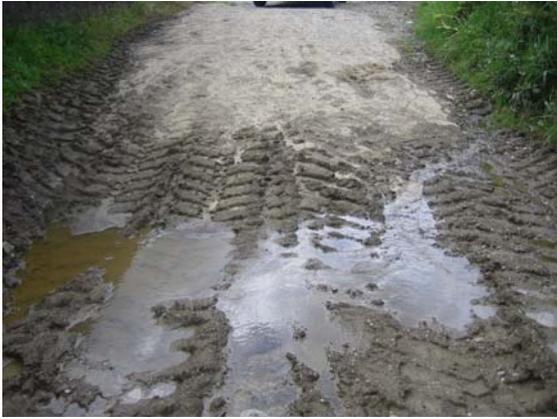
Site 42 Farnankeel bridge

Within the Munster Blackwater and excluding the Allow Sub-Basin six significant Fords were recorded at the following sites:
