**NS 2 FRESHWATER PEARL MUSSEL SUB-BASIN
MANAGEMENT PLANS**

**REPORT ON MORPHOLOGICAL MONITORING AND
CATCHMENT WALKOVER RISK ASSESSMENTS IN THE
NEWPORT CATCHMENT**

September 2009

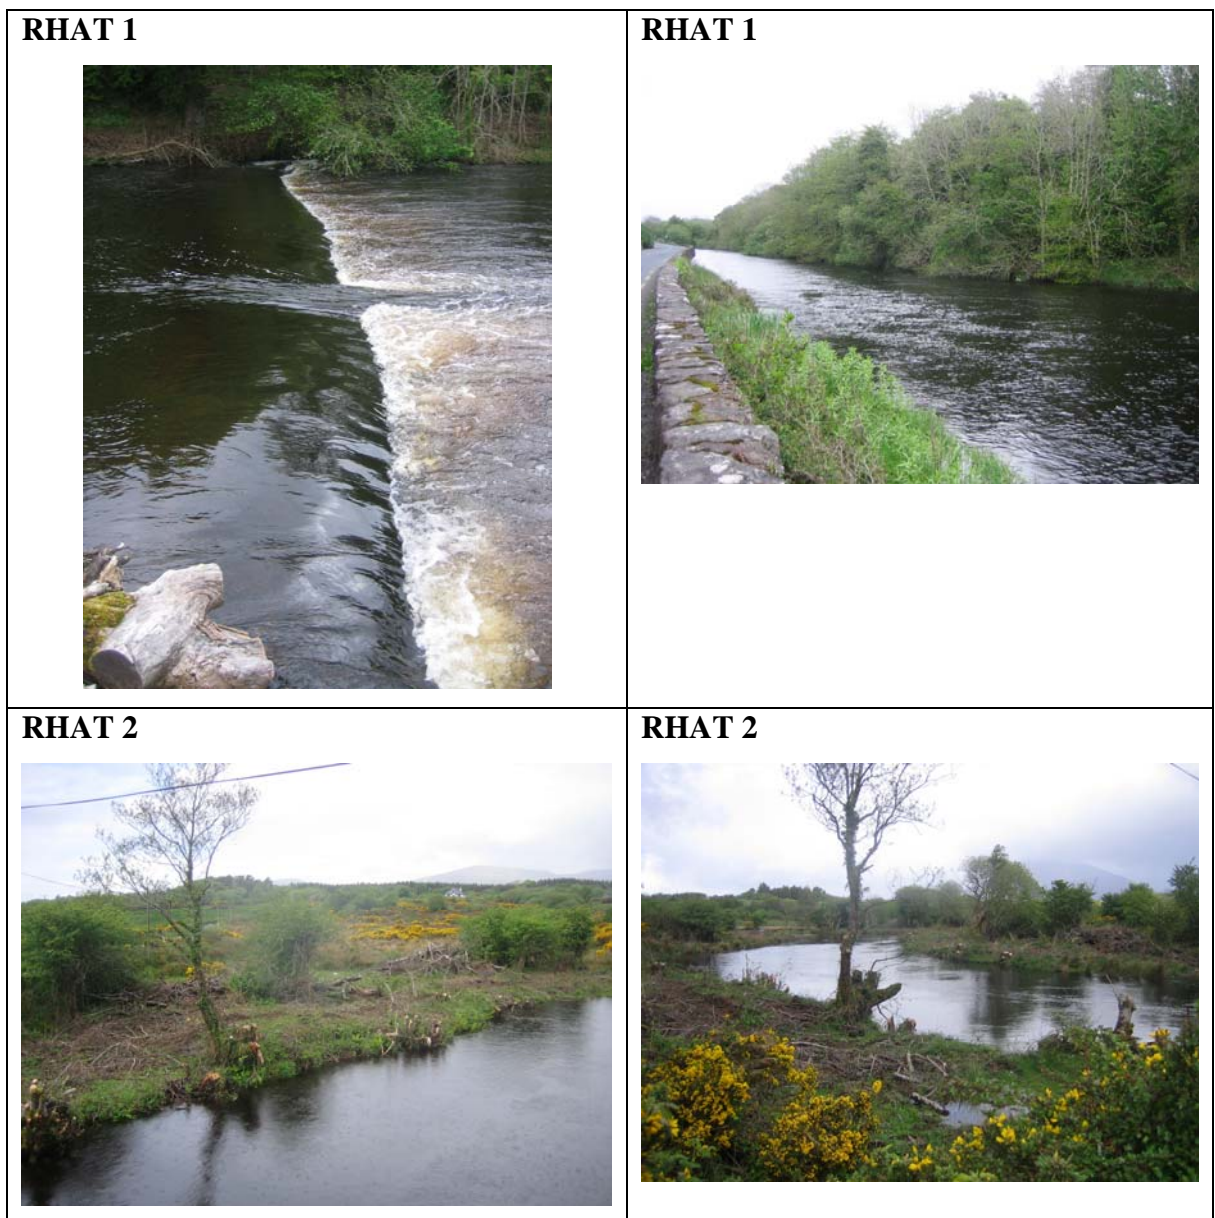
Plate 3.1 Representative photographs from reach:

Two RHAT surveys were carried out in the Newport catchment. RHAT number one was carried out in Newport moving from downstream to upstream. A considerable stretch of the Newport River has a wall running along it where the road runs parallel with the channel. One major bridge together with two intermediate weirs are located along the survey stretch. These are stone or concrete v-notch weirs. There is no riparian zone where the wall runs parallel with the channel. The channel has been resectioned and reinforced on both the left and right banks and also over widened in some areas. It is a lowland meandering channel which was classified as being at “moderate” status, The lowest scoring attributes were – Substrate condition, bank structure and stability, bank vegetation, riparian landcover and floodplain connectivity. The river was in flood

on the day in which the survey took place and although the visibility was poor silt was noted on the substrate with a heavy silt plume evident when the substrate was kicked. The second RHAT survey was undertaken at Crompaun Bridge and again the river was in flood on the day in which the survey took place. Both the left and right banks appear to have been resectioned and the channel has been over deepened and over widened. It is a lowland meandering channel which scored lowest on the bank structure and bank vegetation due to the removal/cutting down of the bankside vegetation on both banks. This survey stretch was also classified as being at moderate status.
