**NS 2 FRESHWATER PEARL MUSSEL SUB-BASIN  
MANAGEMENT PLANS**

**REPORT ON MORPHOLOGICAL MONITORING AND  
CATCHMENT WALKOVER RISK ASSESSMENTS IN THE  
OWENEA CATCHMENT**

**September 2009**

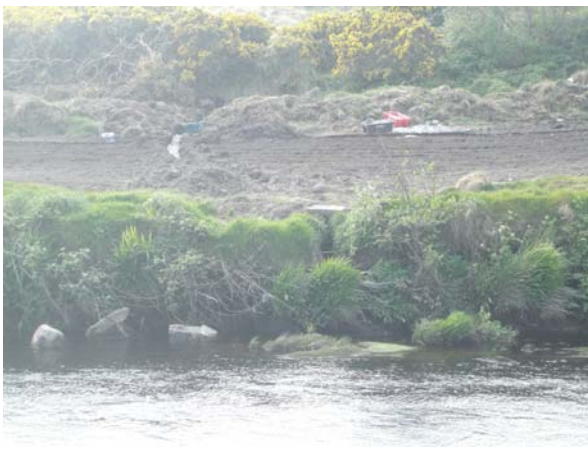
<p><b>RHAT 1 Site 1 Photo 3</b></p>

RHAT Number 1 was carried out at the lower end of the catchment near Ardara on a lowland meandering channel over a 45m stretch. One major bridge and some over deepening was recorded along the survey stretch together with numerous land drains entering the channel. The channel appears to have been drained in the past. All attributes except for barriers to migration and substrate condition scored low. Bank structure and stability, bank vegetation and riparian landcover all only scored one out of four. This is due to the lack of buffer zone and the intensive landuse which in places is right up to the banks. Improved grassland can be found on one bank and recently ploughed land on the other bank with newly excavated drains discharging directly to the

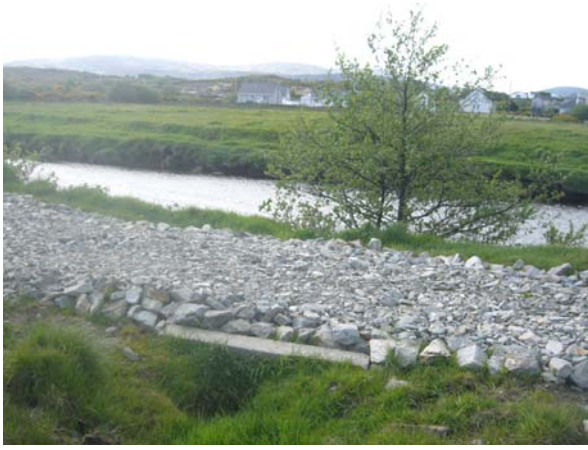
<p><b>RHAT 1 Site 1 Photo 9</b></p>

river channel. Along a significant stretch of the channel a new access road has been laid using rock with little to no buffer with the river channel. In is <1m in most parts of the stretch. (See Site 1 Photo 9). Overall this stretch was classified as moderate status. It has significant alterations which have occurred in the past together with on-going pressures and risks such as the numerous un-managed drains and direct discharges.

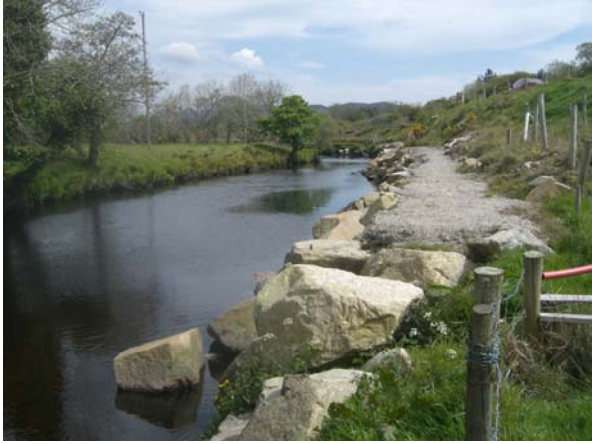
<p><b>RHAT 1 Site 5 Photo 1</b></p>

The second RHAT survey was carried farther up the catchment just outside Glenties at site 5. This was carried out over a 298m survey stretch on a lowland meandering channel. One major and one minor bridge together with a minor weir were recorded along the survey stretch. This stretch has under gone significant morphological

alterations with resectioning on both the left and right banks, excessive (>30%) reinforcement on the left bank and embankments on both the left and right bank. All attributes scored quite low along this survey stretch except for barriers to migration. In particular bank structure and stability, bank vegetation and riparian landcover all scored low due to the physical modifications. Very small amounts of algae were recorded on the bank side but largely the substrate was found to be in good condition.

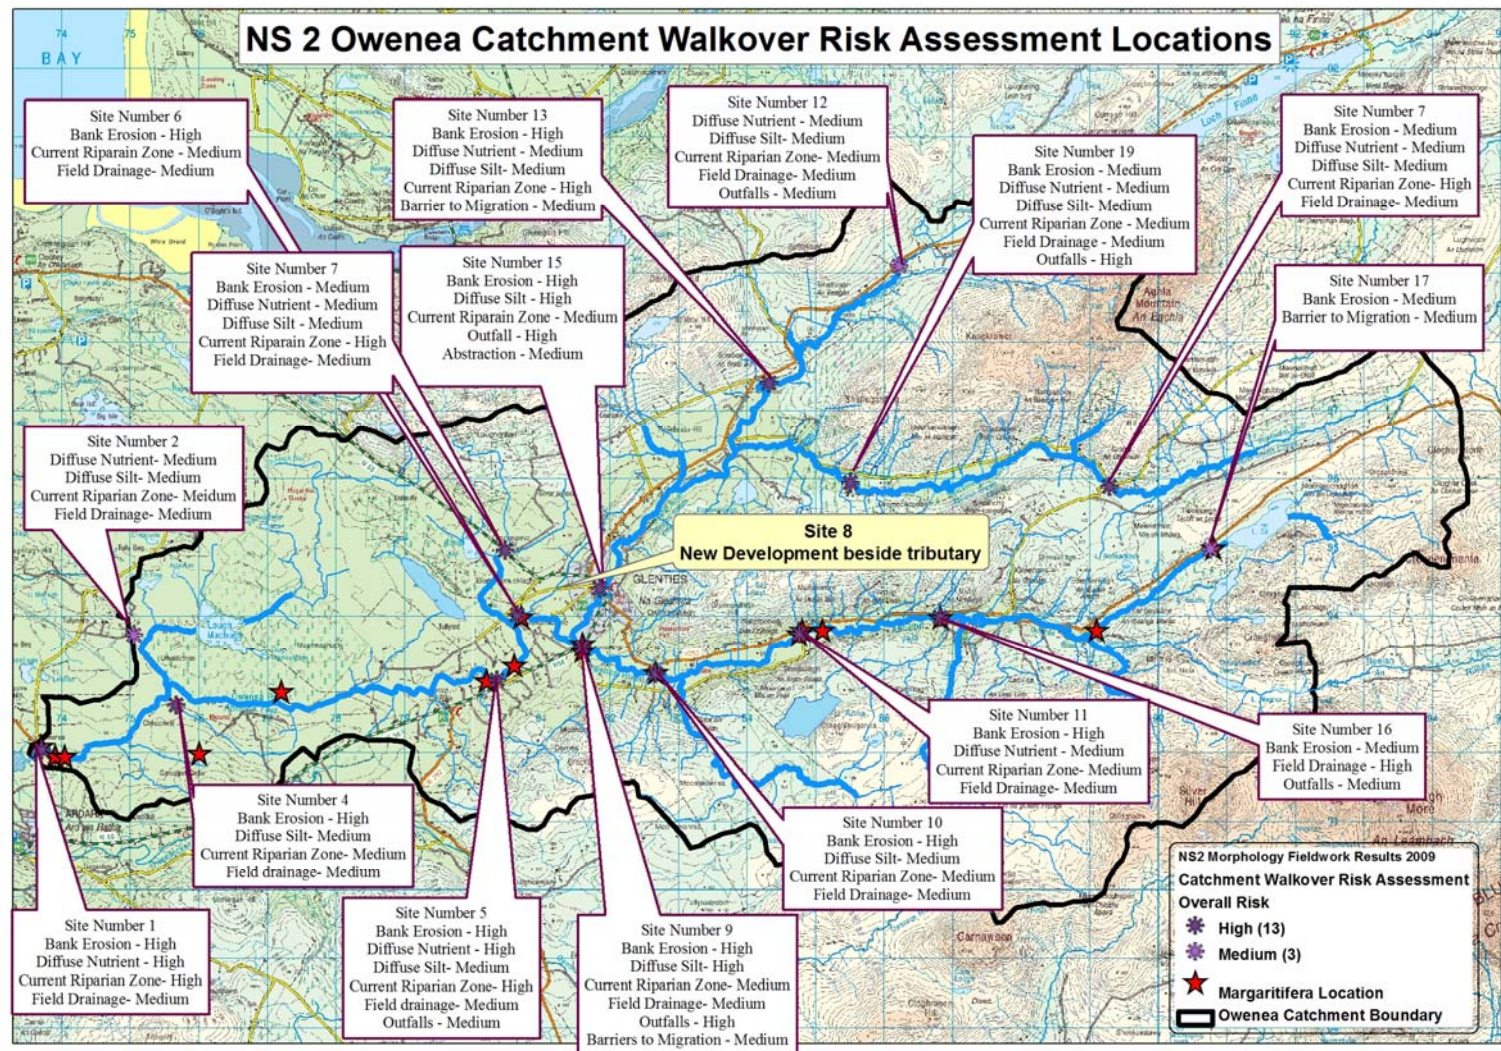
**Figure 3.2 Location of Stopping points and Catchment Walkover Risk Assessments**

A total of nineteen sites were surveyed in the Owenea sub-basin catchment, with a risk assessment carried out at sixteen of these sites (three stopping points). **Figure 3.2** outlines the stopping point locations in addition to the High to Low Risk Assessment from the Catchment Walkover Risk Assessments. Thirteen high risk sites were recorded out of the sixteen that were assessed. The remaining three sites were recorded as medium risk, meaning no low risk sites were recorded within this catchment. **Figure 3.3** outlines the percentage of sites classified at high and medium risk together with the number of stopping points throughout the catchment.

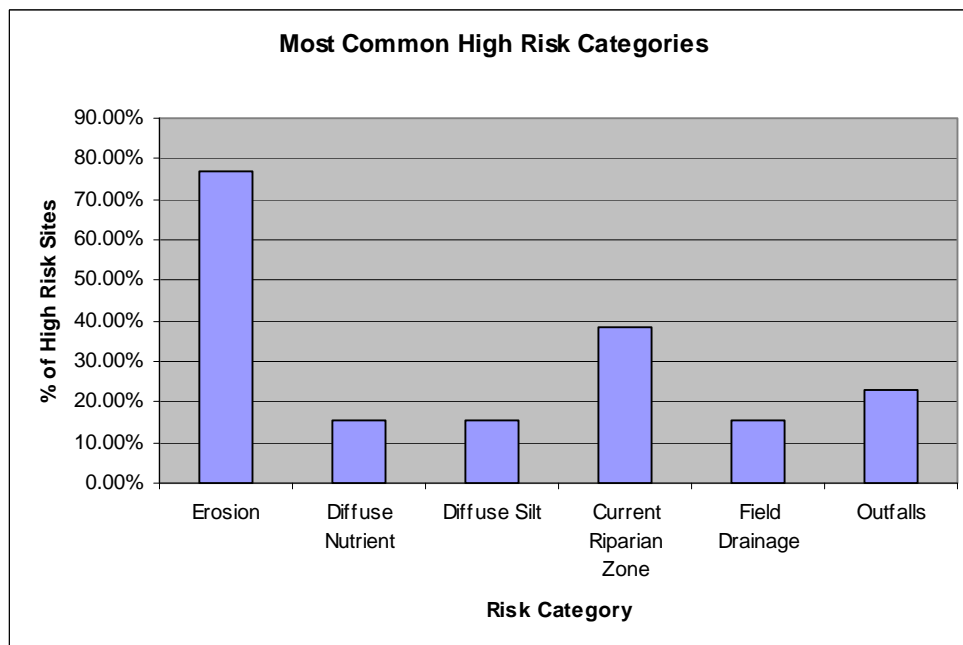
**Figure 3.4 Breakdown of High Risk Categories**

The most common high risk categories identified were:

- Erosion – evident at 77% of high risk sites,
- Current riparian zone – 38% of high risk sites.

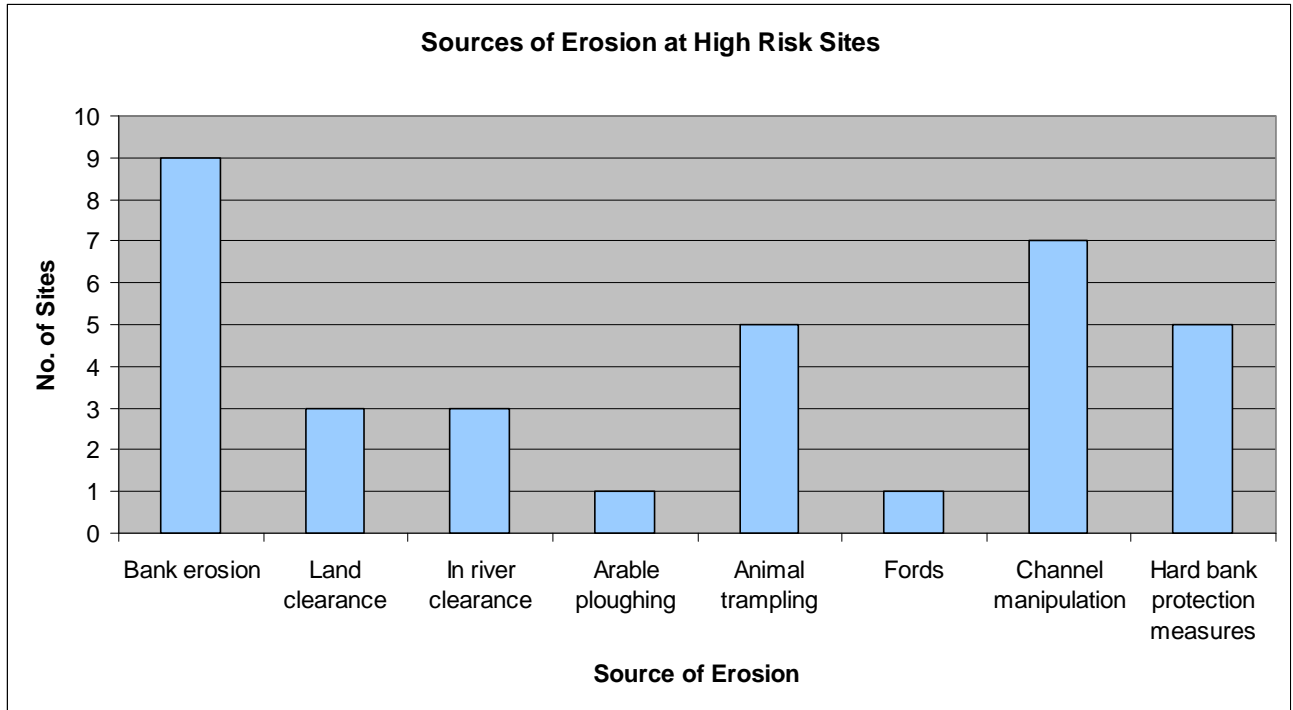
**Figure 3.5 Source of field drainage pressure at high risk sites**

The most frequent source of erosion is bank erosion which is apparent at nine of the thirteen high risk sites. Channel manipulation and bank protection are significant erosion pressures. Outlined below are the sources of erosion leading to a high risk site:
