NS 2 FRESHWATER PEARL MUSSEL SUB-BASIN MANAGEMENT PLANS

REPORT ON MORPHOLOGICAL MONITORING AND CATCHMENT WALKOVER RISK ASSESSMENTS IN THE OWENRIFF CATCHMENT

September 2009

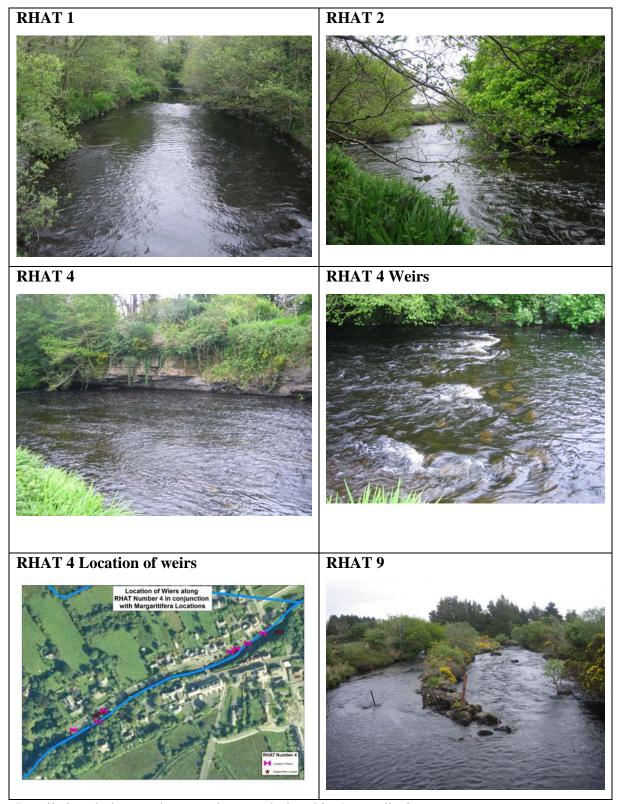
Representative photographs from reach:

RHAT number 4 commenced from the point on the river at Sweeney's bridge and continued downstream as the Owenriff flows along by Oughterad. Nearly 500m of the river was surveyed along this stretch with urbanisation highlighted as the main pressures along its banks and in the riparian zone. One major bridge and 7 minor weirs were recorded along this stretch. The bed of the Owenriff River was lowered by the O.P.W in the context of the Corrib drainage scheme during the 1960's and in order to offset the impact of this on fish populations, fishery personnel later installed a series of low level weirs in the affected channel. Over time and due to the impact of flood events, the weirs deteriorated and are now in need of repair. (WRFB, January 2008). The presence of these weirs led to a low score for barriers to continuity together with a low score for the riparian landcover due to the pressure from the town the reach overall scored a moderate classification. RHAT number 9 as carried out just upstream of Agraffard Lough. One of the main morphological alterations along this stretch is the presence of the dismantled railway line which runs down the centre of the channel. This is acting as a mid channel deflector and causing a considerable obstruction which is altering the channel form and flow type. Overall, from a morphological point of view this survey stretch is in poor condition. There is slumping and bank erosion evident with

an overall poor bank structure and stability. The stretch scored 0.46 which is just inside the moderate category however it is bordering on poor.

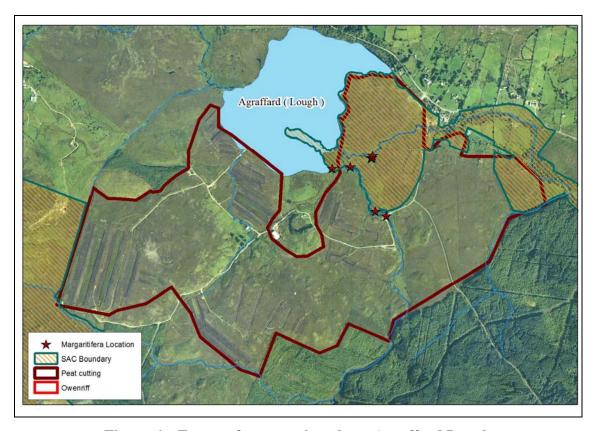
Figure 6 – Extent of peat cutting above Agraffard Lough

During the morphology field work access was not obtained to the area above Agraffard Lough. However, a field visit was carried out accompanied by NPWS staff on the 9th of April 2009. During this site visit approximately 153ha were observed as commercial peat cutting areas with extensive damage to the landscape. Very poor buffer zones, drainage systems and roading were found throughout this area. During this site visit heavy rainfall was experienced throughout the day. The potential for run-off of peat silt is greater during extreme rainfall events. This may lead to large quantities of peat silt

being discharged to the receiving waters. Peat cutting is evident throughout the Owenriff catchment, but most significantly, it occurs within the vicinity of the pearl mussel population just downstream of Agraffard Lough. This area is also delineated as "Moderately Damaged" from the NPWS Commonage Framework plans. It is also located within the SAC boundary as can be seen in Figure 6.
