**NS 2 FRESHWATER PEARL MUSSEL SUB-BASIN  
MANAGEMENT PLANS**

**REPORT ON MORPHOLOGICAL MONITORING AND  
CATCHMENT WALKOVER RISK ASSESSMENTS IN THE  
NORE CATCHMENT**

**September 2009**

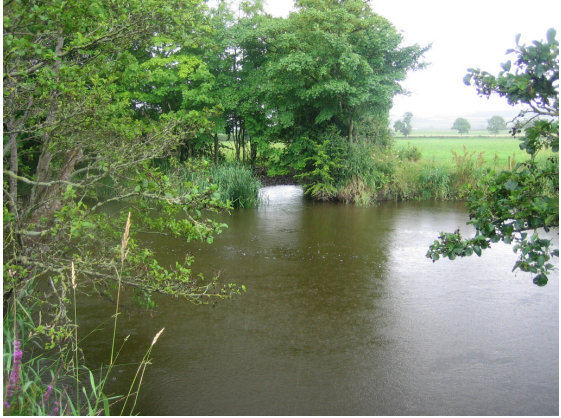
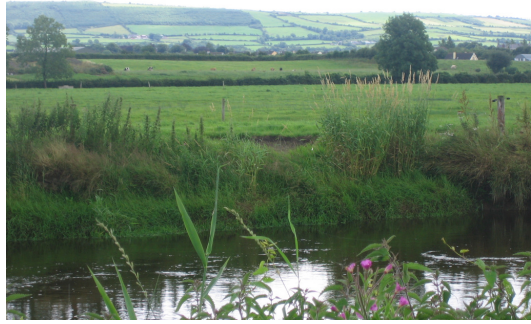
| <p><b>RHAT 1 Site 4 Photo 6</b></p> | <p><b>RHAT 1 Site 4 Photo 5</b></p> |

On the day in which the survey took place RHAT number 4 survey stretch was in spate. The river appears to have been resectioned and reinforced along this stretch together with some over widening and over deepening. Sewage fungus was found at the discharge point from Glanbia Creamery which is located at the end of the survey stretch. This is a lowland meandering channel which scored low on all of the attributes except for barriers to continuity which scored four out of four. Animal trampling and poaching were recorded together with high levels of suspended solids in the channel as a result the substrate condition was not visible. The riparian landcover scored the lowest

at 1.5 out of four due to the intensive landuse of improved grassland which surrounded the survey stretch with little to no buffer zone in some cases. Overall this stretch was classified as good status.

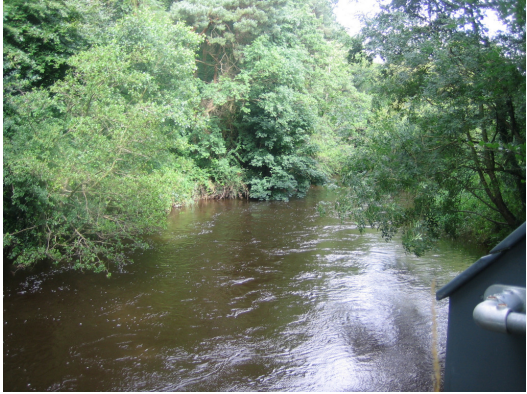
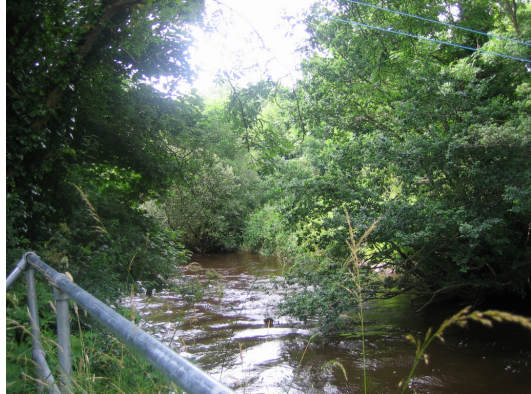
| <p><b>RHAT 2 Site 12 Photo 1</b></p> | <p><b>RHAT 2 Site 12 Photo 2</b></p> |

The second RHAT survey was carried out at Site 12 where access directly to the channel was quite difficult. Resectioning and reinforcement was again evident on both the left and right bank with the channel possible over deepened also. This is a lowland meandering channel with the substrate condition and channel vegetation not visible due to the high water levels on the day in which the survey took place together with the level of suspended solids in the channel. All attributes scored three out of four except for barriers to continuity which scored four out of four. Overall, this survey stretch was classified as moderate status.

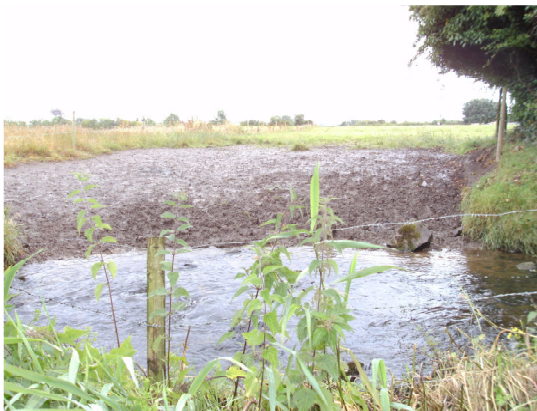
**Plate 3.2** Taken at Site 2 (See Figure 2)

**Plate 3.2 and 3.3** give an indication of some of the extreme cases of animal trampling and poaching which were located through the catchment walkover risk assessments. In both images the banks have become highly eroded leading to a high risk of silt input to the channel.

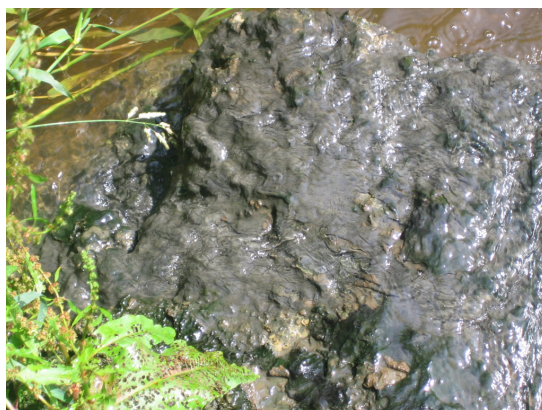
**Plate 3.10 outfall from Glanbia which discharges directly into the Nore main channel**

Plate 3.10 and 3.11 gives an indication of the sewage fungus which was found growing on at the outfall from Glanbia at the time at which the surveys took place. License reviews should be undertaken to ensure the cooling line discharge points located on the Nore main channel are meeting their license requirements.

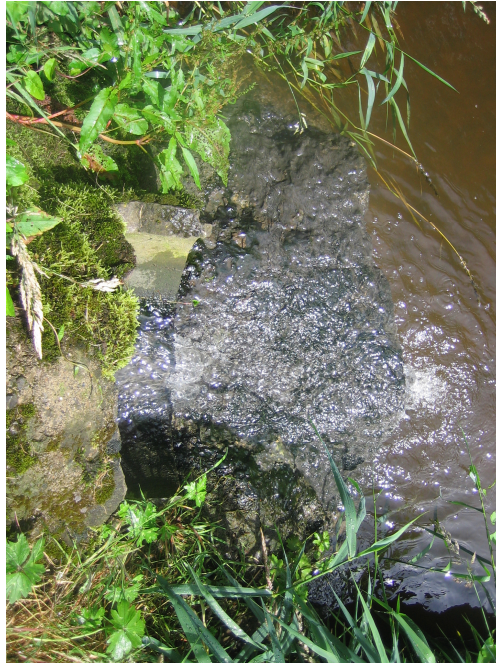
**Plate 3.11 outfall from Glanbia which discharges directly into the Nore main channel**

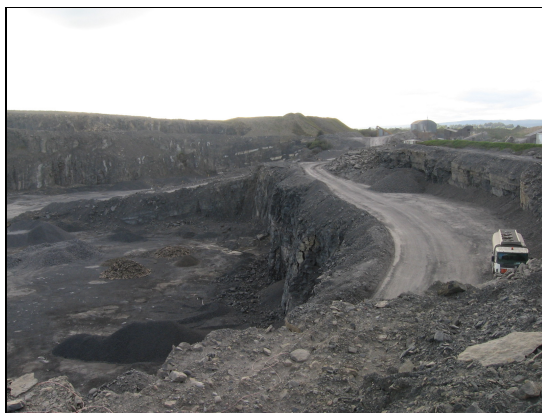
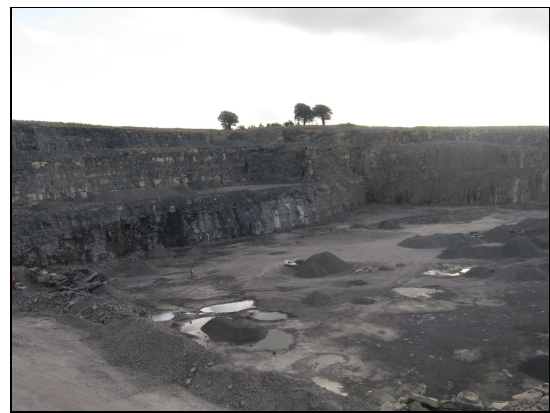
**Plate 3.12 & 3.13 Carroll's Quarry Co. Laois**

The Quarry in question was Carrolls Quarry and was found to be active on the day on which the survey took place. The aerial imagery map shown in **Figure 9** gives an overview of the location of the quarry and its proximity to the river channel. A tributary of the River Nore main channel flows adjacent to the Quarry and appears to also cross through the site. Any silt or pollution discharged to this tributary could have a knock on effect on the Nore main channel, as the tributary feeds in above the Freshwater Pearl Mussel population. The survey in July 2009 comprised a visual inspection of the quarry from the adjacent road/land and of the river approximately 300 m downstream of the quarry. There was no evidence of pollutants discharging from the quarry or of sedimentation in the river on that date.
