# Bandon Ilen Catchment Assessment 2010-2015 (HA 20)

Catchment Science & Management Unit

Environmental Protection Agency

December 2018

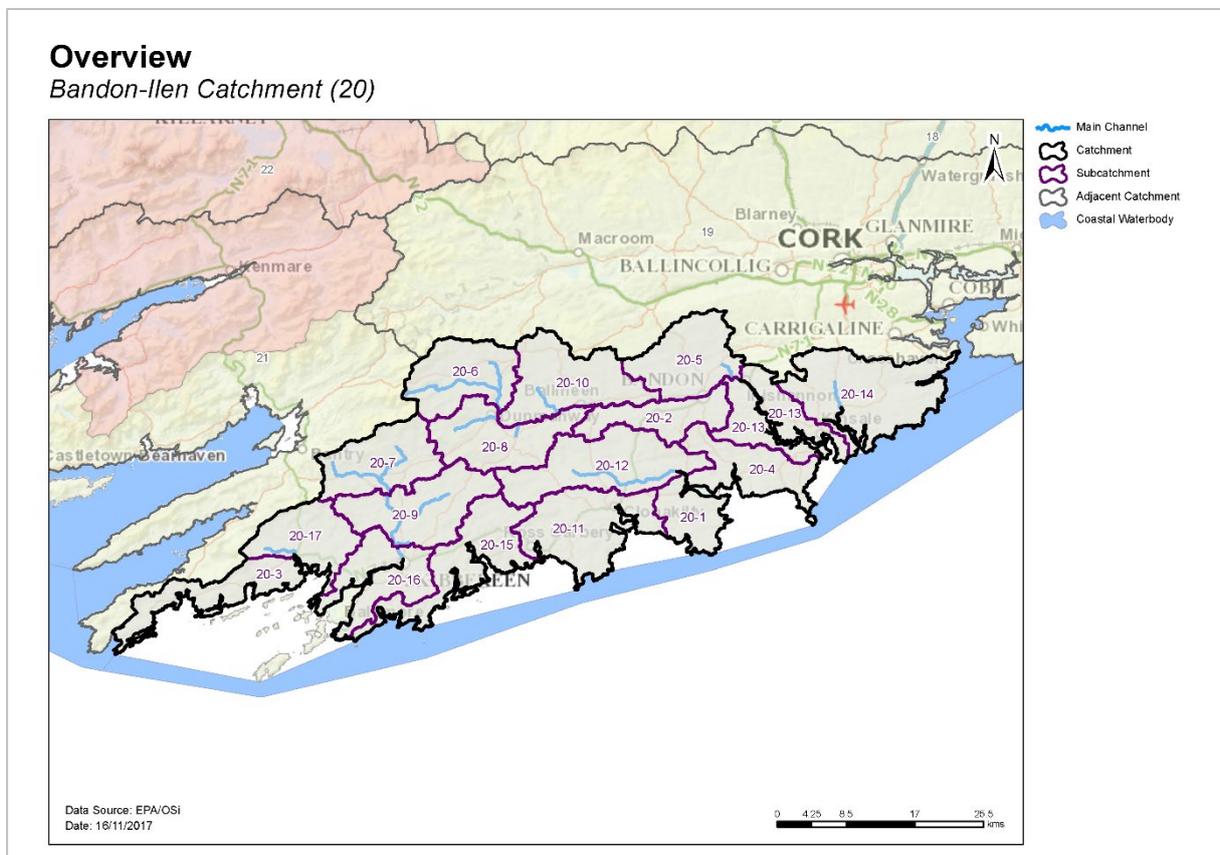
Figure 1. Subcatchments in the Bandon Ilen catchment

The Bandon Ilen catchment comprises 17 subcatchments (Table 1, Figure 1) with 87 river water bodies, six lakes, 25 transitional and coastal water bodies, and five groundwater bodies. There are no heavily modified or artificial water bodies in the Bandon Ilen Catchment.

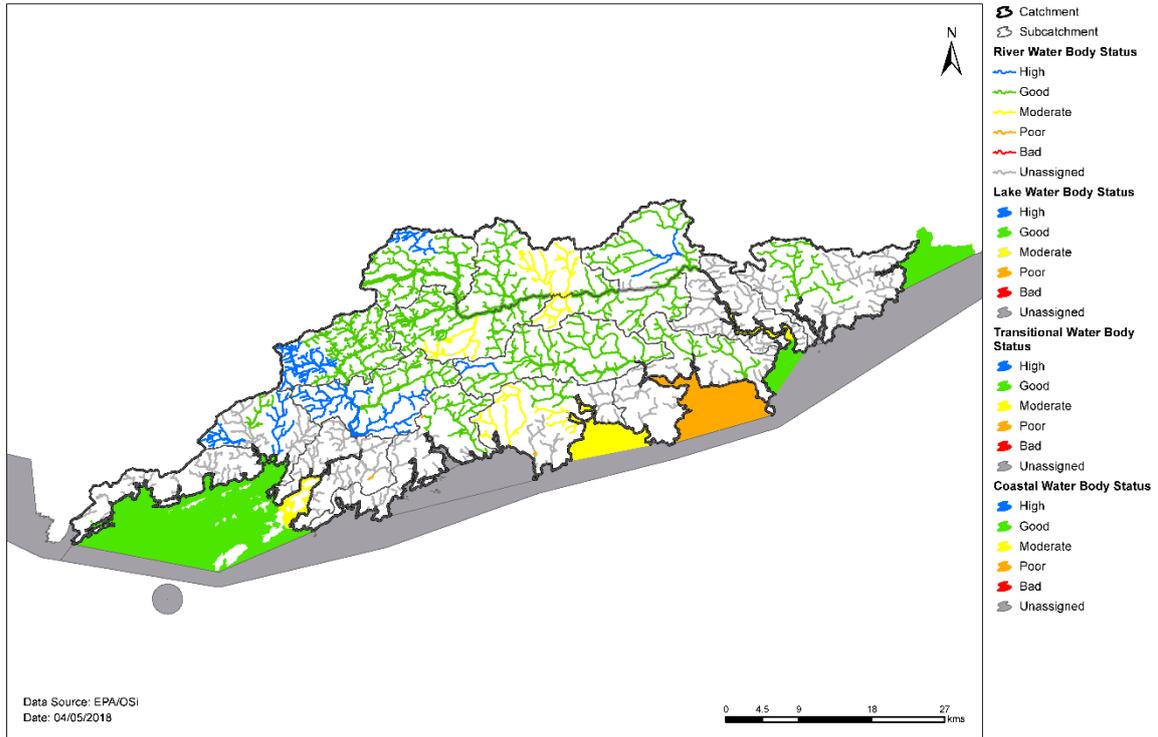
Figure 2. Surface water ecological status

- ◆ There were 51 (55%) river and lake water bodies at Good or High status, and 9 (10%) at less than Good status in 2015 (Table 2, Figure 2). Thirty-three (35%) river water bodies are unassigned.
- ◆ Eleven river water bodies and sites have a high ecological status objective. In 2015, seven (64%) of these water bodies were at High status, and four were at Good (Figure 3, Appendix 1).
- ◆ The numbers of water bodies at each status class in 2007-09 and 2010-15 is shown in Figures 4 (rivers) and 5 (lakes).
- ◆ Since 2007-09 when WFD monitoring began, seven water bodies have an improved status whereas 11 have deteriorated (Figure7).
- ◆ The variation in nutrient concentrations and loads in the Bandon and Argideen main channels are illustrated in Appendix 2.

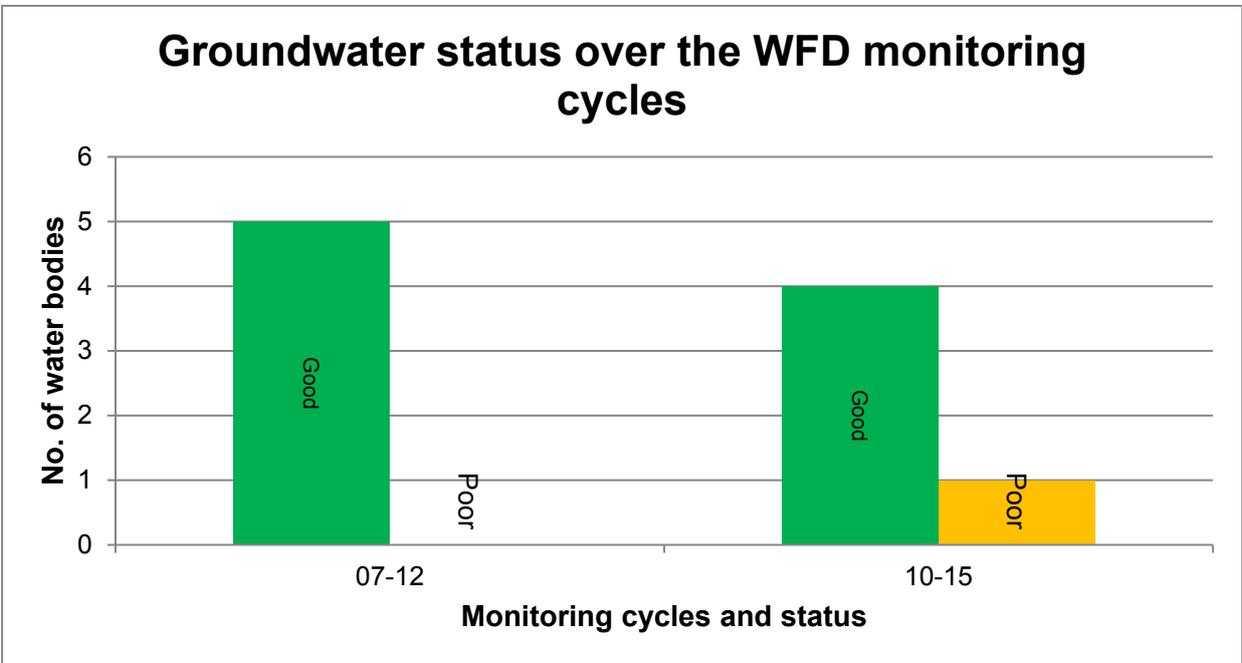
Figure 8. Number of groundwater bodies at each status class in 2007-12 and 2010-15

- ◆ There were four groundwater bodies at Good status and one at Poor status in 2015 (Table 3, Figure 8). The latter water body – IE\_SW\_G\_016 – is due to ammonia issues.(Figure 10).
- ◆ This classification of the Poor status water body was due to improved information being available and the development of technical assessment approaches, rather than there being deterioration in water quality in this groundwater body between 2007-12 and 2010-15.

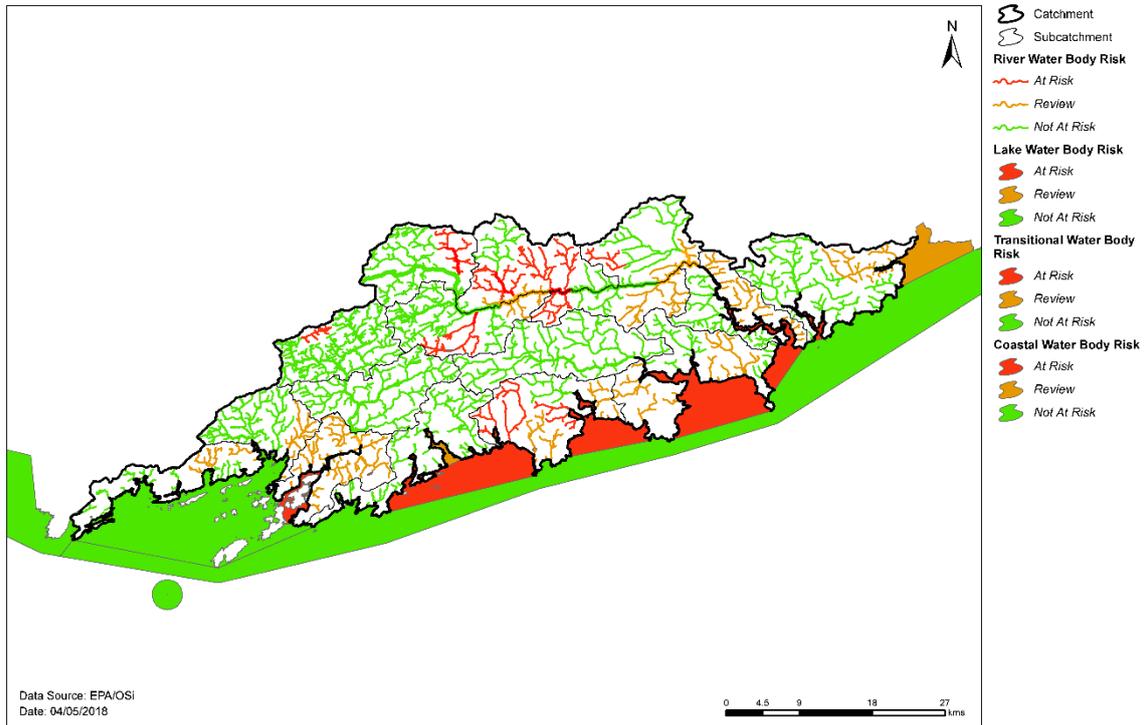
Figure 10. Surface water body risk

- ◆ There are 60 *Not at Risk* river and lake water bodies (Figure 10, Table 2) and these require no additional assessment or measures to be applied, other than those measures that are already in place.
- ◆ There are 19 river and lake water bodies in *Review*. This includes 15 water bodies where more information is required and four water bodies where ecological status is Good but nutrients are elevated.
- ◆ Fourteen river and lake water bodies in the catchment are *At Risk* of not meeting their water quality objectives. Measures will be needed in these water bodies to improve the water quality outcomes. Summary information for the *At Risk* water bodies is given in Appendix 3.

- ◆ There are five *Not at Risk* TraCs water bodies (Figure 10, Table 2) which require no additional measures to be applied, other than those measures that are already in place.
- ◆ Nine TraC water bodies are in *Review*. More information is required in water bodies where measures have recently been implemented and improvements have not yet been realised.
- ◆ There are 11 *At Risk* TraC water bodies that are not meeting their water quality objectives. These include three TraCs water bodies that are unassigned (Oysterhaven, Rosscarbery Bay and Rosscarbery Harbour) but which have some evidence that there are water quality issues. Measures will be needed in these water bodies to improve the water quality outcomes.

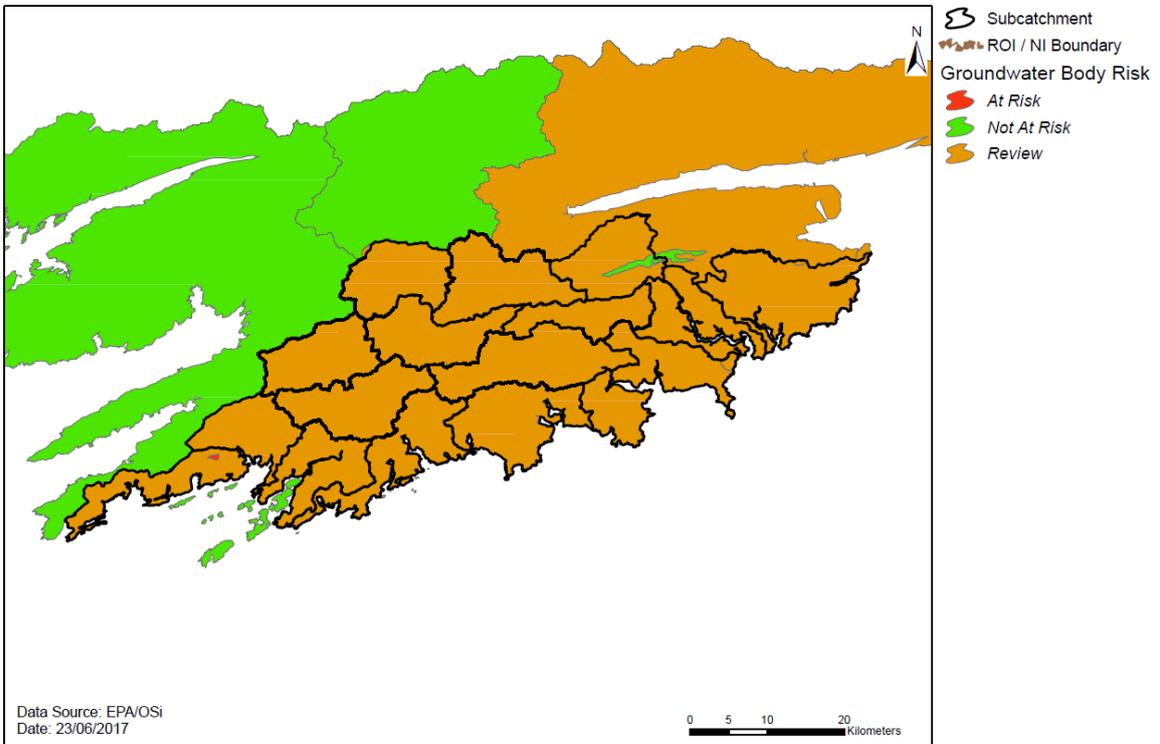
Figure 11. Groundwater body risk

- ◆ Four groundwater bodies (Bandon, Skibbereen-Clonakilty, Brinny Gravels East and Brinny Gravels West) are in *Review* (Figure 11, Table 3). Two of the groundwater bodies (*Bandon* and Skibbereen-Clonakilty) have elevated nitrate concentrations. The remaining two groundwater bodies (Brinny Gravels East and Brinny Gravels West) are likely to be contributing phosphate to associated surface water bodies.
- ◆ There is one *At Risk* groundwater body IE\_SW\_G\_016 – due to ammonia from a waste site that has the potential to contribute to associated surface water bodies. Measures will be needed in this water body to improve water quality outcomes.

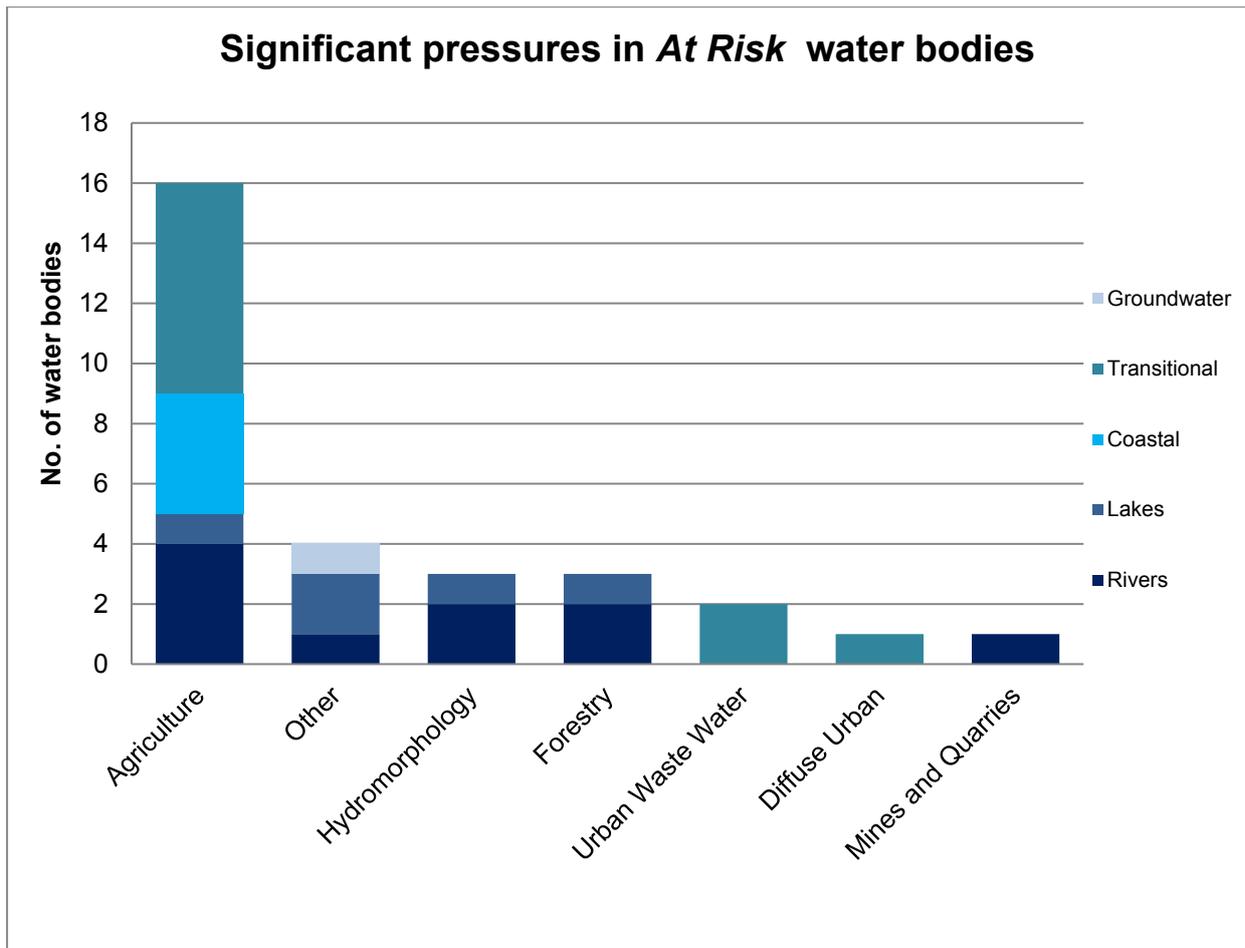
Figure 12 Significant pressures impacting on *At Risk* water bodies

- ◆ Where surface water bodies have been classed as *At Risk* by water quality or survey data, significant pressures have been identified.
- ◆ Figure 12 shows a breakdown of the number of *At Risk* surface water bodies in each significant pressure category.

- ◆ Significant pressures have been identified in 25 water bodies, three of which have multiple pressures. Additional significant pressures will be identified as further Catchment Assessments are carried out.
- ◆ The significant pressure affecting the greatest number of surface water bodies is agriculture, followed by other, hydromorphological pressures, forestry, urban waste water, diffuse urban, and mines and quarries.

- ◆ The significant pressure affecting the IE\_SW\_G\_016 groundwater body is the waste facility W0089-02. The key parameter of concern is ammonia. Figure 12 shows the breakdown of the number of *At Risk* groundwater bodies in each significant pressure category.

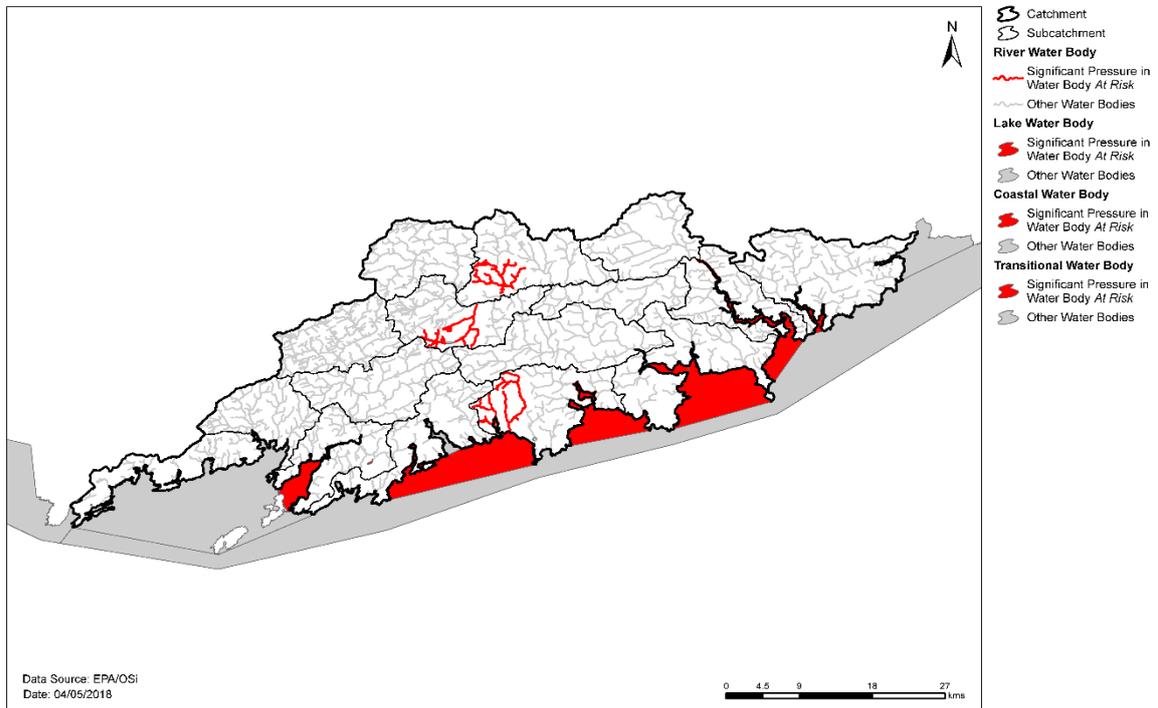
Figure 13. Water bodies that are *At Risk* and are impacted by agricultural activities

- ◆ Agriculture is a significant pressure in four river water bodies in the Bandon Ilen catchment (wnahinchy\_010, Blackwater (Bandon)\_030, Tinneel Stream\_010 and Bealanascartane\_010), one lake water body (Abisdealy lake), seven transitional water bodies (Argideen Estuary, Clonakilty Harbour, Rosscarbery Harbour, Lower Bandon Estuary, Upper Bandon Estuary, Oysterhaven and Ilen Estuary), and four coastal water bodies (Courtbacsherry Bay, Clonakilty Bay, Rosscarbery Bay and Kinsale Harbour), shown in Figure 13. The issues related to farming in this catchment are generally related to loss of phosphorus and ammonia loss to surface waters from, for example, direct discharges; or runoff from yards, roadways or other compacted surfaces, or runoff from poorly draining soils. Sediment can also be a problem from land drainage works, bank erosion from animal access or stream crossings. The pollution impact potential map showing areas of relative risk for phosphorus loss from agriculture to surface water is given in Appendix 6.

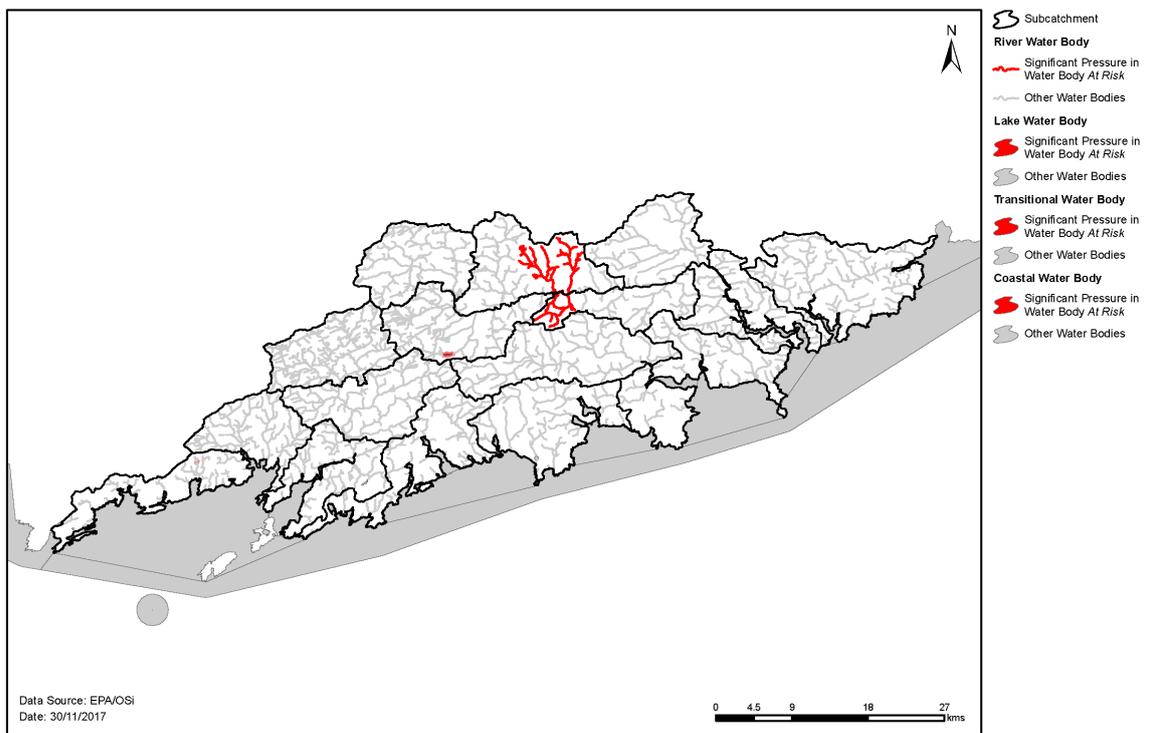
Figure 14. Water bodies that are *At Risk* and are impacted by other anthropogenic pressures

- ◆ *Unknown Anthropogenic*  
One river water body (Bandon\_060) and two lake water bodies (Skeagh and Curraghlicky) have unknown anthropogenic pressures (Figure 14). One groundwater body (IE\_SW\_G\_016) has a waste facility as a significant pressure.

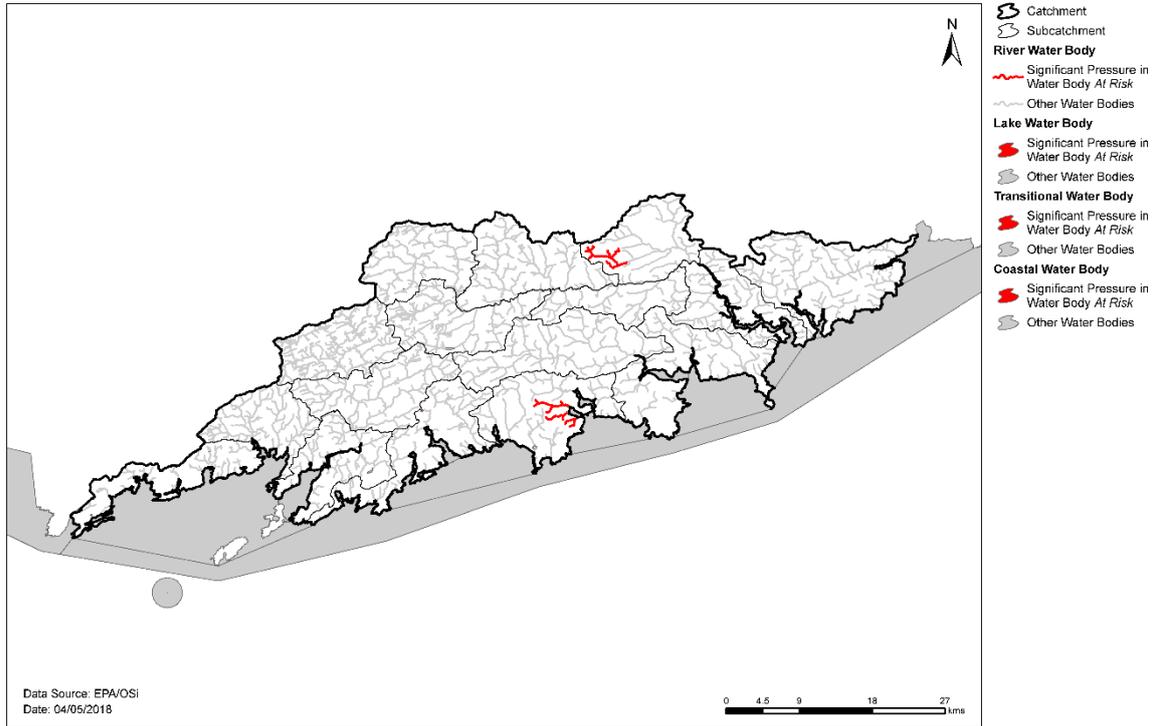
Figure 15. Water bodies that are *At Risk* and are impacted by hydromorphological pressures

- ◆ Two river water bodies, Ballymahane 010 and Carhoo 010 are subject to extensive modification, both within and along the channel. A weir has impacted the hydrological conditions of a lake water body (Ballin CK) within the Roury subcatchment. (Figure 15).
- ◆ See Appendix 3 for information on these water bodies.

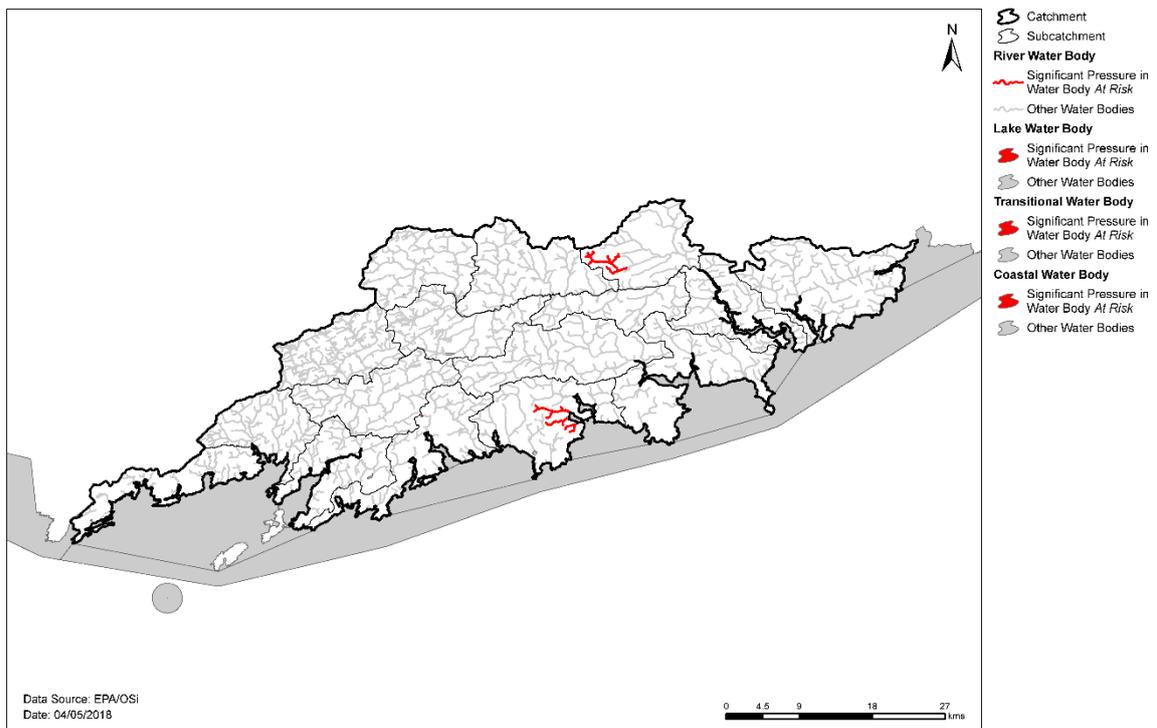
Figure 16. Water bodies that are *At Risk* and are impacted by forestry activities

- ◆ Forestry has been identified as a significant pressure in one lake water body (Coolkellure Lake) and two river water bodies (Caha\_020 and Owennashingaun\_010), as shown in Figure 16. Significant issues from forestry are typically input of sediment from road construction, planting and harvesting operations, and nutrient input from fertilisation of young trees.

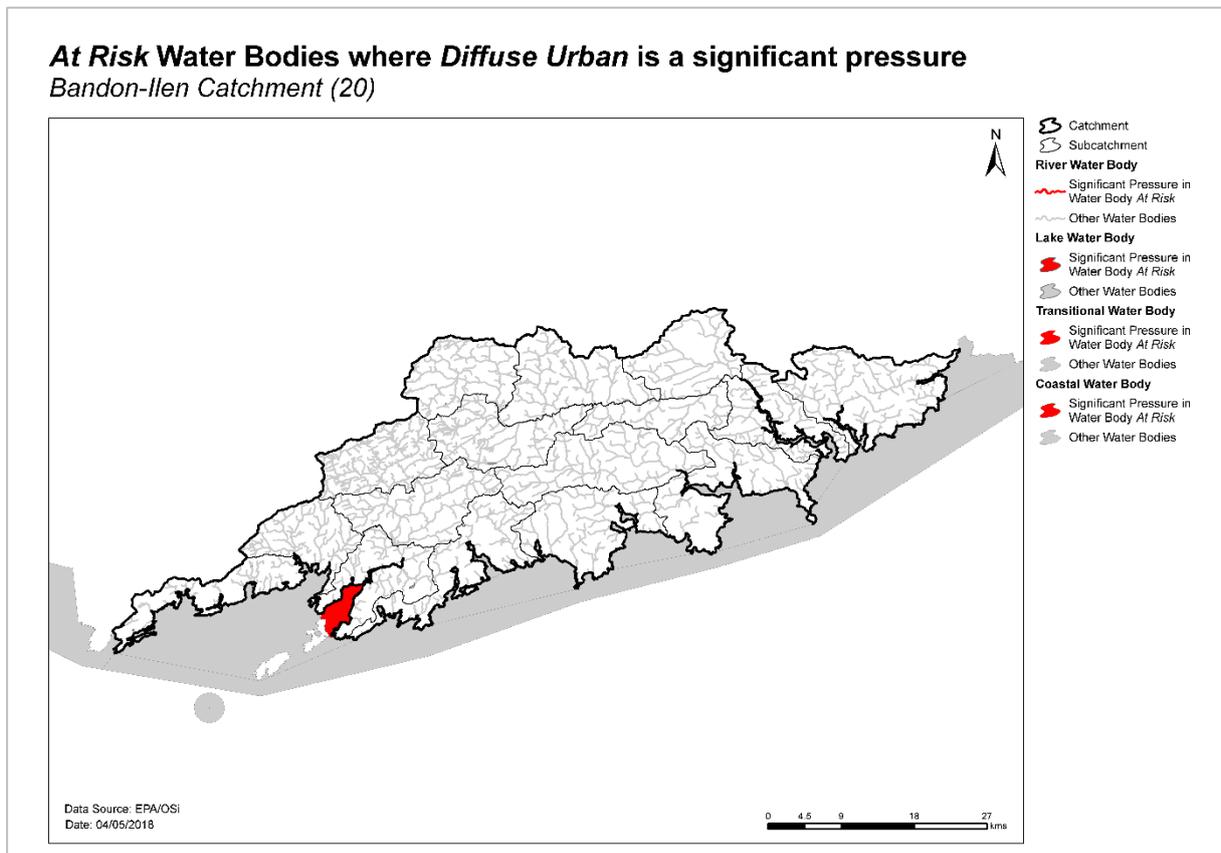
Figure 18. Water bodies that are *At Risk* and are impacted by diffuse urban impacts

- ◆ Diffuse urban has been identified as a significant pressure in the Ilen Estuary transitional water body (Figure 18).

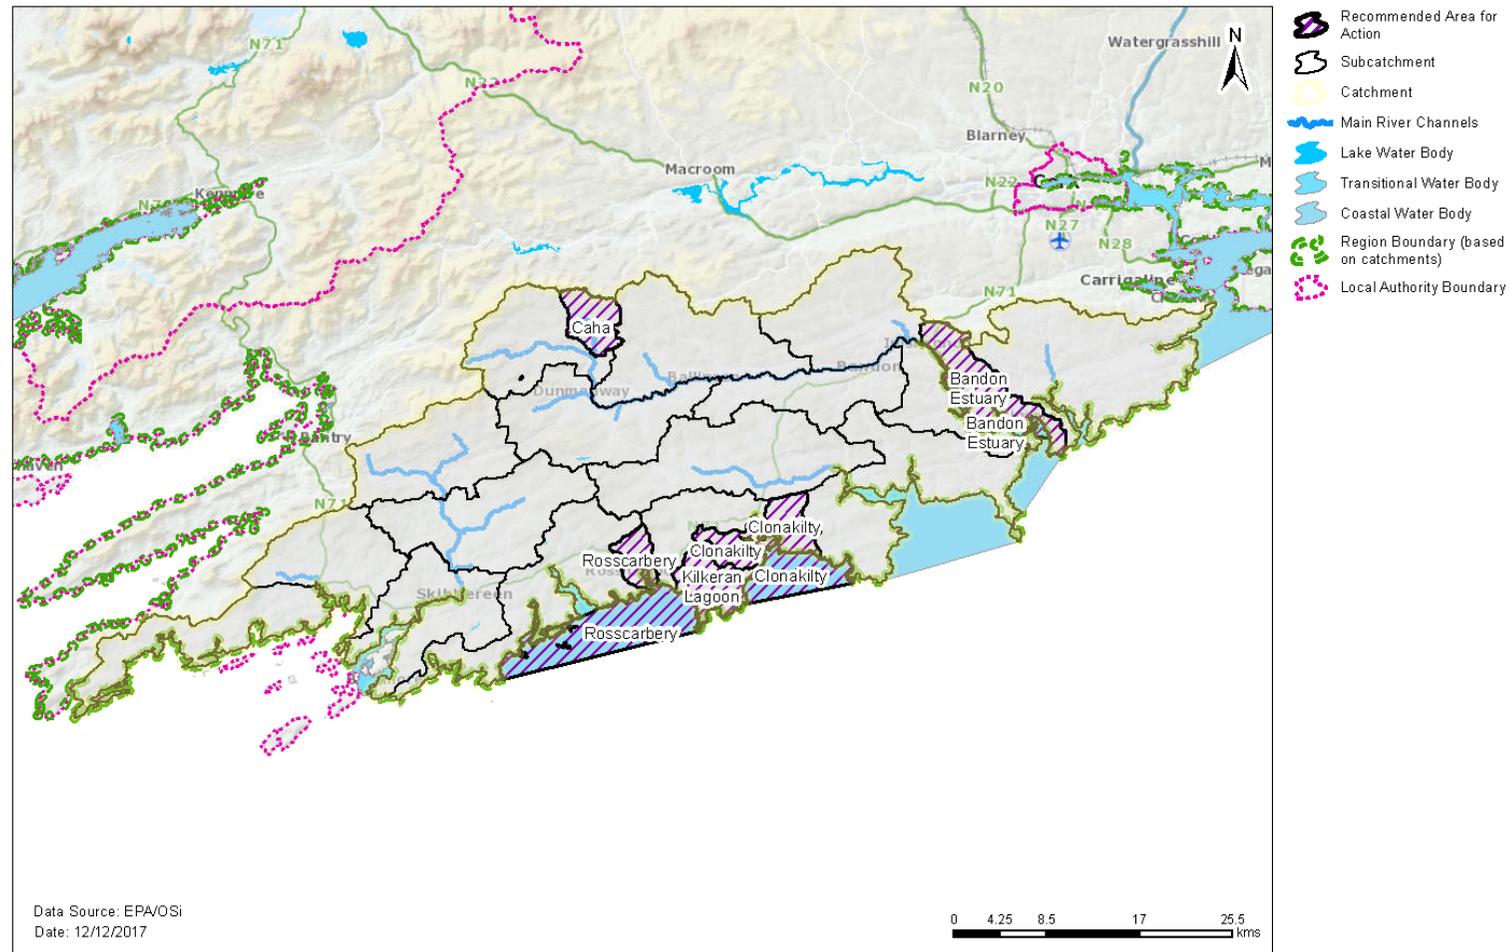
Figure 20 Location of Recommended Areas for Action in the Bandon Ilen Catchment

- ◆ Five recommended areas for actions (Table 11, Figure 20) were selected.
- ◆ These are the Kilkeran Lagoon, Clonakilty, Bandon estuary, Caha and Rosscarbery.
- ◆ These include:
  - nine river and lake water bodies - four *At Risk* and five *Review*, and
  - seven transitional and coastal water bodies - six *At Risk* and one *Review*.
- ◆ Two groundwater bodies, that are in *Review* due to groundwater contribution of nutrients to surface water bodies, intersect with five of the recommended areas for action, see Table 12. Actions taken to improve surface water will need to take account of the groundwater contribution to surface water.

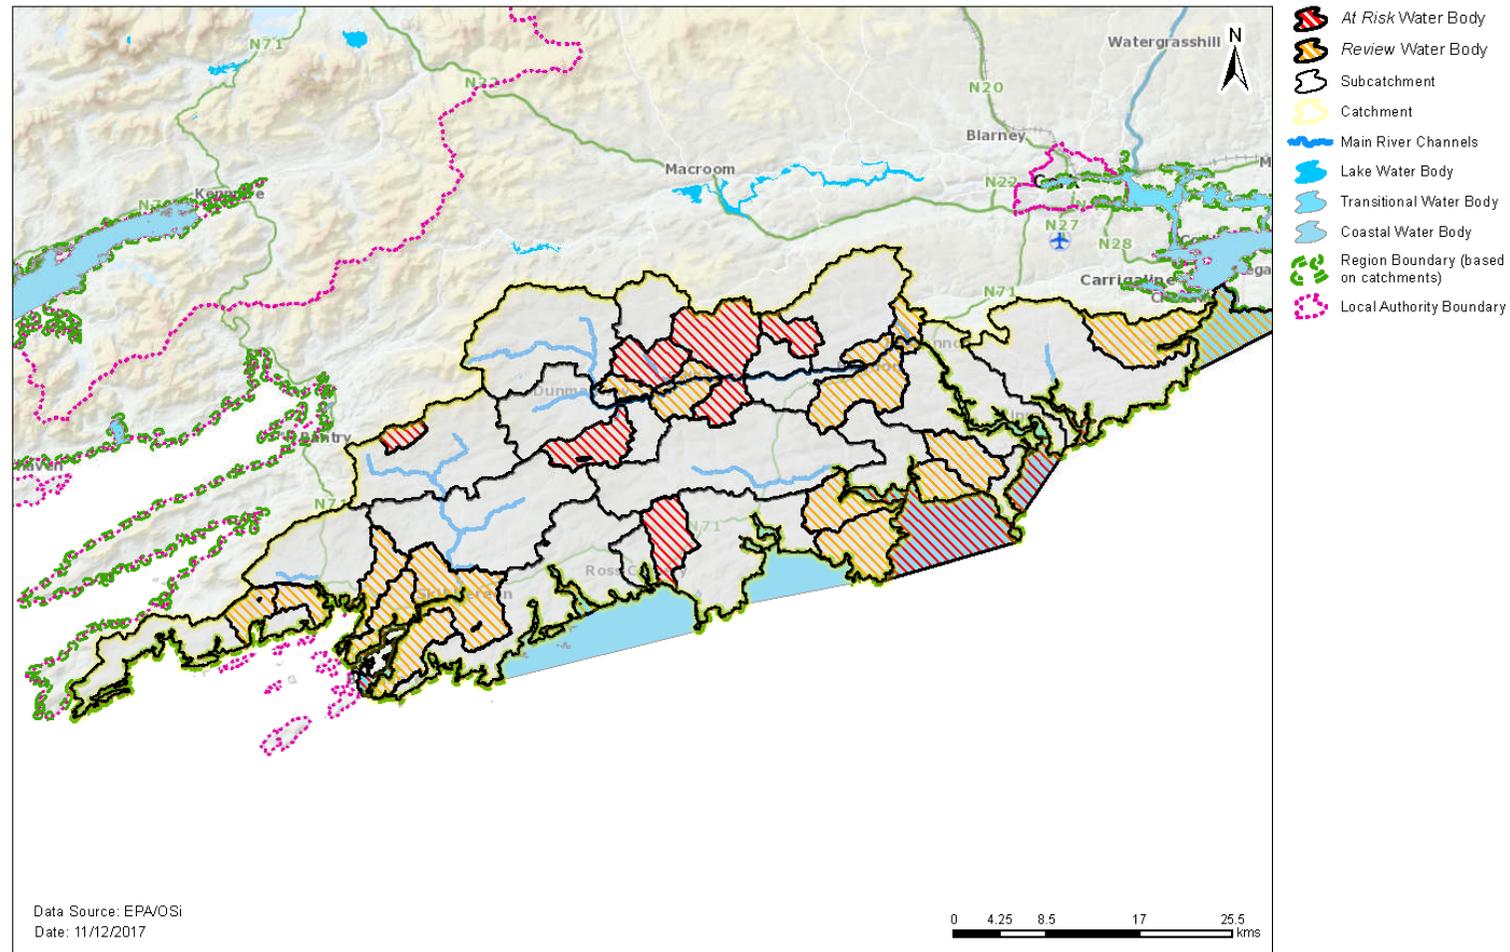
Figure 21 Location of *At Risk* and *Review* water bodies located outside Recommended Areas for Action in the Bandon Ilen Catchment

A remaining thirty-seven *At Risk* and *Review surface* water bodies were not included in the recommended areas for action for the second cycle. The distribution of these is presented in Figure 21. These include:

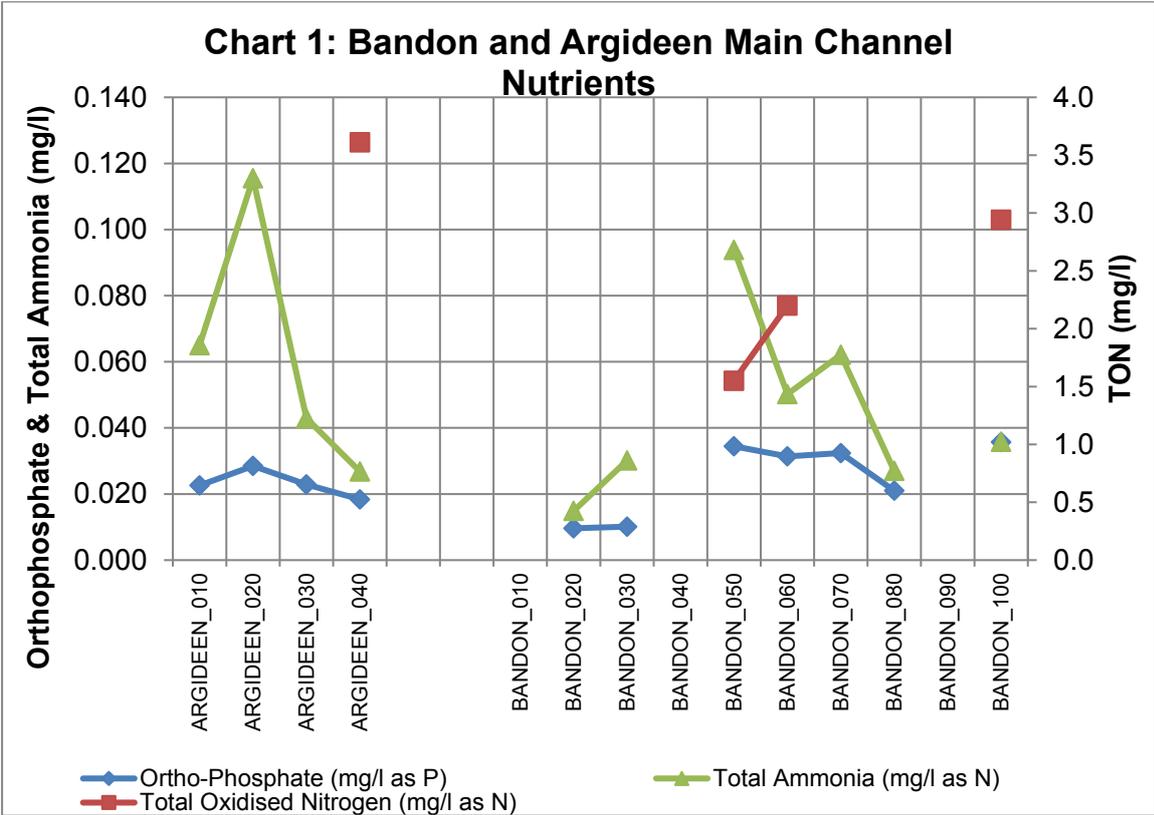
The results of the water quality assessment for the Bandon and Argideen main channels are illustrated in Chart 1. The assessment is based on the mean concentrations between 2013 and 2015 at each site from the headwaters down to the estuary. Orthophosphate concentrations in the Argideen River are below the EQS at all sampling points where monitoring data is available, ranging from 0.018 to 0.023mg/l. Total ammonia concentrations are either at or below the EQS (0.065mg/l) along the channel, apart from ARGIDEEN\_020, where a significant concentration peak (0.12mg/l) occurs. TON data is only available for ARGIDEEN\_040 (3.61mg/l), which exceeds the TON threshold (2.6mg/l).

Along the Bandon main channel orthophosphate concentrations are relatively low in upstream reaches. BANDON\_050, 060 and 070 have concentrations which approach the EQS (0.035mg/l), however the EQS is only exceeded at BANDON\_100. Total ammonia concentrations are below the EQS at all sampling points along the main channel, with the exception of BANDON\_050 with exceeds the threshold. TON data is available for three of the 10 main channel sampling points, showing a trend of increasing downstream concentrations and exceeding the threshold (2.6mg/l) at BANDON\_100.

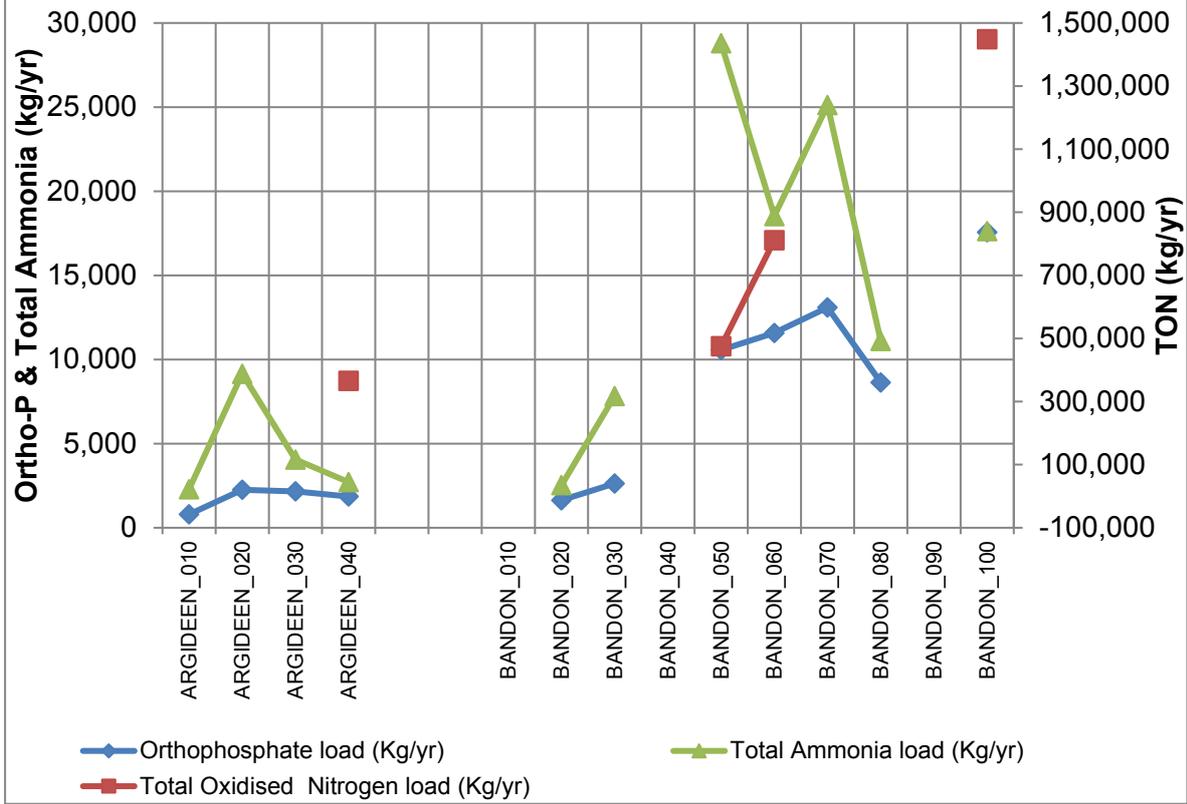
**Chart 2: Bandon Main Channel Nutrient Loading**

The nutrient loadings, as shown in Chart 2, show similar trends to the concentrations trends in Chart 1, with highest loads corresponding to concentration peaks.

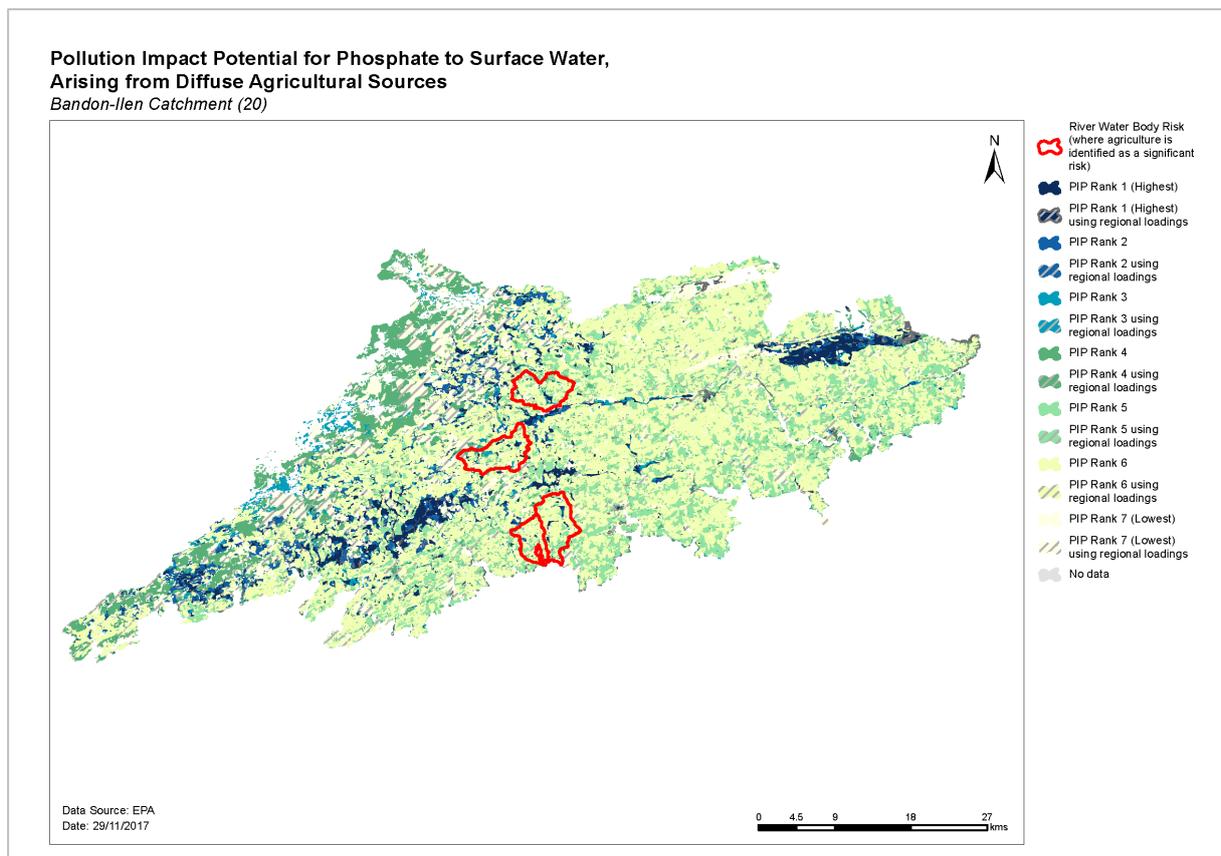
## Appendix 6 Pollution Impact Potential (PIP) Map for Phosphorus

For areas where agriculture is deemed as the significant pressure, areas of high risk to surface water can be targeted. The map below shows relative risk of loss of phosphorus to surface water. The risk of phosphorus losses is strongly correlated on whether the land is poorly draining or free draining and the loadings applied i.e. significant loadings applied on poorly draining areas result in a high potential risk to surface water. However, this figure does not imply that actual losses from these areas are occurring but is a useful tool for informing where resources should be focused (i.e. by allowing high risk areas to be identified and prioritised for further investigation). PIP maps are available online at a scale of 1:20,000 and can be accessed by public bodies via the EDEN process.
