**NS 2 FRESHWATER PEARL MUSSEL SUB-BASIN
MANAGEMENT PLANS**

**REPORT ON MORPHOLOGICAL MONITORING AND
CATCHMENT WALKOVER RISK ASSESSMENTS IN THE
GLASKEELAN CATCHMENT**

September 2009

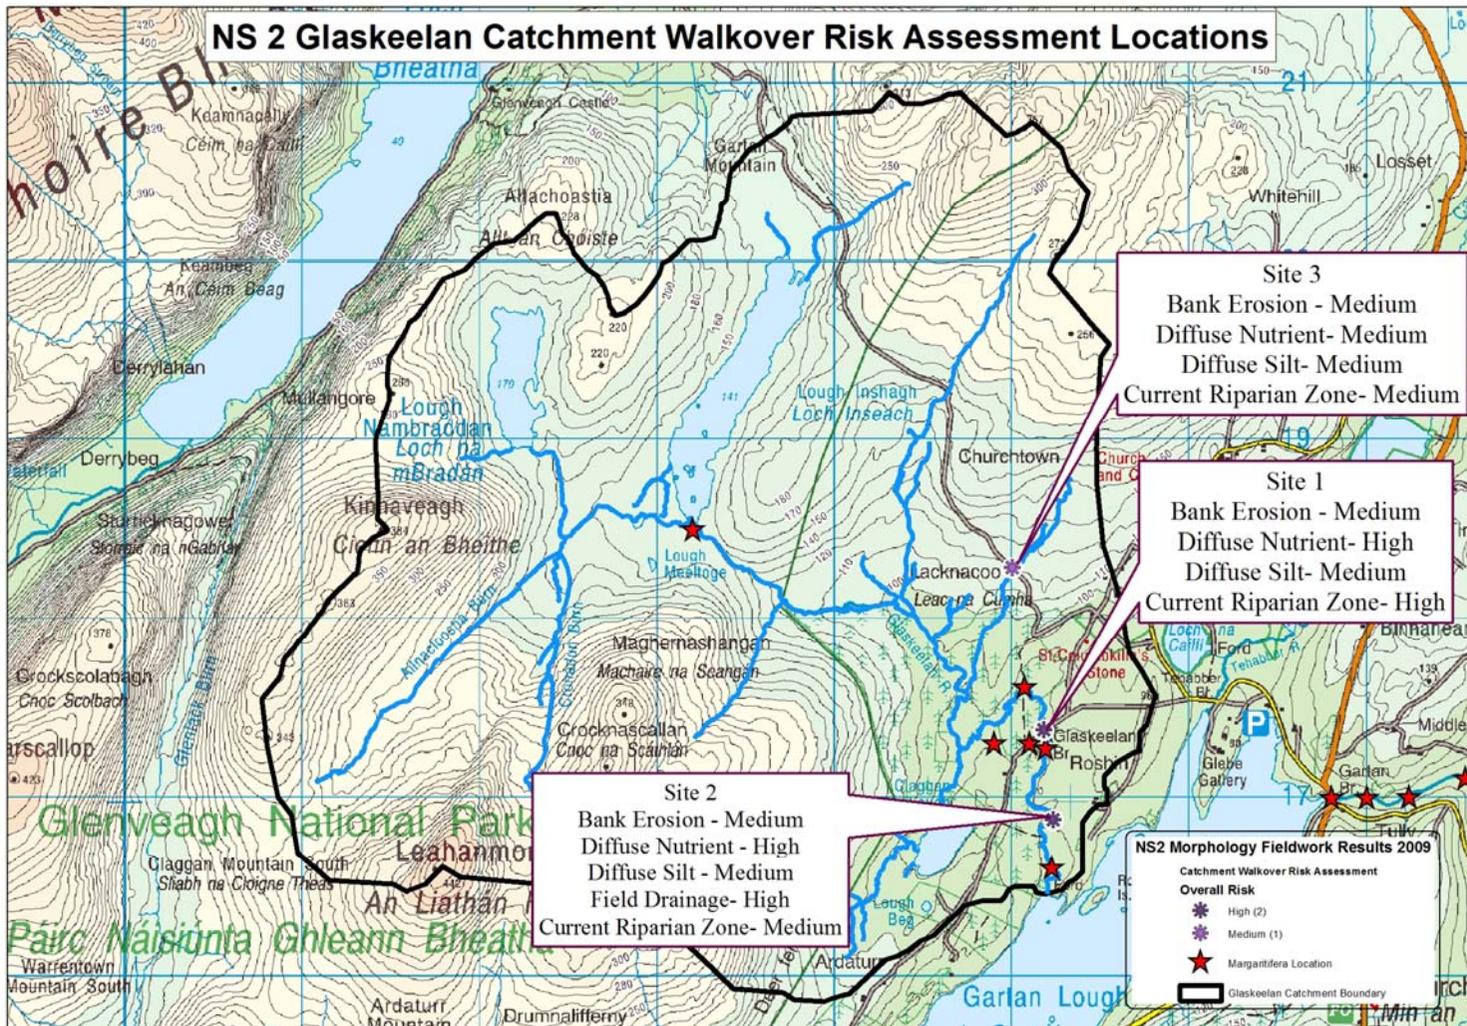
Figure 1 Location of Catchment Walkover Risk Assessments

A total of three sites were surveyed in the Glaskeelan sub-basin catchment, with a risk assessment carried out at all three of these sites. Figure 1 outlines the locations of the High to Low Risk Assessment from the Catchment Walkover Risk Assessments. Two high risk sites were recorded out of the three that were assessed. The remaining site was recorded as medium risk, meaning no low risk sites were recorded within this catchment. Figure 2 outlines the percentage of sites classified at high and medium risk throughout the catchment.

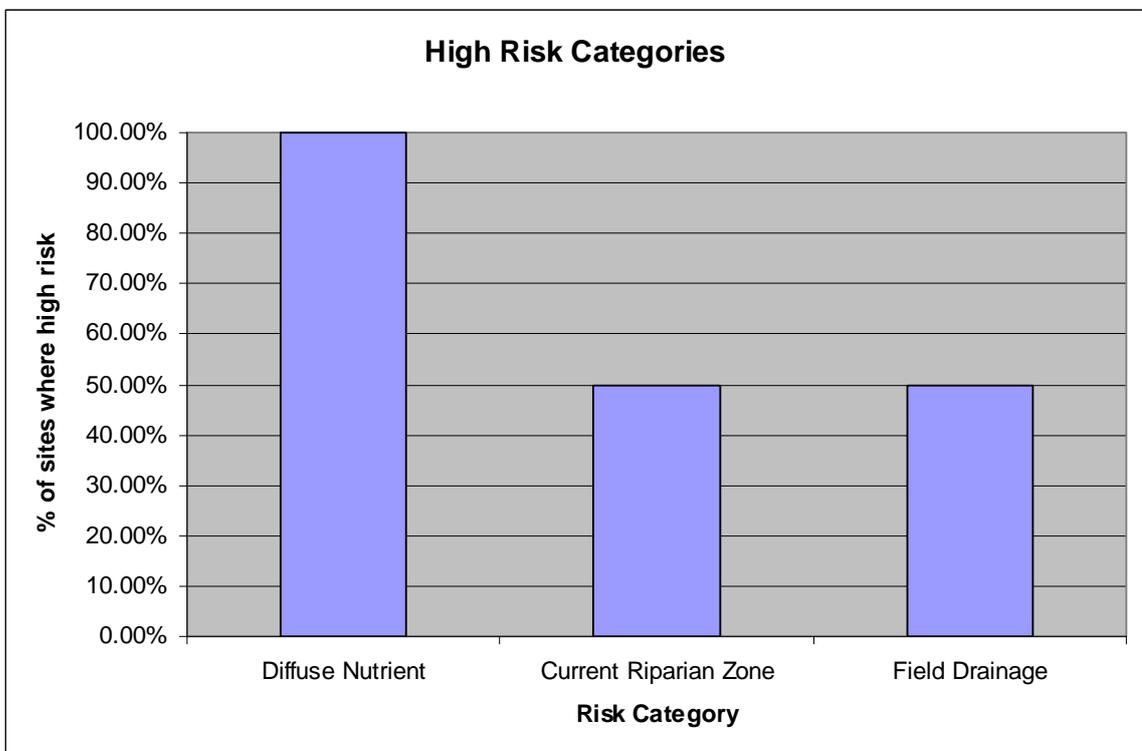
Figure 3 Breakdown of High Risk Categories

The break-down of pressure categories identified as high risk are outlined in Figure 3

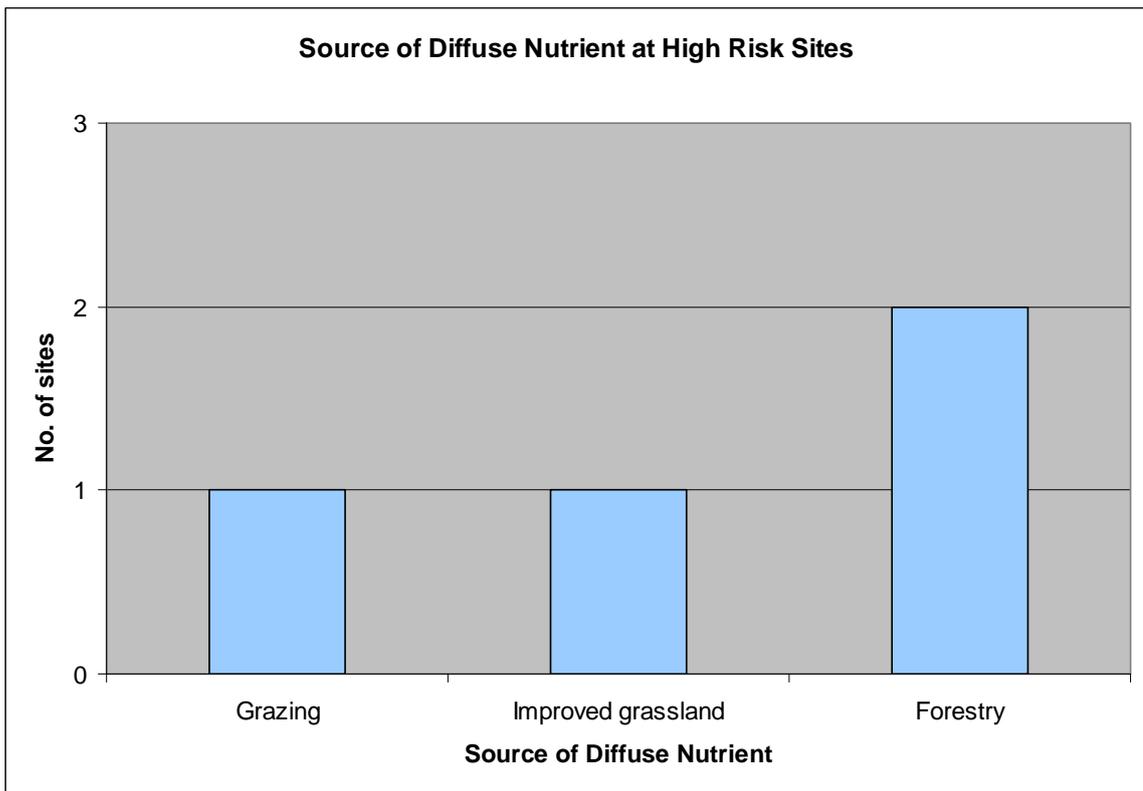
Figure 4 Sources of Diffuse Nutrient at High Risk Sites

The most common source of diffuse nutrient was forestry evident at both high risk sites. A break-down of the individual sources of diffuse nutrient at high risk sites is given in **Figure 4**.

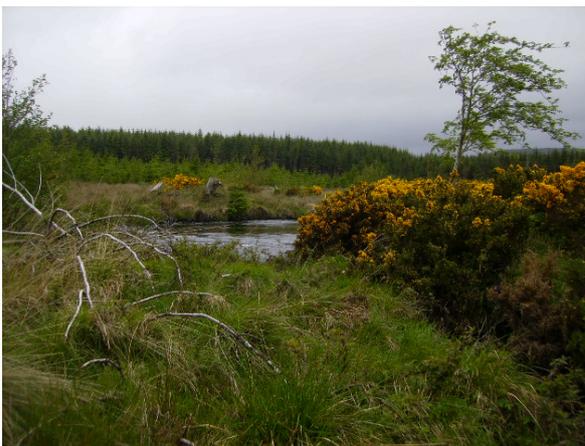
Site 1, Photo 2 – New and old forestry

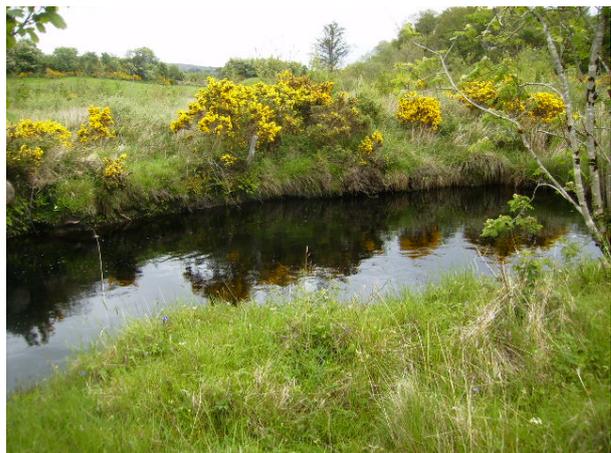
Site 2 – Photo 7 Deep slow moving channel – possible historically drained.

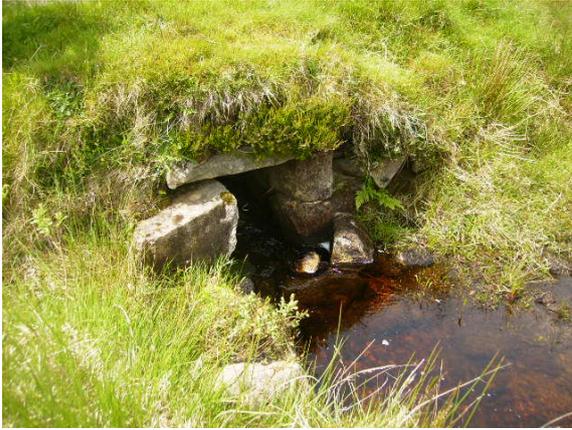
Site 3, Photo 5 – Old stone culvert

3	Glaskeelan		205003	418282	1,2										
3	Glaskeelan		205003	418282	3										
3	Glaskeelan		205003	418282	4										Ditch dug along hiking trail / mountain track leading to tributary
3	Glaskeelan		205007	418284	5										Stone culvert under hiking path

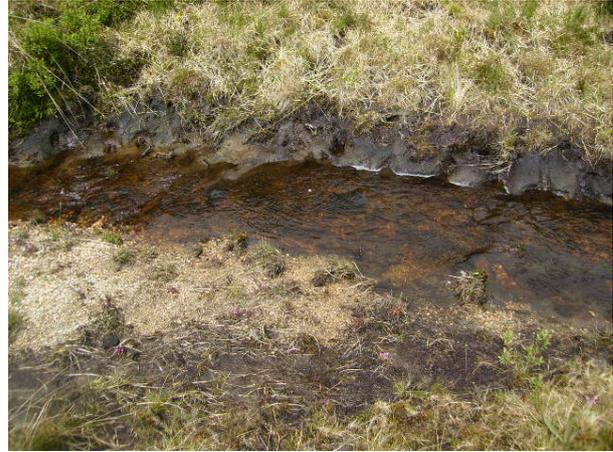
Site 3, Photo 6 – Peaty soils, peat stain channel
