**NS 2 FRESHWATER PEARL MUSSEL SUB-BASIN
MANAGEMENT PLANS**

**REPORT ON MORPHOLOGICAL MONITORING AND
CATCHMENT WALKOVER RISK ASSESSMENTS IN THE
CLADY CATCHMENT**

September 2009

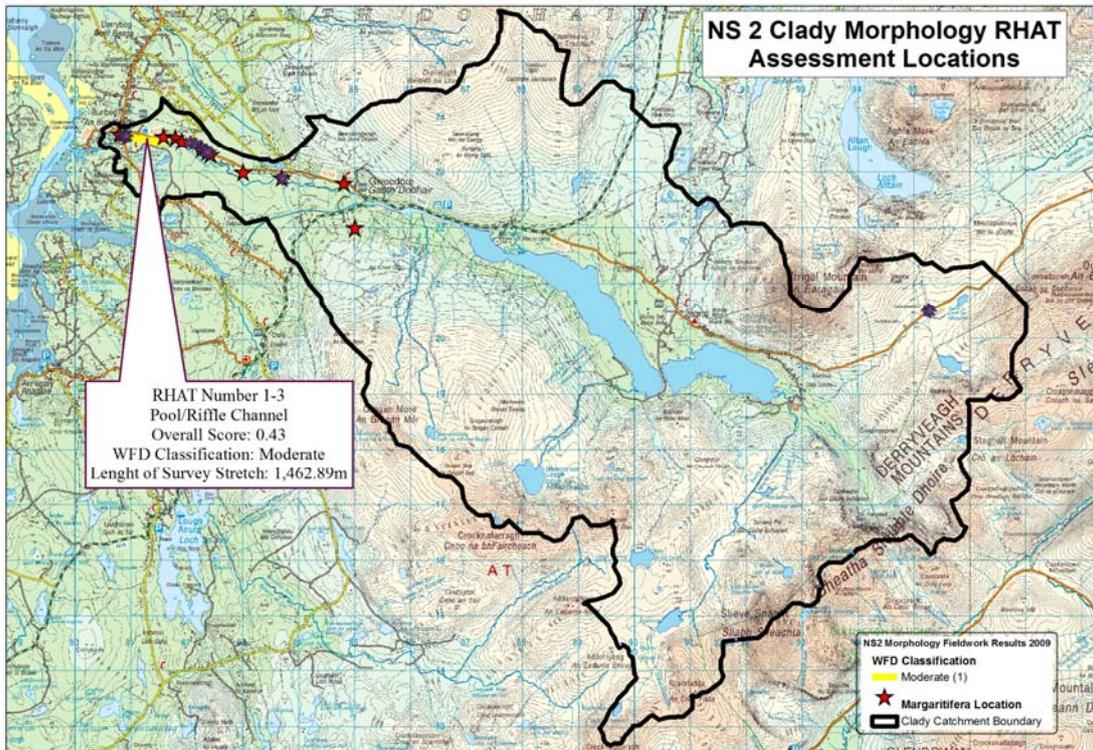
Figure 1 Morphology RHAT Assessment Locations

Figure 1 indicates where the Clady morphology and catchment walkover risk assessments were carried out throughout the catchment.

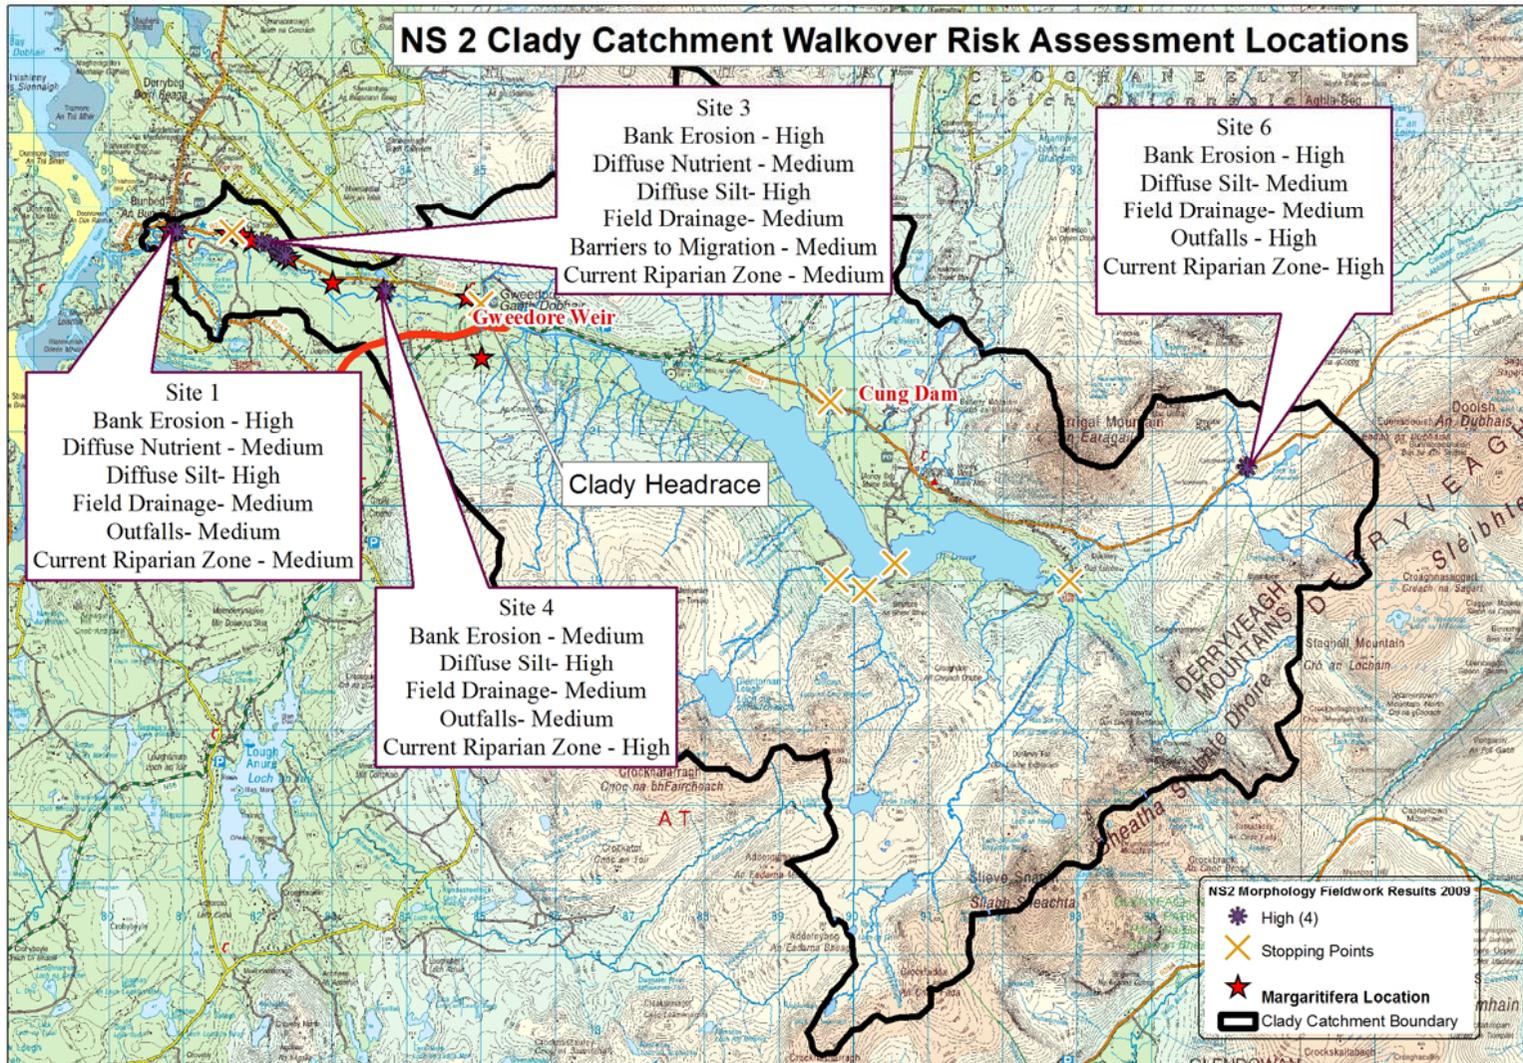
Figure 3.2 Location of Stopping points and Catchment Walkover Risk Assessments

A total of eleven sites were surveyed in the Clady sub-basin catchment, with a risk assessment carried out at four of these sites (7 stopping points). **Figure 3.2** outlines the stopping point locations in addition to the High to Low Risk Assessment from the Catchment Walkover Risk Assessments. All four assessed sites were recorded as high risk; meaning no medium or low risk sites were recorded within this catchment. **Figure 3.3** outlines the percentage of sites classified at high risk together with the number of stopping points throughout the catchment.

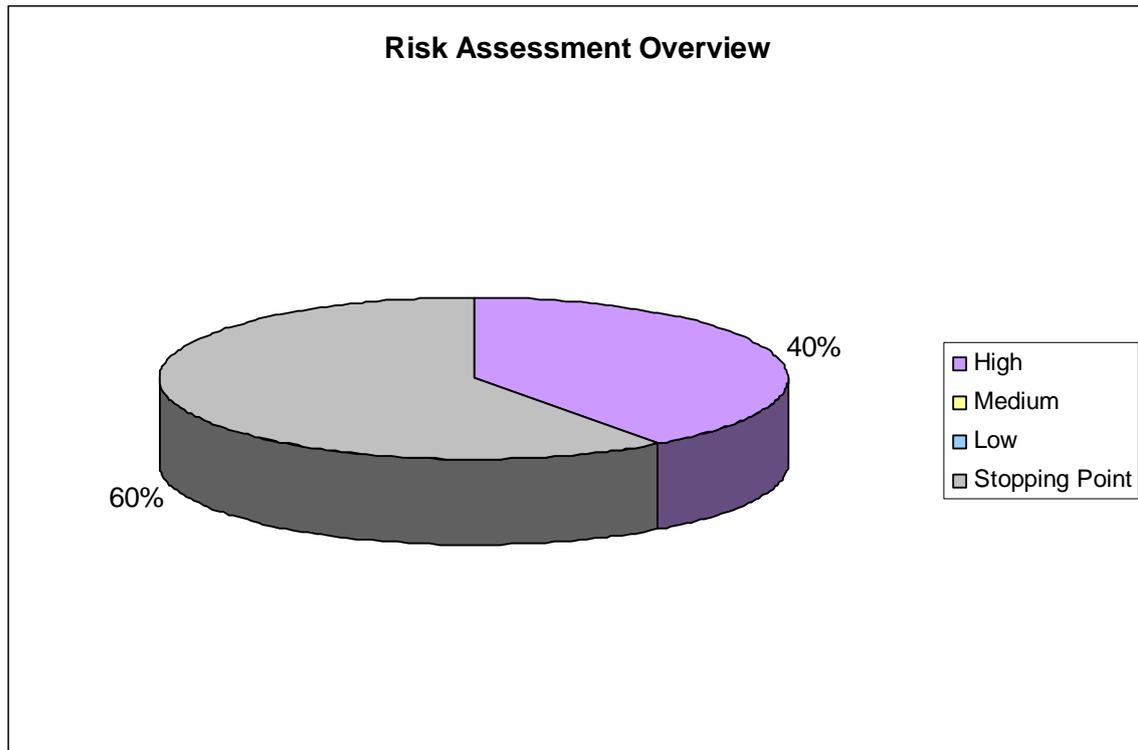
Figure 3.3 Risk Assessment Overview

Where one or any of these aspects is found to be the cause of significant impact to the riparian zone, or the channel along the stretch then this category may be assigned a high risk score. Locations where pressures were evident in the field which were not highlighted through the desk based assessment were also noted as stopping points. These points were not selected prior to fieldwork, they were opportunistic as the catchment drive through was taking place. The pie chart in **Figure 3.3** indicates the percentage of stopping points also.

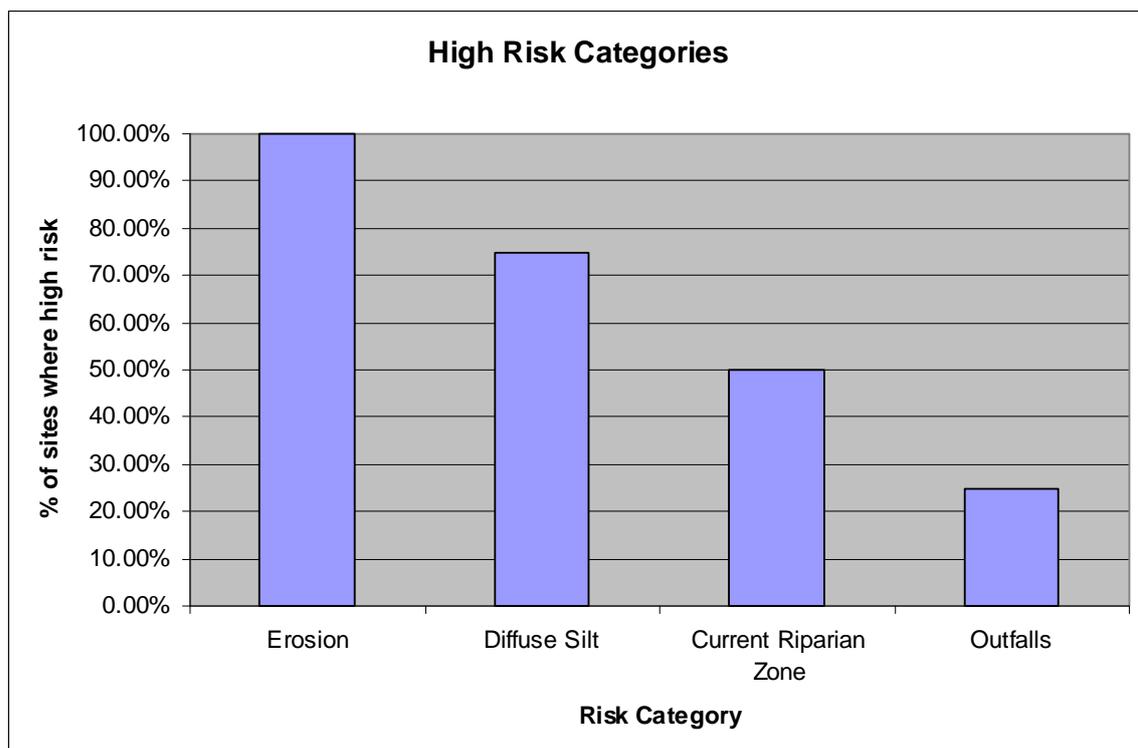
Figure 3.4 Breakdown of High Risk Categories

The break-down of pressure categories identified as high risk are outlined in **Figure 3.4**

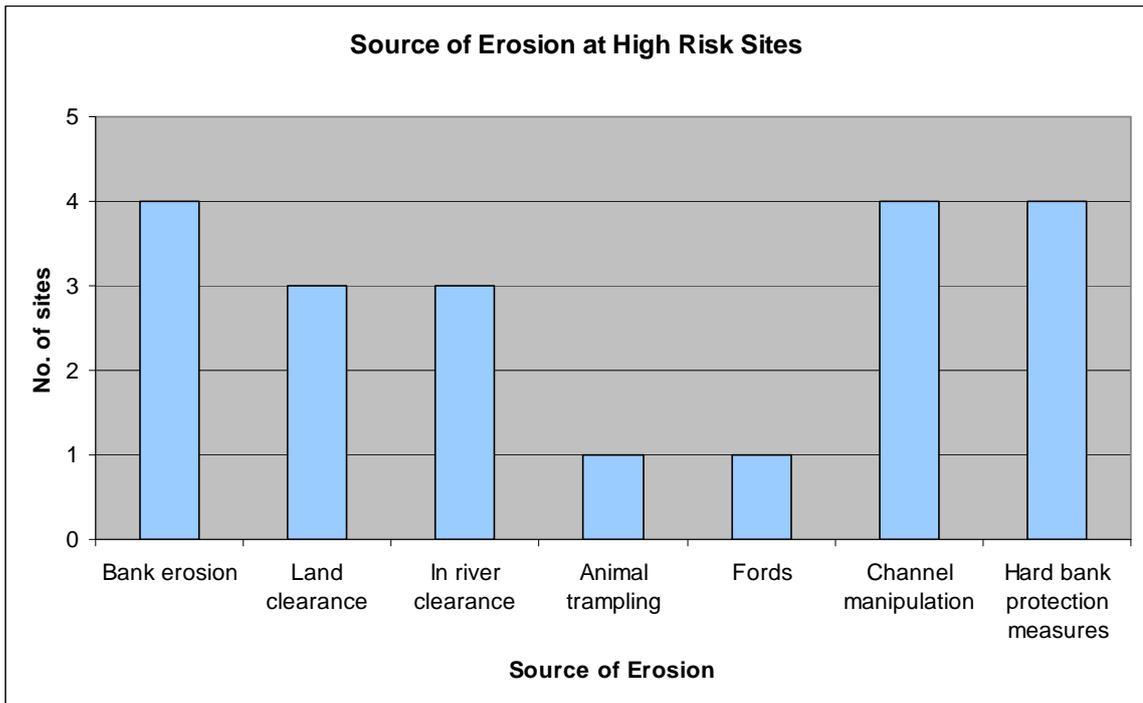
Figure 3.5 Source of Erosion at high risk sites

The most common sources of erosion were bank erosion, channel manipulation and bank protection measures each of which were evident at all four high risk sites. A breakdown of the individual sources of erosion at high risk sites is given in **Figure 3.5**

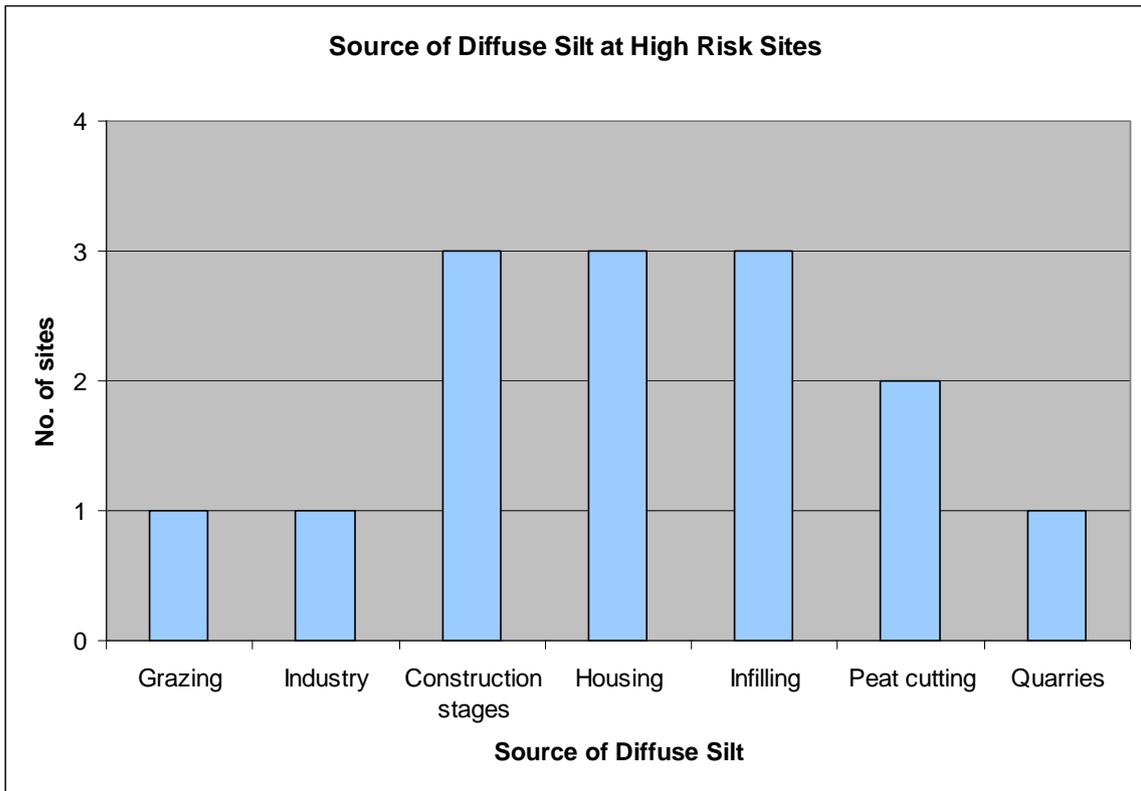
Figure 3.6 Sources of Diffuse Silt at High Risk Sites

The most common sources of diffuse silt at high risk sites are construction, housing and infilling; other sources of diffuse silt identified at high risk sites are illustrated in **Figure 3.9** below.

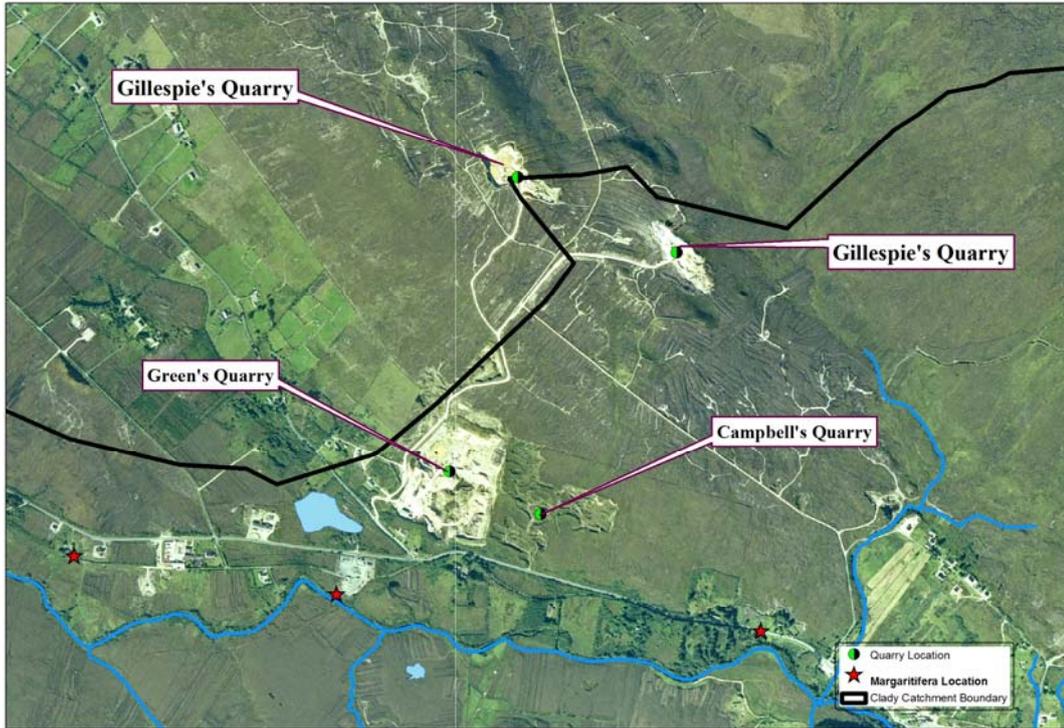
Figure 3.7 Location of Quarries adjacent to Freshwater Pearl Mussel locations

The Clady catchment contains nine quarries of which four are adjacent to a river stretch which has been classified as a “*current stretch*” i.e. where pearl mussel most likely occurs according to best professional judgement. The remaining quarries lie upstream within the catchment with one small quarry also located between Lough Nacung and Dunlewy Lough as per **Figure 3.7& 3.8**.

The potential risk from quarry dust, effluent or pollution incidents was investigated further at those quarries which could potentially impact the freshwater pearl mussel and its habitat largely within Meenderrygamph and Clois Claidí junction. A joint survey of the quarries which are in close proximity to the pearl mussel populations located within the Clady was carried out by Donegal CoCo, NPWS and the Northern Regional Fisheries Board. Of those quarries within the Meenderrygamph area a site visit was carried out at Gillespie's quarry. Planning for this quarry has expired as of the start of 2009. An application to renew the discharge licence was submitted to Donegal CoCo but has since been withdrawn. The owners of this quarry have been informed that a Habitats Directive Article (6) Appropriate Assessment would be required as part of any planning permission application or discharge licence renewal. This Appropriate Assessment would need to include a hydro-geological investigation in order to ensure no possible discharge to the Clady as rock seams might be factor in the movement of quarry water within this area.

The cluster of quarries near Clois Claidí junction was also investigated. While none of these quarries are currently active any proposal to re-commence operations here must be subject to a discharge licence, and/or planning control through Donegal CoCo. All applications should also include a Habitats Directive Article (6) Appropriate Assessment.
