**NS 2 FRESHWATER PEARL MUSSEL SUB-BASIN
MANAGEMENT PLANS**

**REPORT ON MORPHOLOGICAL MONITORING AND
CATCHMENT WALKOVER RISK ASSESSMENTS IN THE
CURRANE CATCHMENT**

September 2009

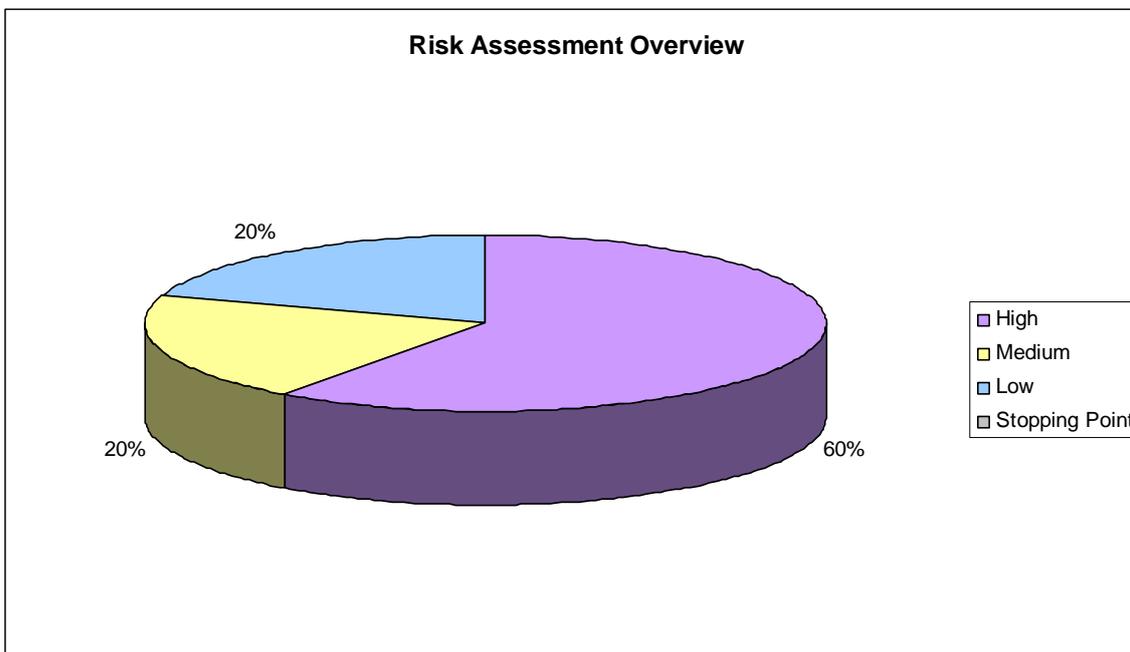
Figure 2 Risk Assessment Overview

A total of thirteen sites were surveyed in the Currane Sub-basin catchment; five within the Capall and seven within the Cumberagh with two stopping points. **Figure 2** outlines the stopping point locations together with the High to Low Risk Assessment from the Catchment Walkover Risk Assessments. Within the Capall catchment three high risk sites were recorded out of the five that were assessed. Of the two remaining one site was recorded as medium risk, meaning one low risk site was recorded within this catchment. Figure 3 outlines the percentage of sites classified at high, medium and low risk throughout the catchment. The most common high risk categories identified were:

- Current Riparian Zone – at 67% of high risk sites,
- Field Drainage – at 67% of high risk sites.

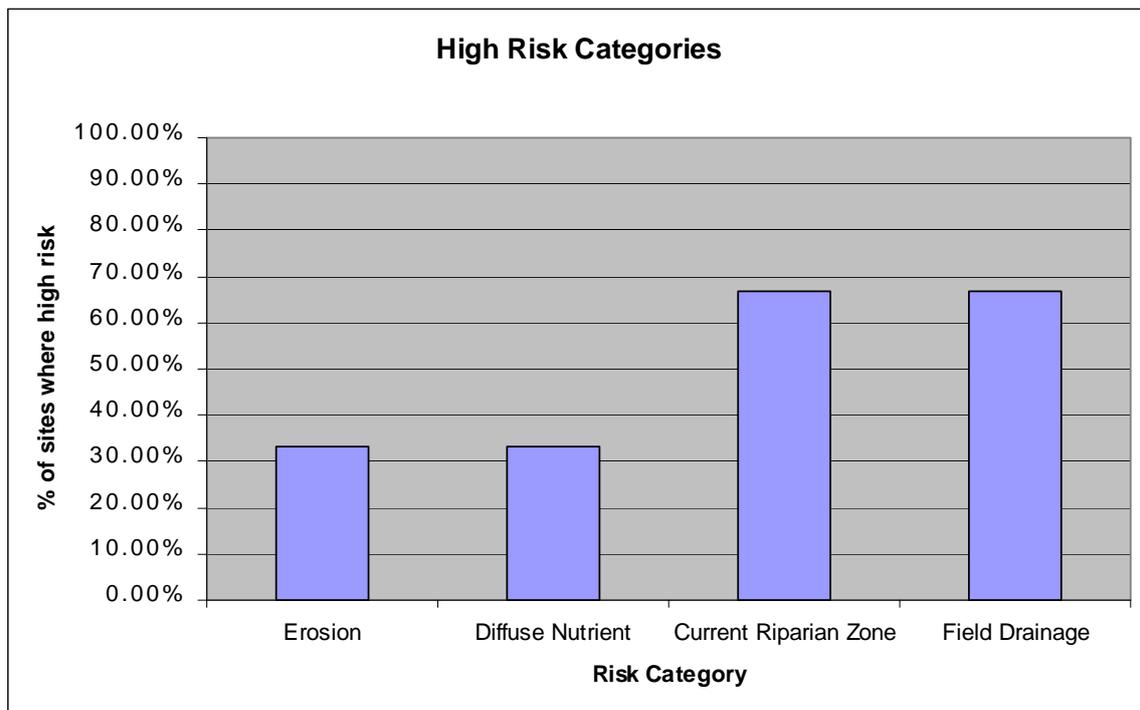
Figure 4 Break-down of High Risk categories

The break-down of high risk categories leading to a high risk site are shown in **Figure 4**.

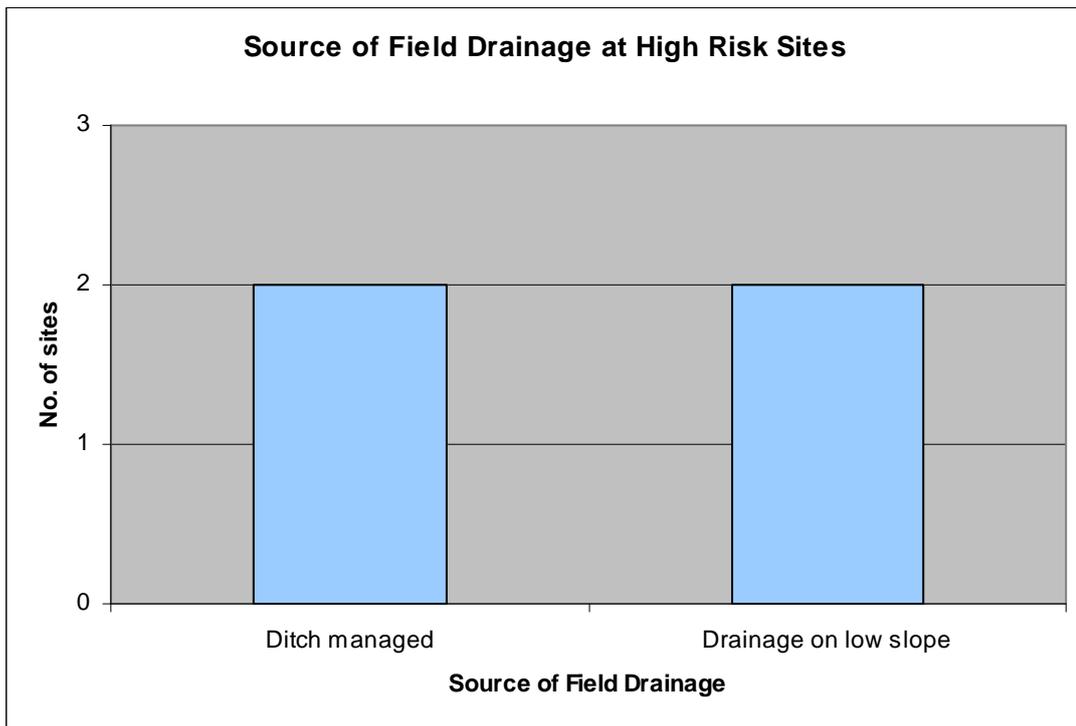
Figure 5 Source of field drainage at high risk sites

The most common sources of field drainage at high risk sites were managed ditches and drainage on a low slope; with each being high risk at two sites.

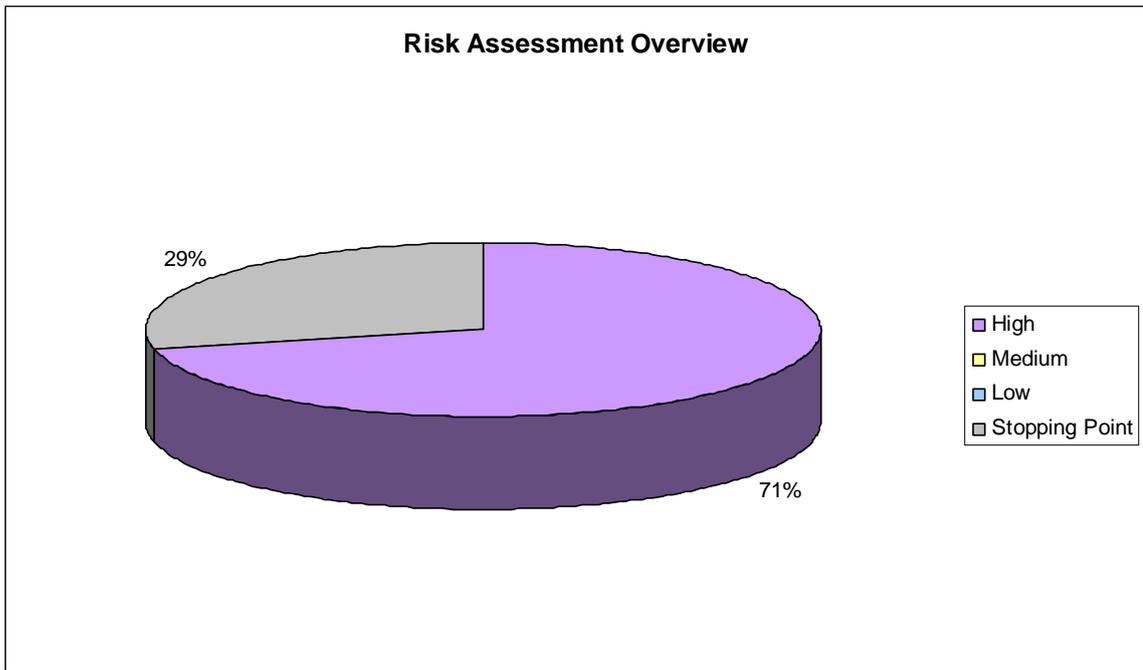
Figure 6 Risk Assessment Overview

All five sites were classified as high risk within the Cumberagh catchment. **Figure 6** outlines the percentage of sites classified at high risk together with the number of stopping points throughout the catchment. The most common high risk categories identified were:

- Erosion – evident at 60% of high risk sites,
- Diffuse Nutrient – evident at 40% of high risk sites,
- Current riparian zone – evident at 40% of high risk sites.

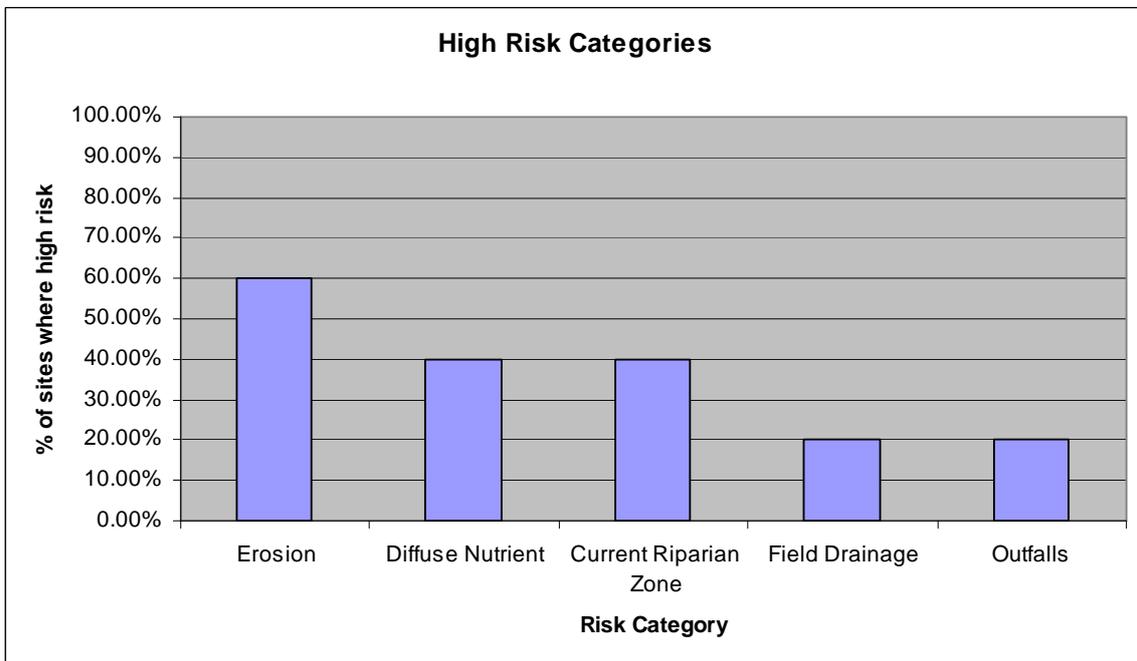
Figure 7 Breakdown of high risk categories

The breakdown of pressure categories identified as high risk are outlined in **Figure 7**

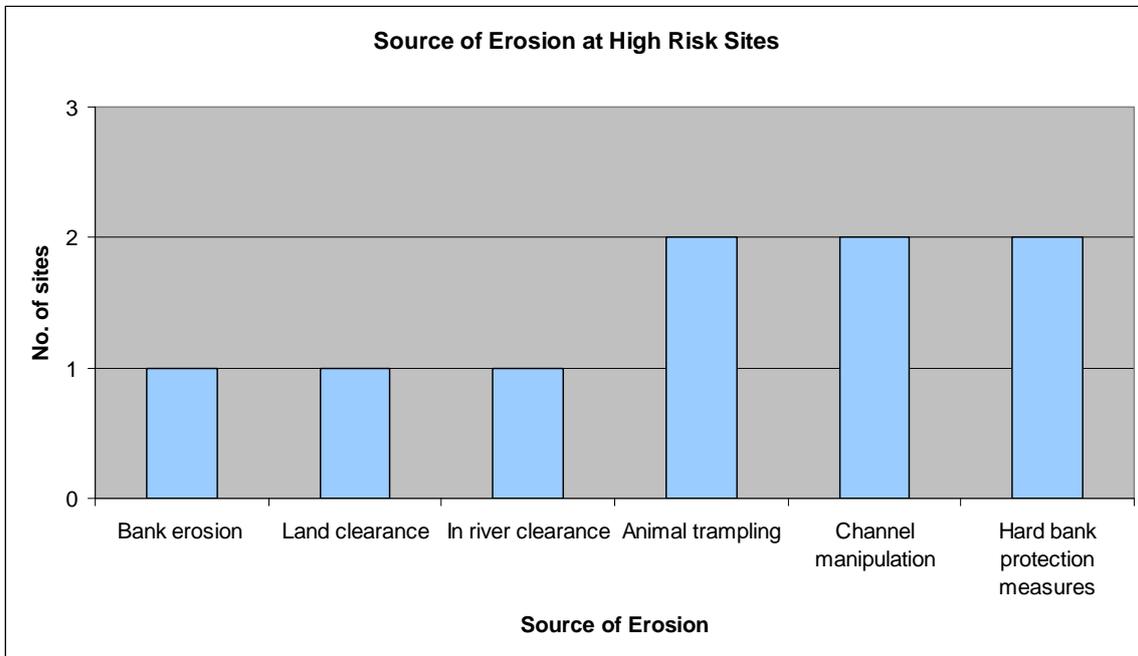
Figure 8 Sources of erosion at high risk sites

The most common sources of erosion are animal trampling, channel manipulation and bank protection measures each evident at two of the three high risk sites. The additional sources of high risk erosion are shown in **Figure 7**.
