**NS 2 FRESHWATER PEARL MUSSEL SUB-BASIN
MANAGEMENT PLANS**

**REPORT ON MORPHOLOGICAL MONITORING AND
CATCHMENT WALKOVER RISK ASSESSMENTS IN THE
ALLOW CATCHMENT**

September 2009

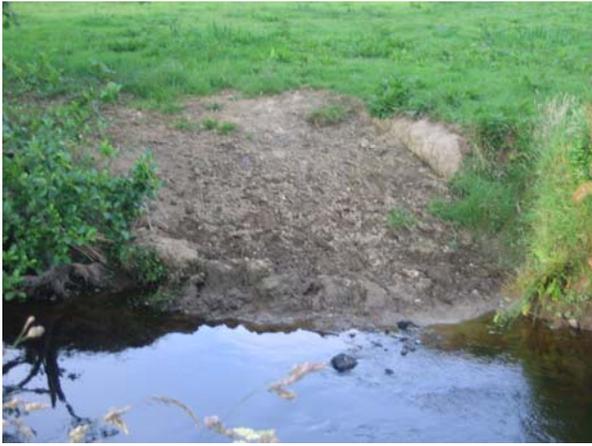
RHAT 87 Site 87 Photo 15

the substrate also at the beginning of the survey stretch. (See Photo 13). The Riaprian Landcover attribute was also marked down due to the presence of cattle access with noted trampling and/or poaching along on of the banks. Along some of the survey stretch there was also a very poor buffer zone. (See photo 15). Although these attributes scored low the overall stretch was still classified as being at high status as the pressures recorded were quite localised.

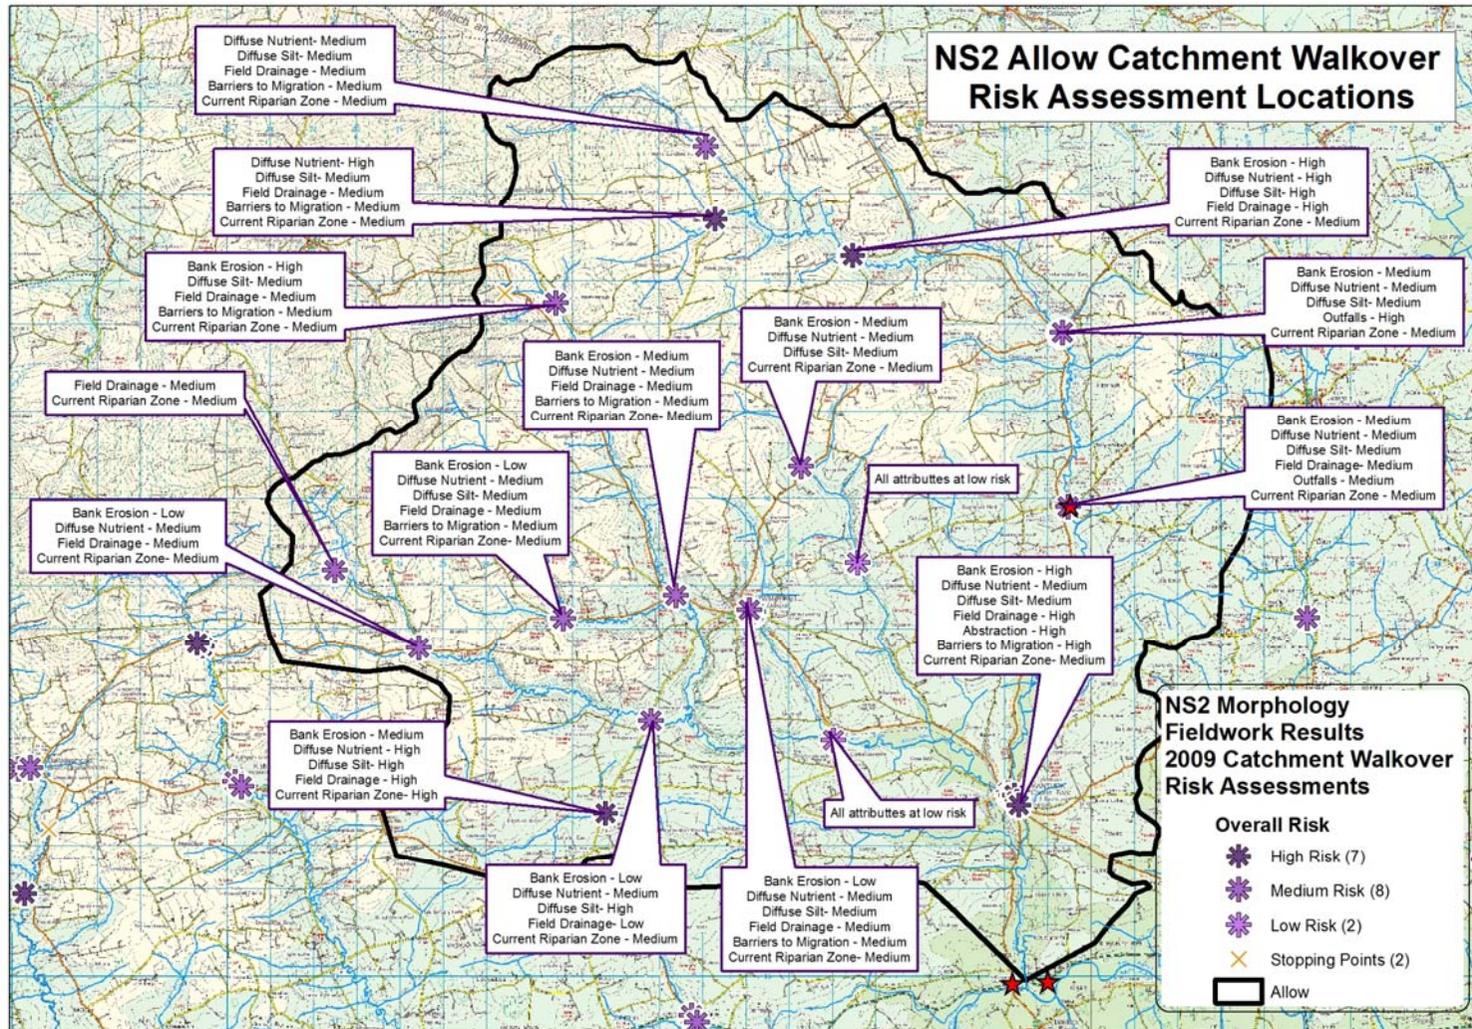
Figure 2 Location of Stopping points and Catchment Walkover Risk Assessment

A total of 19 sites were surveyed in the Allow Sub-basin catchment; with a risk assessment carried out at 15 of these sites (Three stopping points). **Figure 2** outlines the stopping point locations together with the High to Low Risk Assessment from the Catchment Walkover Risk Assessments. Eight out of the 15 sites were considered to be high risk with seven classified as medium risk, and two were determined to be low risk. At stopping point 3 a clear felled area was recorded along the riparian zone of the river on the right bank. This area of forestry was recently felled up to the banks of the small tributary with very little buffer zone. From the 2005 aerial imagery we can see the intact forestry coupe and from stopping point 3 photo 4 we can see the felling which has taken place along the steep slopes of the right bank.

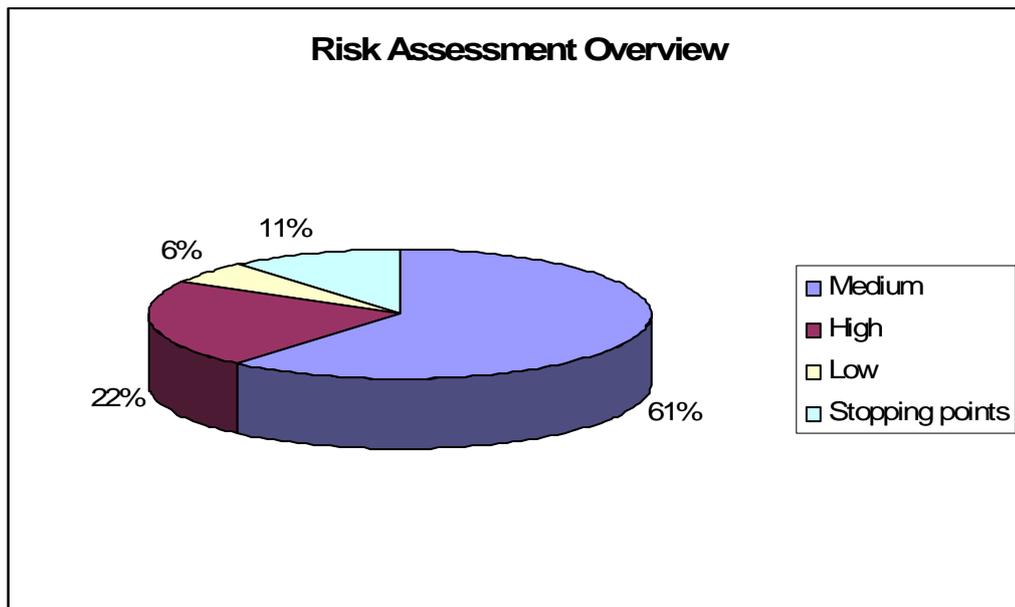
Figure 3 Risk Assessment Overview

Figure 3 outlines the percentage at high, medium and low risk sites throughout the catchment together with the number of stopping points.

Where one or any of these aspects is found to be the cause of significant impact to the riparian zone, or the channel along the stretch then this category may be assigned a high risk score. Although only 13% of high risk sites were as a result of the current riparian zone attribute, 27% of the medium risk sites were as a result of a poor riparian zone. Figure 3 outlines the percentage number of sites at High, Medium or Low risk. Locations where pressures were evident in the field which were not highlighted through the desk based assessment were also noted as stopping points. These points were not selected prior to fieldwork, they were opportunistic as the catchment drive through was taking place. The pie chart in **Figure 3** indicates the percentage of stopping points also.

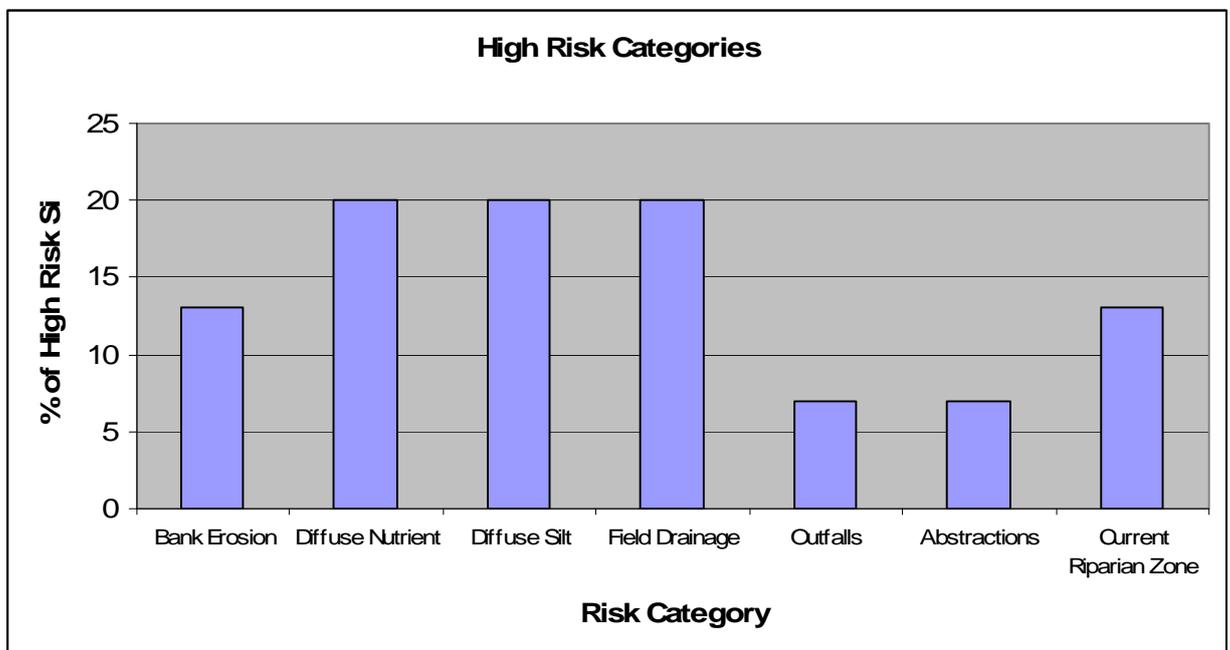
Figure 4 Breakdown of High Risk Categories

The break-down of pressure categories identified as high risk are outlined in Figure 3
