**NS 2 FRESHWATER PEARL MUSSEL SUB-BASIN  
MANAGEMENT PLANS**

**REPORT ON MORPHOLOGICAL MONITORING AND  
CATCHMENT WALKOVER RISK ASSESSMENTS IN THE  
KERRY BLACKWATER CATCHMENT**

**September 2009**

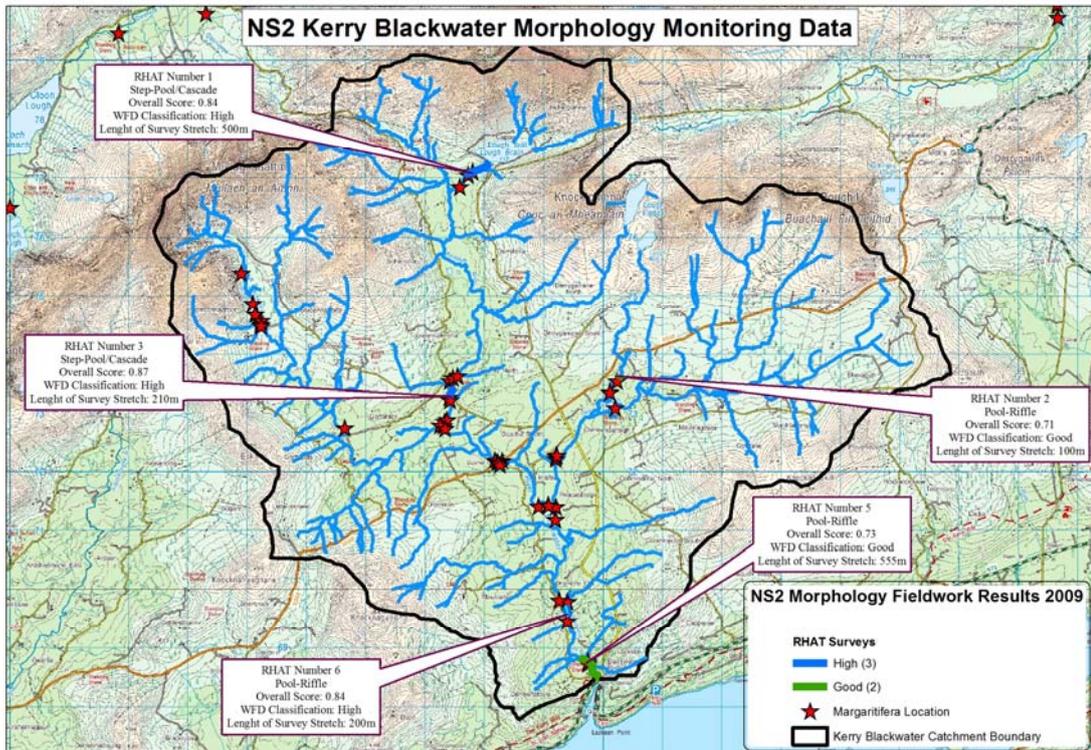
Figure 1 Morphology RHAT Assessment Locations

Five RHAT surveys were carried out throughout the Kerry Blackwater catchment. The results of these surveys can be found in the electronic appendix. Two were deemed to be at good status in the lower reaches of the catchment where as the three survey stretches in the upper and mid sections of the catchment was at High status. RHAT number 1 scored well on all attributes except for substrate condition and riparian land cover. This was due to the extensive cover of filamentous algae which was found along the survey stretch both within the channel itself and along the side channels and in coming drainage channels. The riparian landcover also scored low due to the pressure from overgrazing by sheep in this area. Although fencing is good in the first portion of this stretch, the same approach needs to be continued along the entire river length to prevent further deterioration of the channel.

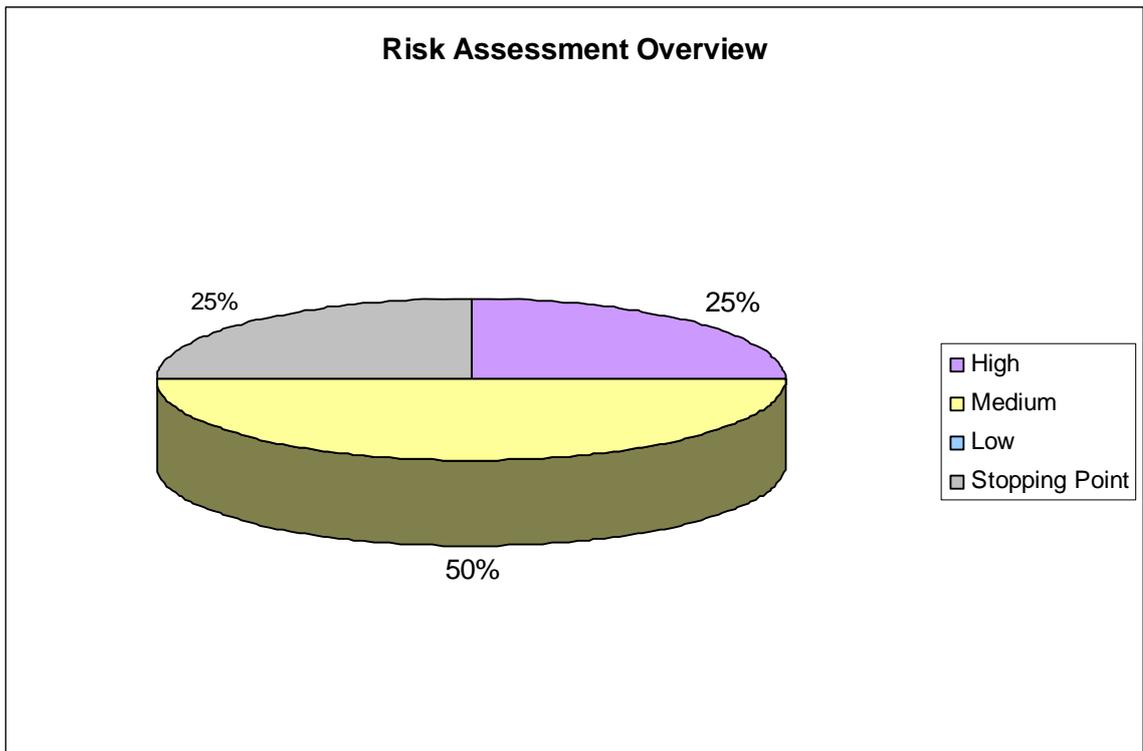
**Figure 3 Risk Assessment Overview**

Where one or any of these aspects is found to be the cause of significant impact to the riparian zone, or the channel along the stretch then this category may be assigned a high risk score. **Figure 2** outlines the percentage number of sites at High, Medium or Low risk. Locations where pressures were evident in the field which were not highlighted through the desk based assessment were also noted as stopping points. These points were not selected prior to fieldwork, they were opportunistic as the catchment drive through was taking place. The pie chart in **Figure 2** indicates the percentage of stopping points also.

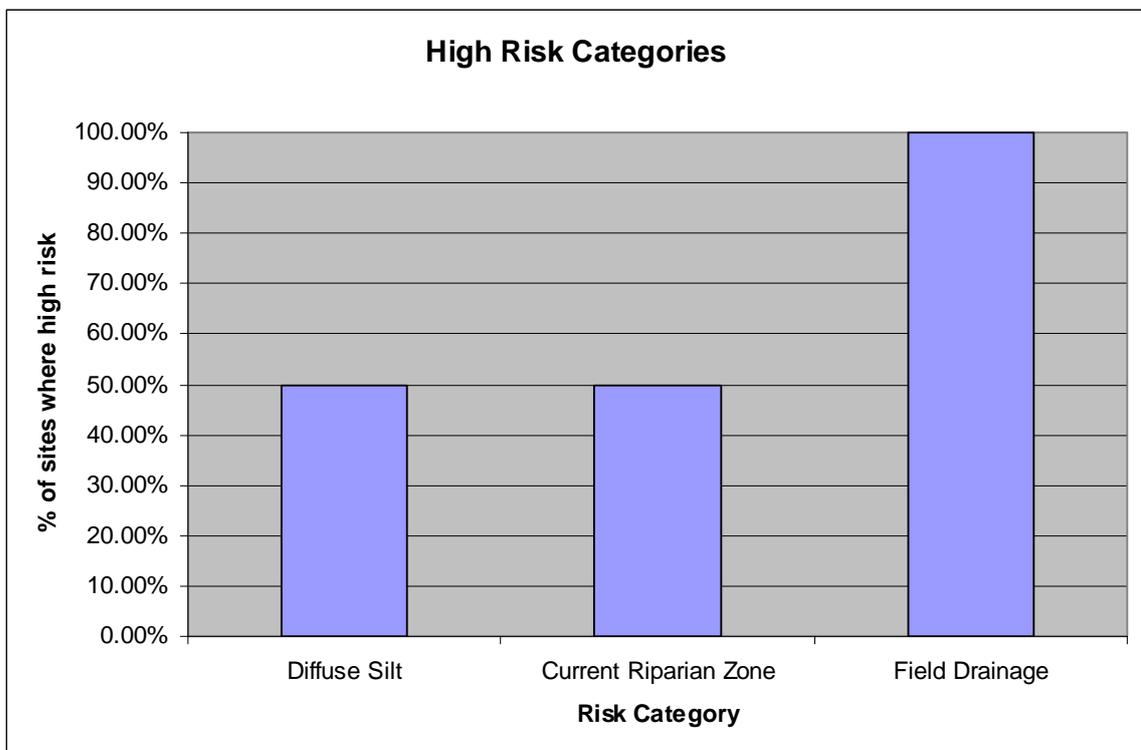
**Figure 4 Breakdown of High Risk Categories**

The break-down of pressure categories identified as high risk are outlined in Figure 3

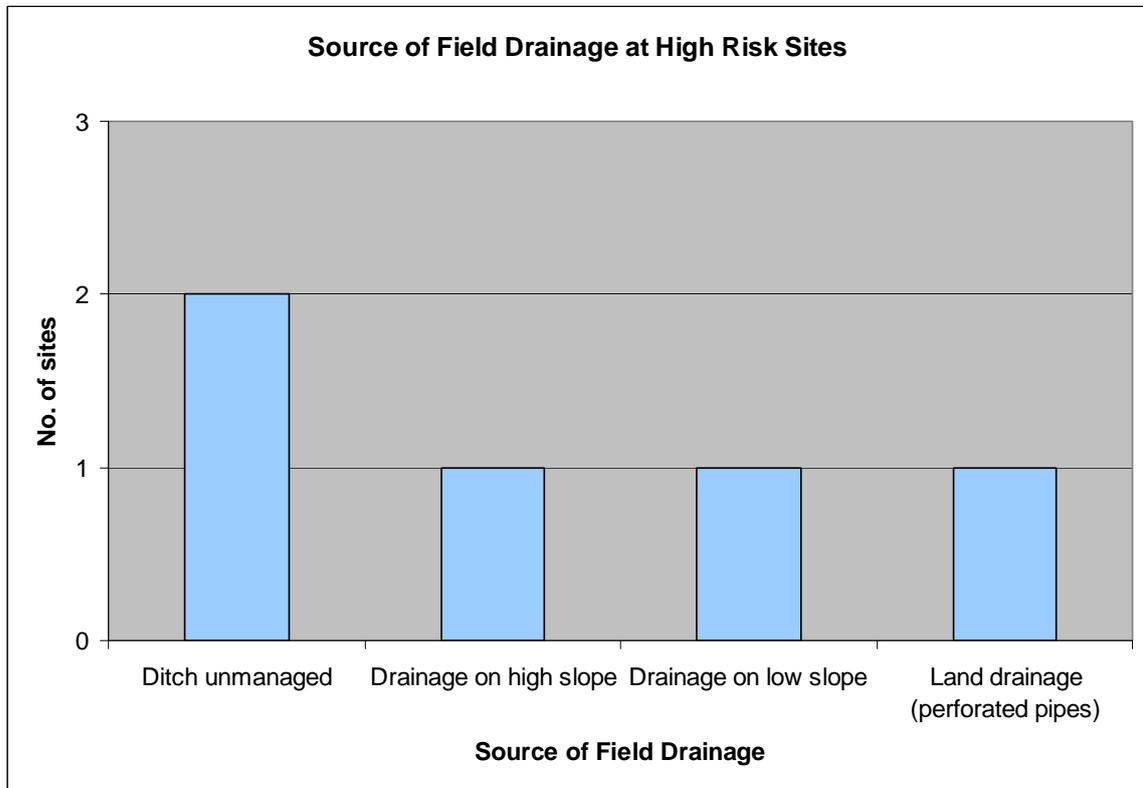
**Figure 5 source of field drainage pressure at high risk sites**

The most common source of field drainage was managed ditches. A break-down of the individual sources of field drainage at high risk sites is given below:
