**NS 2 FRESHWATER PEARL MUSSEL SUB-BASIN
MANAGEMENT PLANS**

**REPORT ON MORPHOLOGICAL MONITORING AND
CATCHMENT WALKOVER RISK ASSESSMENTS IN THE
OWENAGAPPUL CATCHMENT**

September 2009

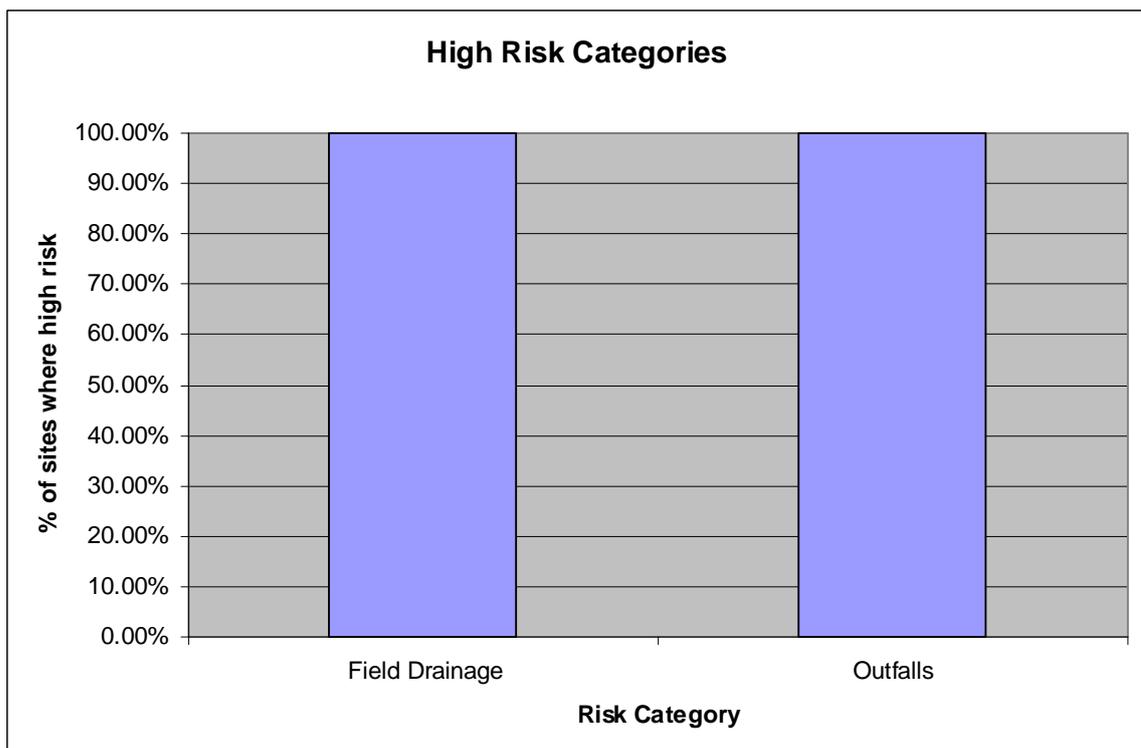
Figure 3.4 Break-down of High Risk categories

The break-down of pressure categories identified as high risk are outlined in **Figure 3.4**

The sources of field drainage at the high risk site were drainage on a high slope and 'other sources' specifically drainage pipes from the nearby. The outfalls identified were an industrial outfall from a waste water treatment plant and storm drains.
