**NS 2 FRESHWATER PEARL MUSSEL SUB-BASIN
MANAGEMENT PLANS**

**REPORT ON MORPHOLOGICAL MONITORING AND
CATCHMENT WALKOVER RISK ASSESSMENTS IN THE
MUNSTER BLACKWATER CATCHMENT**

September 2009

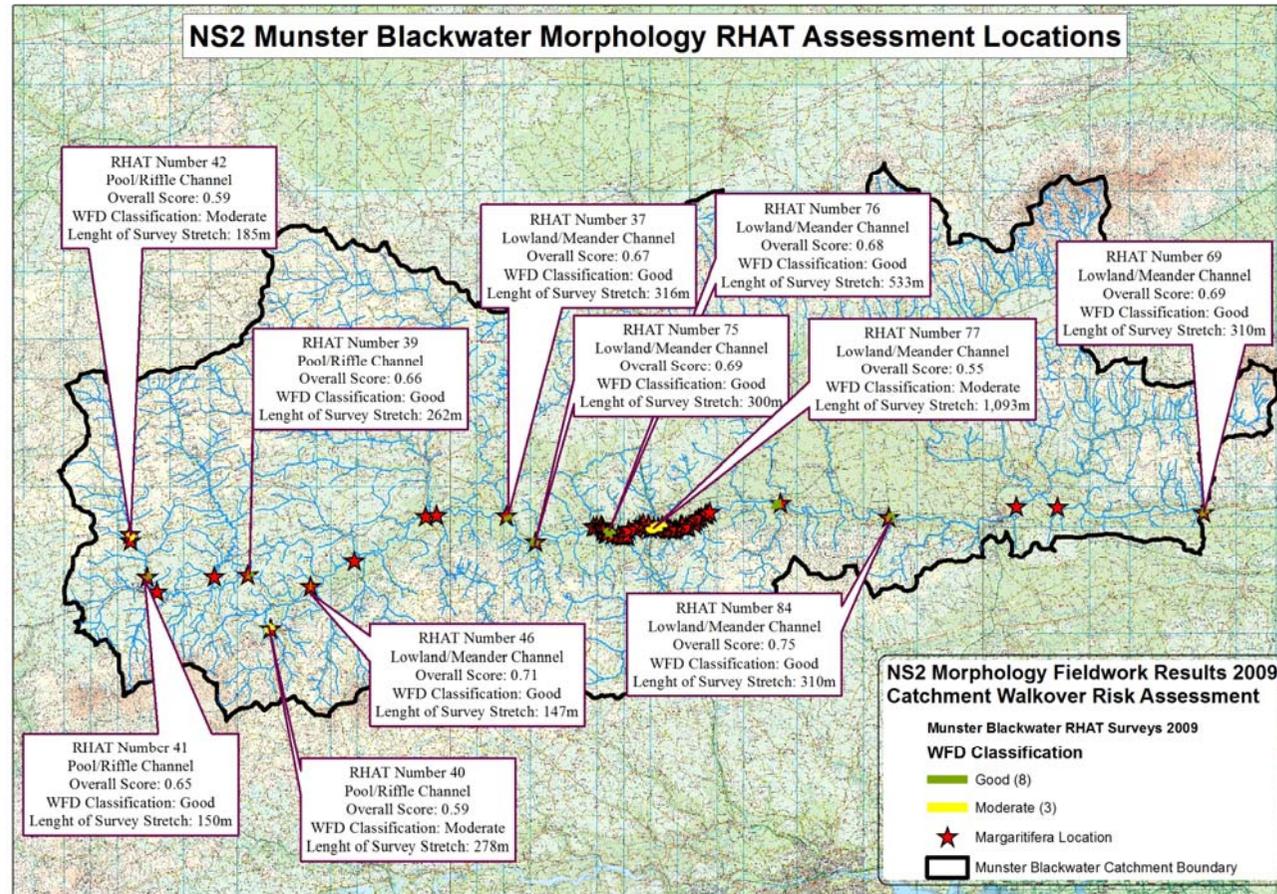
Figure 1 Morphology RHAT Assessment Locations

Eleven RHAT surveys were carried out throughout the Munster Blackwater catchment. The results of these surveys can be found in the electronic appendix and are also shown in Figure 1 above. Eight were deemed to be at good status. The RHAT surveys were carried out in the vicinity of the pearl mussel populations. The “Good” status sites were found throughout the catchment from Ballyduff to Ballydesmond. The three moderate sites were located in Mallow, Millstreet and Knocknagree to the west of the catchment. Going from West to east across the catchment RHAT number 42 which was surveyed at Farankeal bridge scored 0.59 and was classified as being at moderate status. This stretch contained high banks on both sides downstream of the bridge. Erosion and bare banks with a lack of buffer zone was present. On meeting the landowner he indicated that he is in REPS and has undertaken works in line with the REPS guidelines. New fencing has been erected as a result the conditions downstream may improve in the future as an adequate buffer zone has also been left. High levels of silt were recorded in the channel with the underneath of one bridge arch containing a mound of silt.

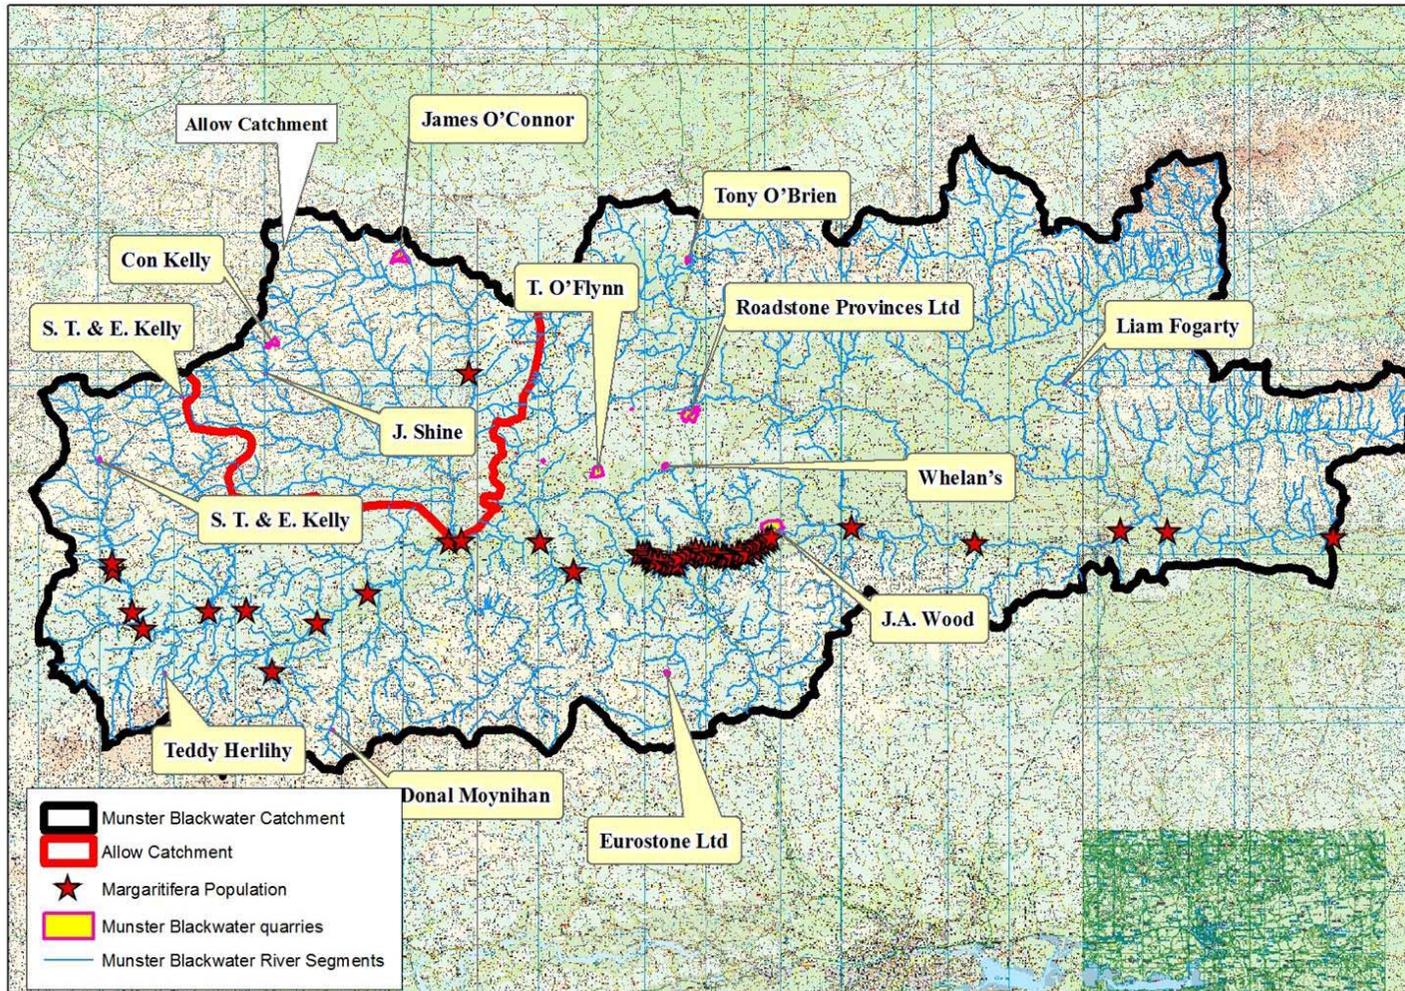
Figure 2 Location of 19 quarries throughout the Munster Blackwater

A total of 89 sites were surveyed throughout the Munster Blackwater Sub-basin catchment; with a risk assessment carried out at 73 of these sites (16 stopping points). **Figure 2** outlines the stopping point locations together with the High to Low Risk Assessment from the Catchment Walkover Risk Assessments. Thirty one out of the eighty nine risk assessment sites were considered to be high risk, forty one at medium risk and only 6 at low risk. **Figure 4** outlines the percentage at high and medium risk together with the number of stopping points throughout the catchment. Nineteen quarries were either surveyed or have been recorded through the desk based assessment for the draft sub-basin management plans throughout the Munster Blackwater (See Figure 3.). All have been registered with the details provided below in **Table 1**. Only one of these large quarries is located directly beside a pearl mussel location. This is the J.A. Wood at Lacknamona in Mallow. This is an extremely large quarry which extracts rock. The remaining 18 quarries are spread throughout the catchment and are depicted in **Figure 2** below.

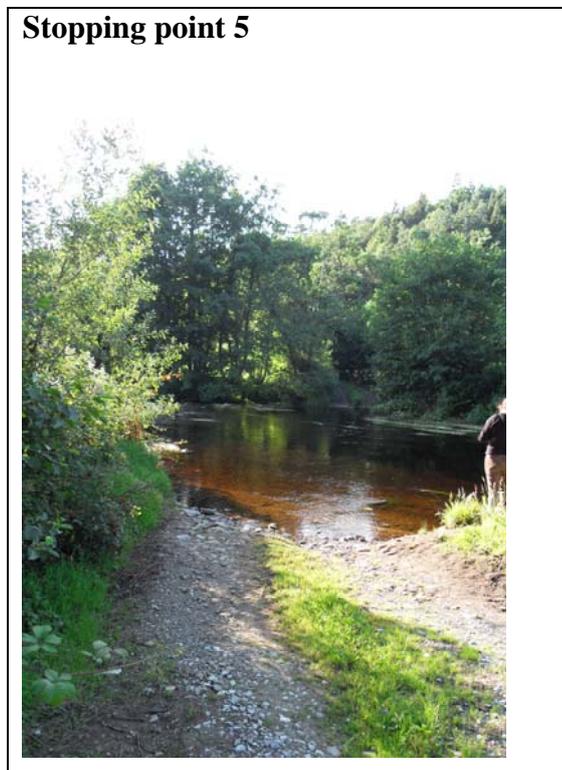
Site 42 Farnankeel bridge

Within the Munster Blackwater and excluding the Allow Sub-Basin six significant Fords were recorded at the following sites:

- Stopping Point 5
- Site 42 Farnankeel Bridge
- Site 45 Owentaraglin
- Site 58 Funshion River
- Site 68 Araglin
- Site 75 Munster Blackwater
- Site 84 Ballyhooley

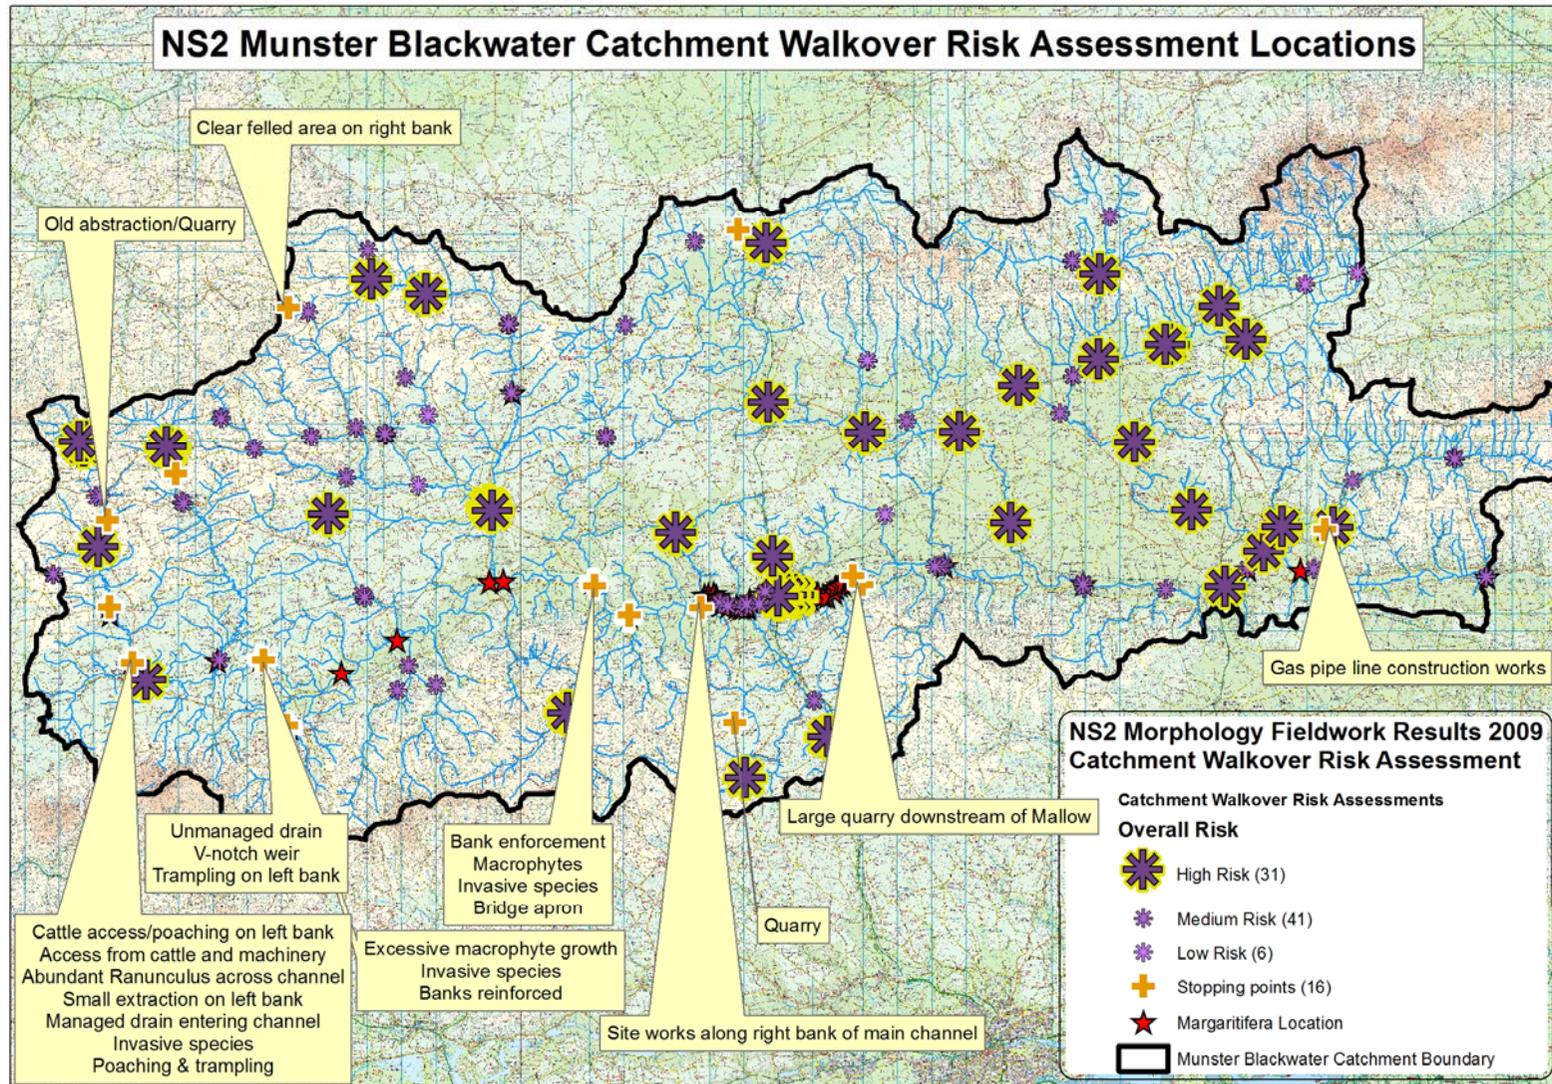
Figure 3 Location of Stopping points and Catchment Walkover Risk Assessment

Where one or any of these aspects is found to be the cause of significant impact to the riparian zone, or the channel along the stretch then this category may be assigned a high risk score. **Figure 4** outlines the percentage number of sites at High, Medium or Low risk. Locations where pressures were evident in the field which were not highlighted through the desk based assessment were also noted as stopping points. These points

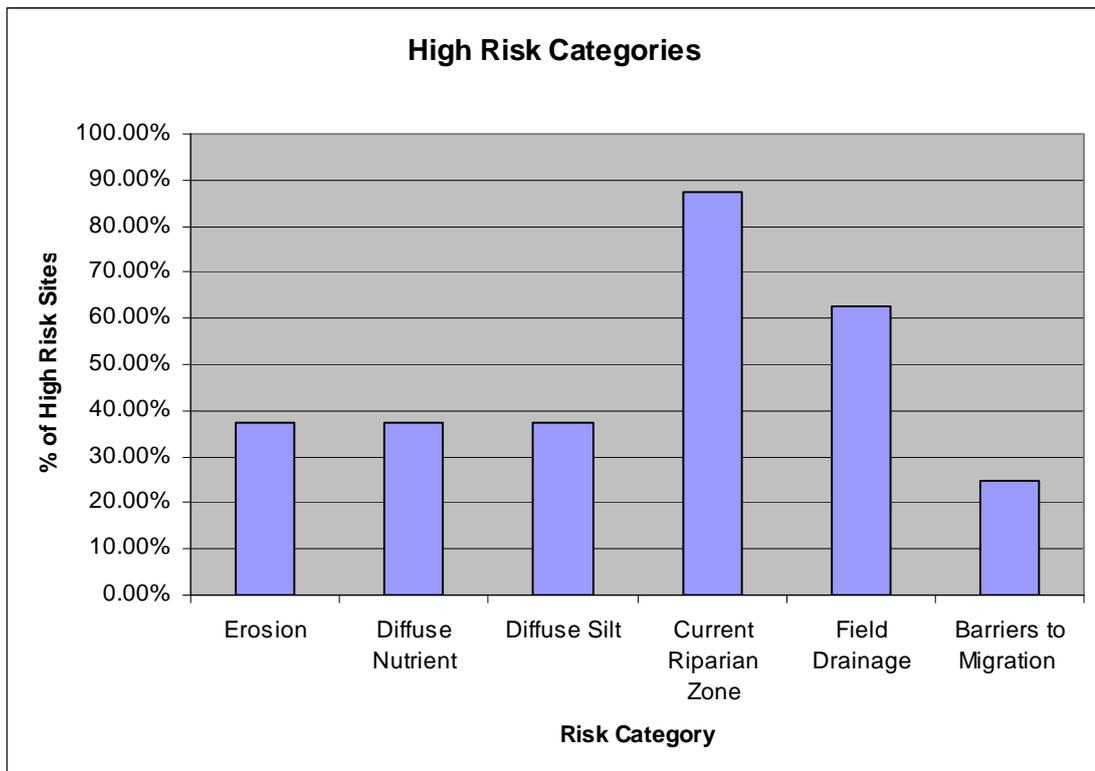
Figure 5 Breakdown of High Risk Categories

The current riparian zone category is a considerable pressure within this catchment, however this pressure generally relates to how a poor riparian zone can intensify other pressures e.g. animal trampling caused by a lack of fencing or increased diffuse nutrient as a result of an ineffective or poor buffer zone.

As a result quantitative statistics do not adequately convey the pressures that arise through a high risk riparian zone, the main issues identified were:

- A complete lack of fencing or insufficient fencing on agricultural land – within this catchment this has resulted in increased erosion from extensive animal trampling and fords, increased nutrient enrichment from animals being within and near channel, increased silt within channel as trampling causes patches of bare sediment which is washed into the river channel;
- A lack of adequate buffer or tree line in areas where the channel is within close proximity to forestry or intensive agriculture, this results in an increase in diffuse nutrient as nutrients are washed directly into the channel from agricultural land or forestry, increased levels of silt entering river as there is no buffer during forestry felling or crop harvesting.
- The most common sources of field drainage were unmanaged ditches and drainage on a high slop each creating a high risk pressure at three sites.
