**NS 2 FRESHWATER PEARL MUSSEL SUB-BASIN  
MANAGEMENT PLANS**

**REPORT ON MORPHOLOGICAL MONITORING AND  
CATCHMENT WALKOVER RISK ASSESSMENTS IN THE  
NORE CATCHMENT**

**September 2009**

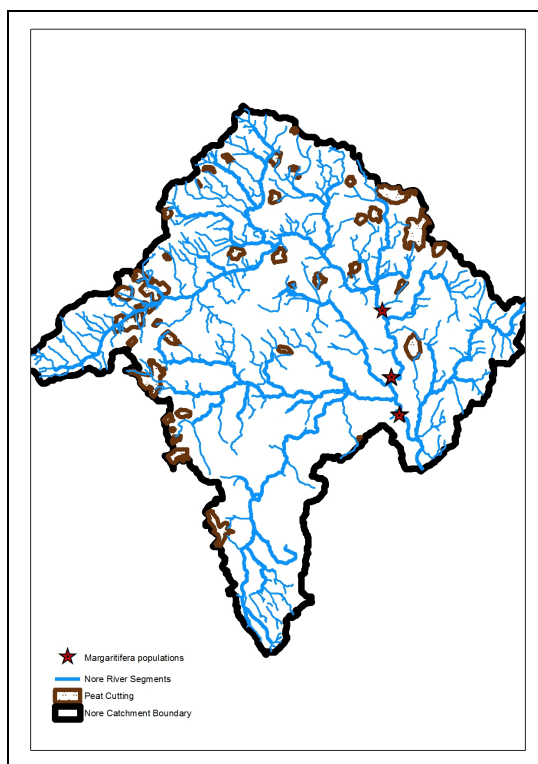
**Figure 5.0 indicates the areas of peat cutting observed using aerial imagery.**

Peat cutting is evident throughout the Nore catchment largely to the North and North West of the catchment. These areas of peat cutting (totalling 4200ha) are of key concern in terms of potential impact to the pearl mussels. The total area provided above and depicted in **Figure 5.0** is taken from polygons which were delineated through the desk based assessment of the 2005 Aerial Imagery.

During the 2009 catchment walkover field surveys some of these areas of peat extraction were targeted for further investigation in particular to identify areas of commercial peat extraction and those which are directly discharging to the river watercourse. This exacerbates the sediment run-off problem by providing channels for rain water, thereby transporting heavy sediment loads to the river. Furthermore, the lack of riparian zone increases the probability of excessive sediment run-off to the river.

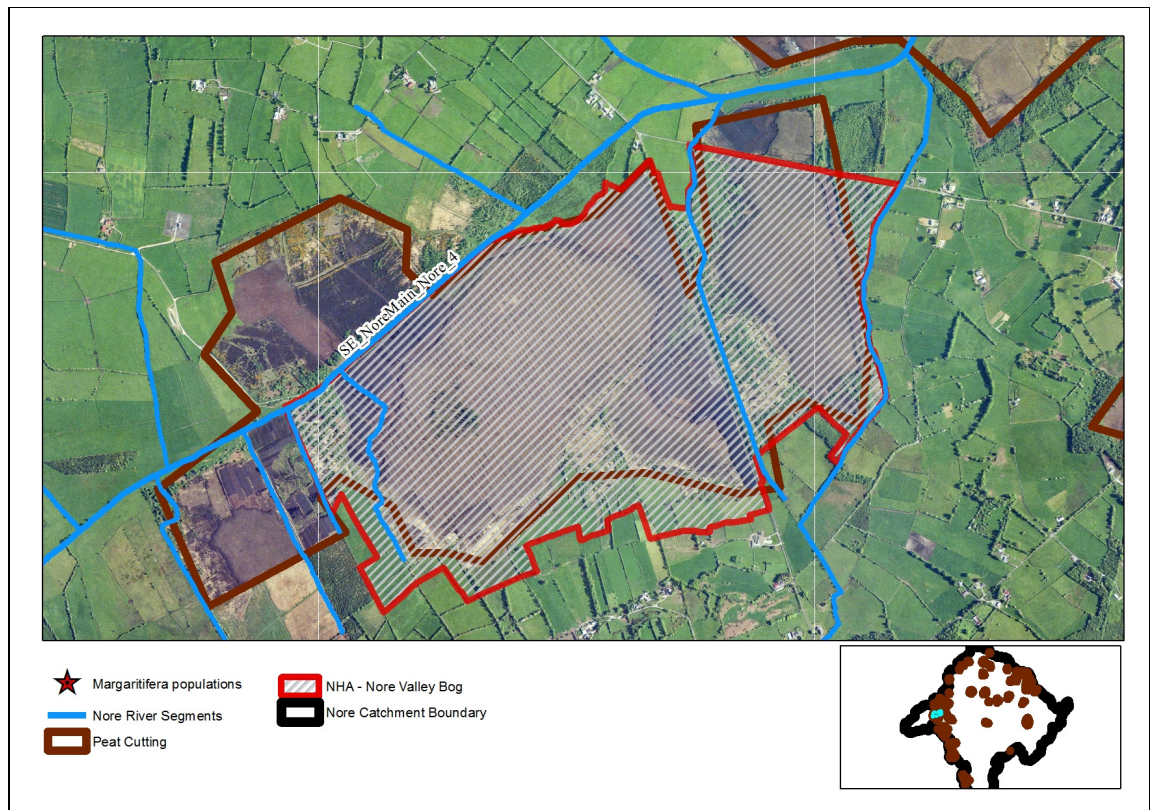
**Figure 6.0 Nore Valley Bog NHA**

Timoney Bog which is contained within the Nore Valley Bog NHA was found to be operating on a private basis. The extent to which the peat extraction covered would indicate that it should be IPPC licensed and operated commercially. Field investigations found no controls in place to prevent silt and nutrient input to the river watercourse and visible impacts on water quality were noted.

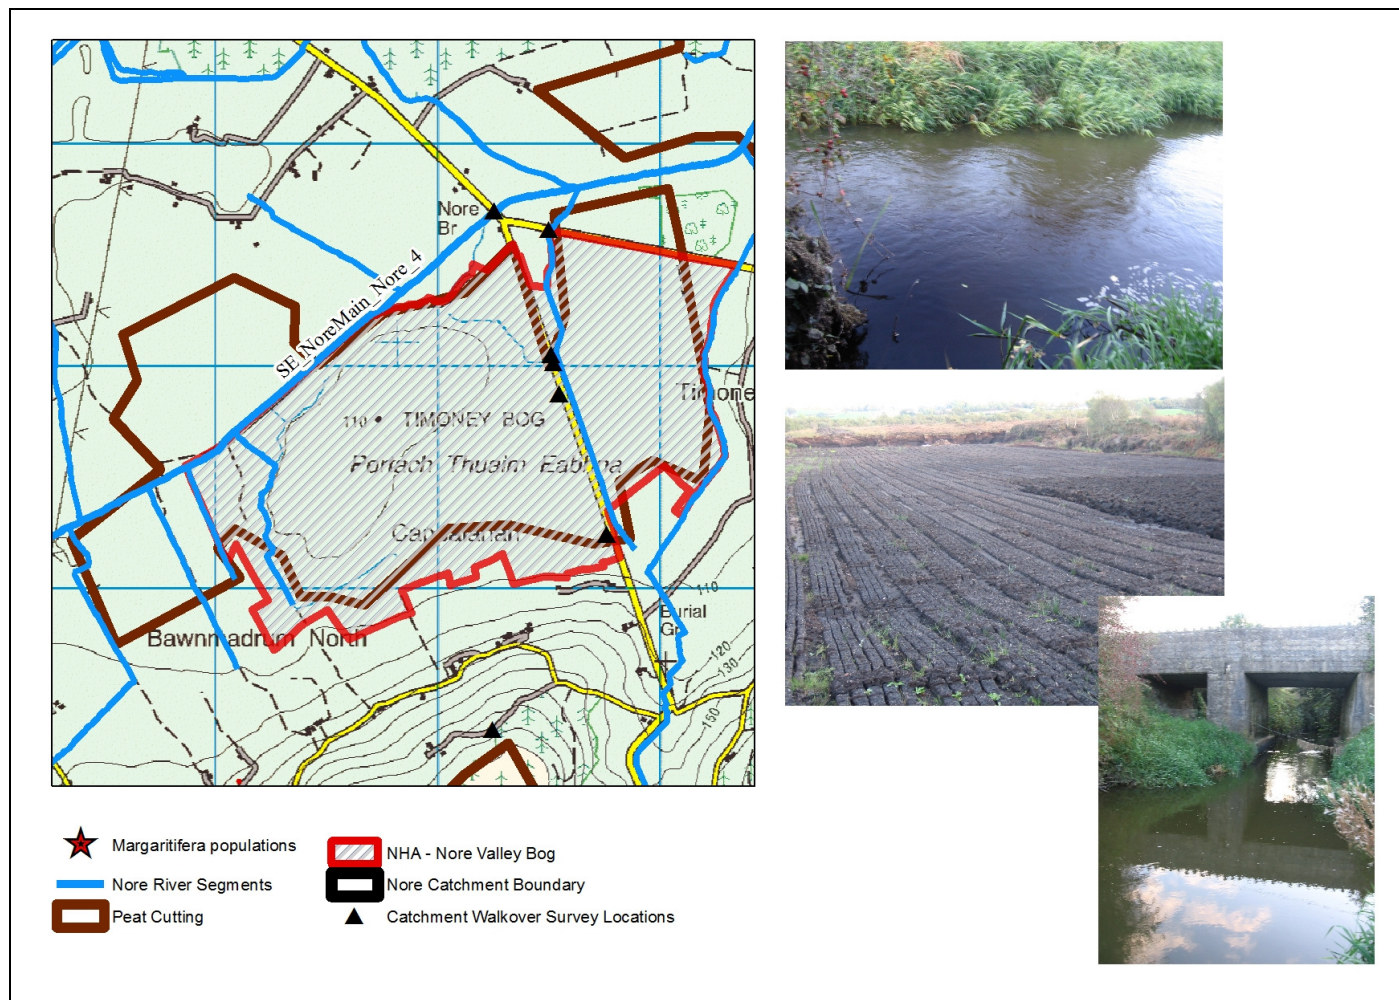
**Figure 7.0 Catchment Walkover Survey locations indicating poor water quality**

The Freshwater Pearl Mussel is extremely sensitive to sedimentation therefore any activity that can give rise to sediment inputs to water has the potential to impact on the species. One of the key issues for the future management of the Nore catchment and the return of the Freshwater Pearl Mussel population within this catchment to favourable conservation status is the minimisation of sediment losses arising from peat abstraction and spreading. **Figure 7** above provides an indication of the high levels of suspended solids and fine silts which can be found within the rivers of the Nore catchment in association with these peat cutting areas.

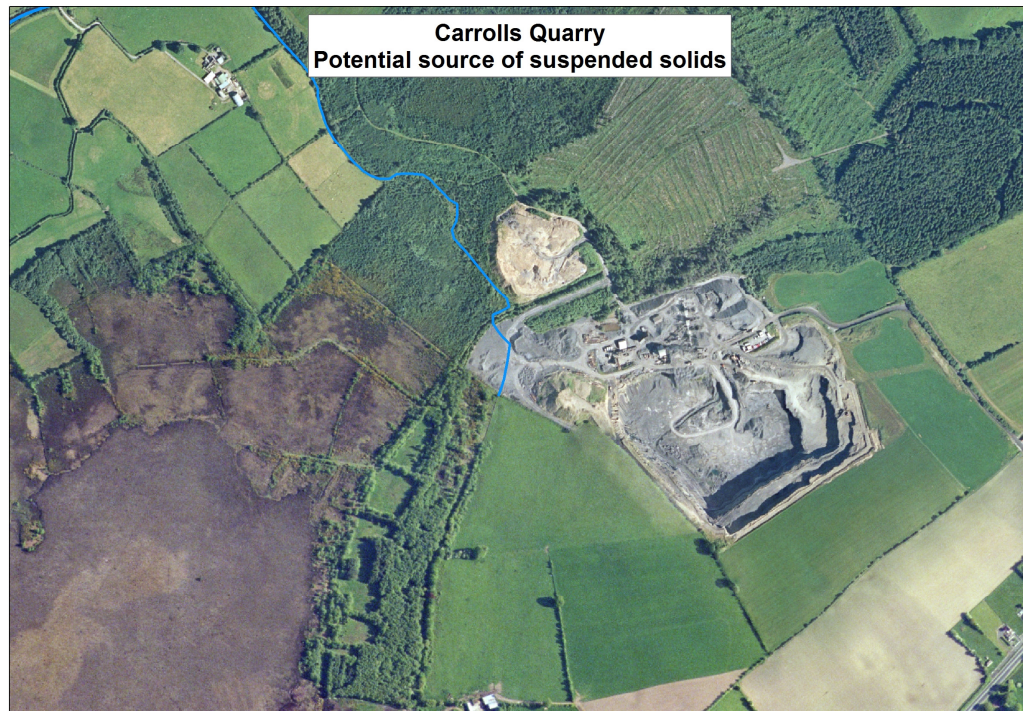
**Figure 9 Aerial Imagery of Carrolls Quarry**

The Quarry in question was Carrolls Quarry and was found to be active on the day on which the survey took place. The aerial imagery map shown in **Figure 9** gives an overview of the location of the quarry and its proximity to the river channel. A tributary of the River Nore main channel flows adjacent to the Quarry and appears to also cross through the site. Any silt or pollution discharged to this tributary could have a knock on effect on the Nore main channel, as the tributary feeds in above the Freshwater Pearl Mussel population. The survey in July 2009 comprised a visual inspection of the quarry from the adjacent road/land and of the river approximately 300 m downstream of the quarry. There was no evidence of pollutants discharging from the quarry or of sedimentation in the river on that date.
