**NS 2 FRESHWATER PEARL MUSSEL SUB-BASIN
MANAGEMENT PLANS**

**REPORT ON MORPHOLOGICAL MONITORING AND
CATCHMENT WALKOVER RISK ASSESSMENTS IN THE
NEWPORT CATCHMENT**

September 2009

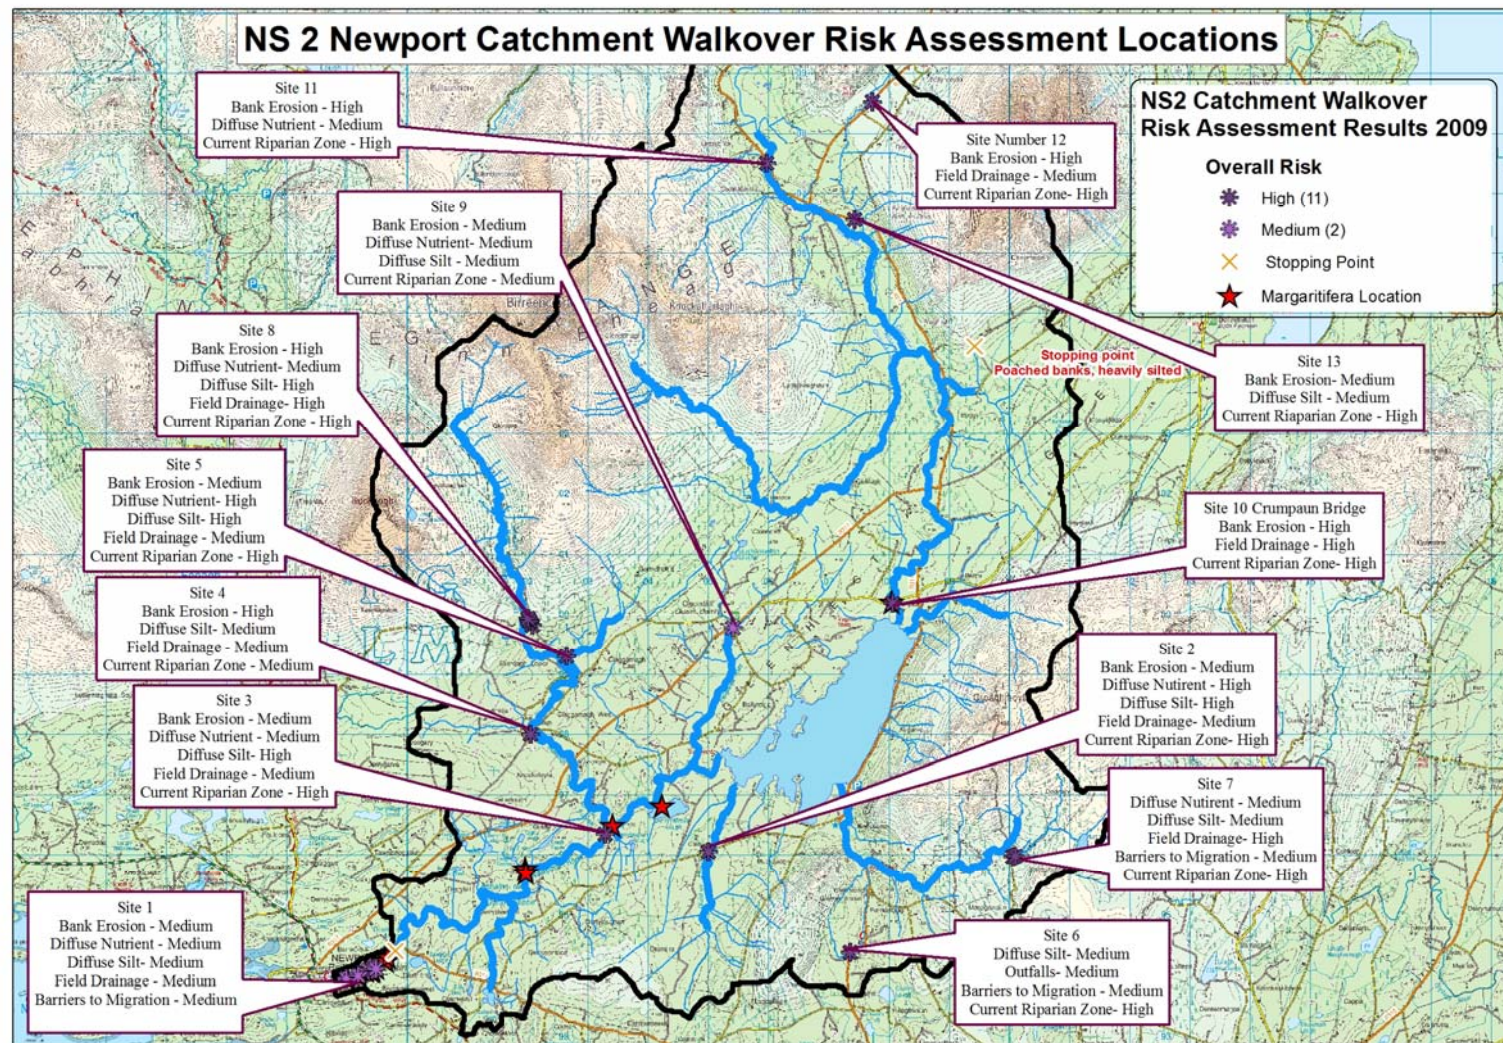
Figure 3.2 Location of Stopping points and Catchment Walkover Risk Assessments

A total of eighteen sites were surveyed in the Newport catchment, with a risk assessment carried out at eight of these sites (ten stopping points). **Figure 3.2** outlines the stopping point locations in addition to the High to Low Risk Assessment from the Catchment Walkover Risk Assessments. Six high risk sites were recorded out of the eight that were assessed. A further two sites were recorded as medium risk, meaning no low risk sites were recorded within this catchment. **Figure 3.3** outlines the percentage of sites classified at high and medium risk together with the number of stopping points throughout the catchment.

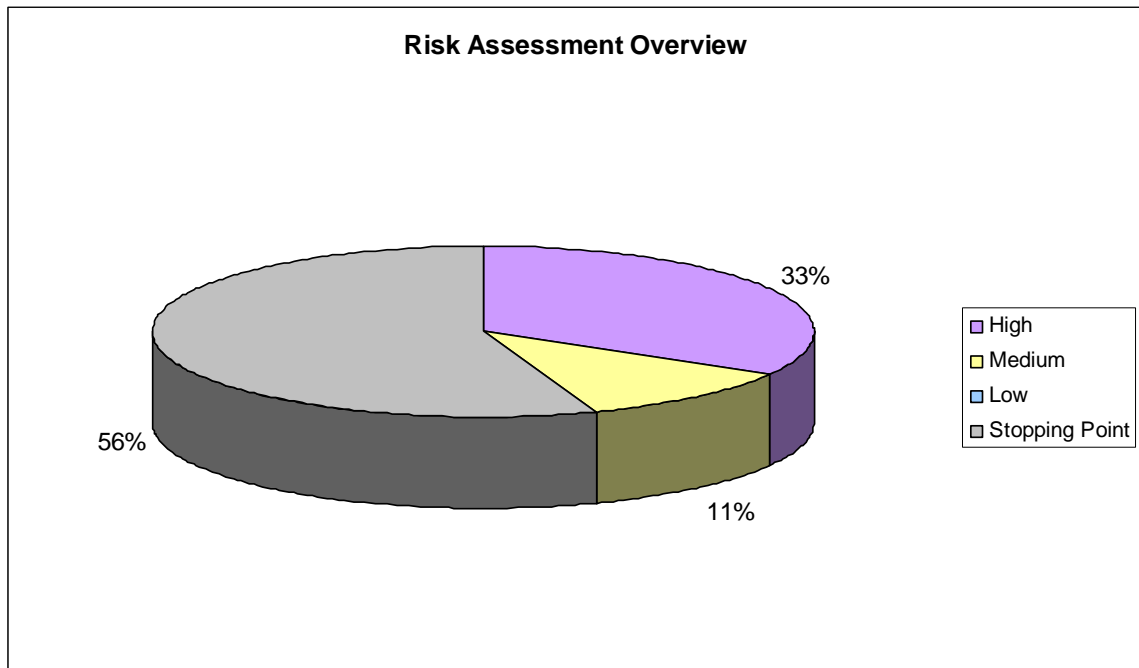
Figure 3.3 Risk Assessment Overview

Where one or any of these aspects is found to be the cause of significant impact to the riparian zone, or the channel along the stretch then this category may be assigned a high risk score. Locations where pressures were evident in the field which were not highlighted through the desk based assessment were also noted as stopping points. These points were not selected prior to fieldwork, they were opportunistic as the catchment drive through was taking place. The pie chart in **Figure 3.3** indicates the percentage of stopping points also.

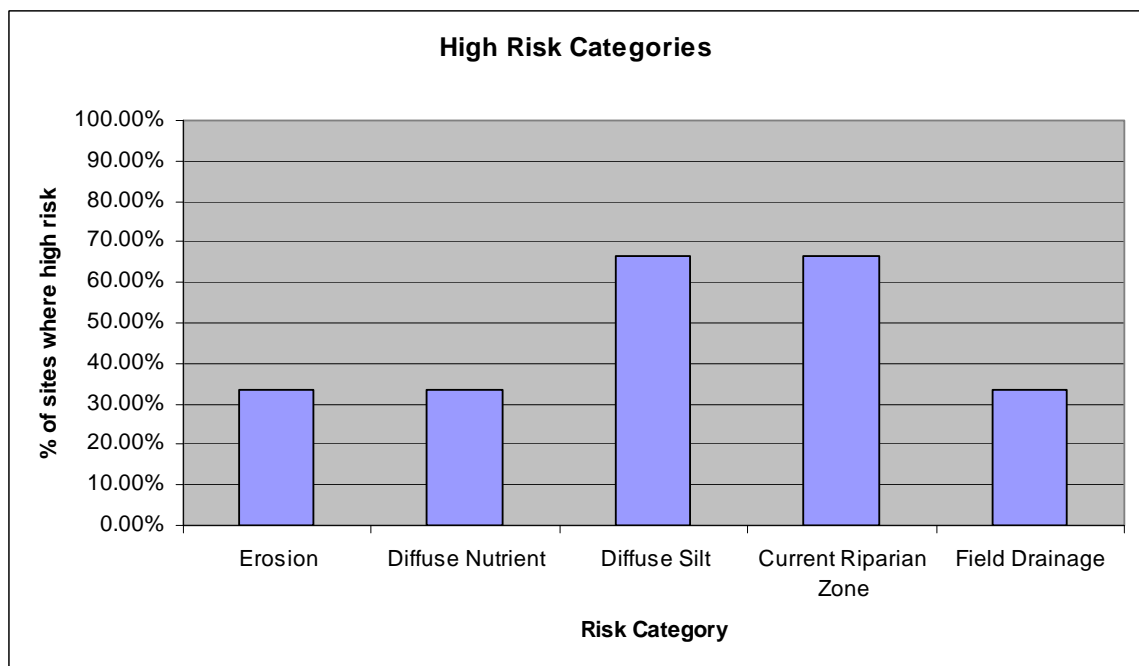
Figure 3.4 Breakdown of High Risk Categories

The break-down of pressure categories identified as high risk are outlined in **Figure 3.4**

The current riparian zone category is a considerable pressure within this catchment, however this pressure generally relates to how a poor riparian zone can intensify other pressures e.g. animal trampling caused by a lack of fencing or increased diffuse nutrient as a result of an ineffective or poor buffer zone.

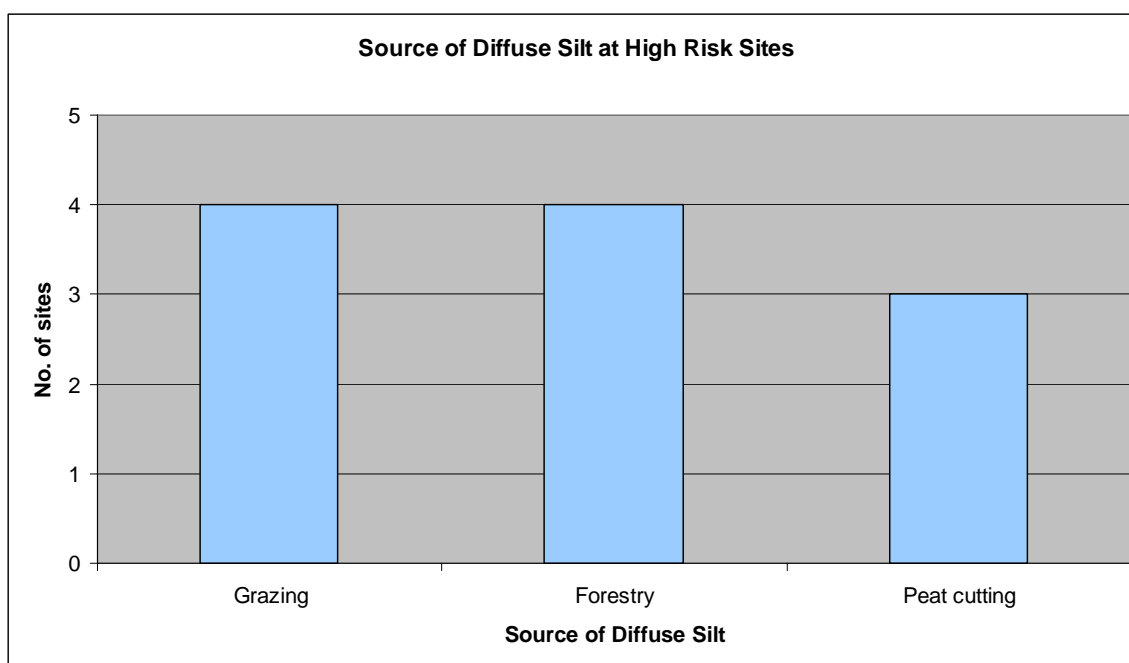
Figure 3.5 Source of field drainage pressure at high risk sites

The most common sources of diffuse silt were grazing and forestry; each being present at four high risk sites. The individual sources of diffuse silt are shown below.
