**NS 2 FRESHWATER PEARL MUSSEL SUB-BASIN  
MANAGEMENT PLANS**

**REPORT ON MORPHOLOGICAL MONITORING AND  
CATCHMENT WALKOVER RISK ASSESSMENTS IN THE  
OWENEA CATCHMENT**

**September 2009**

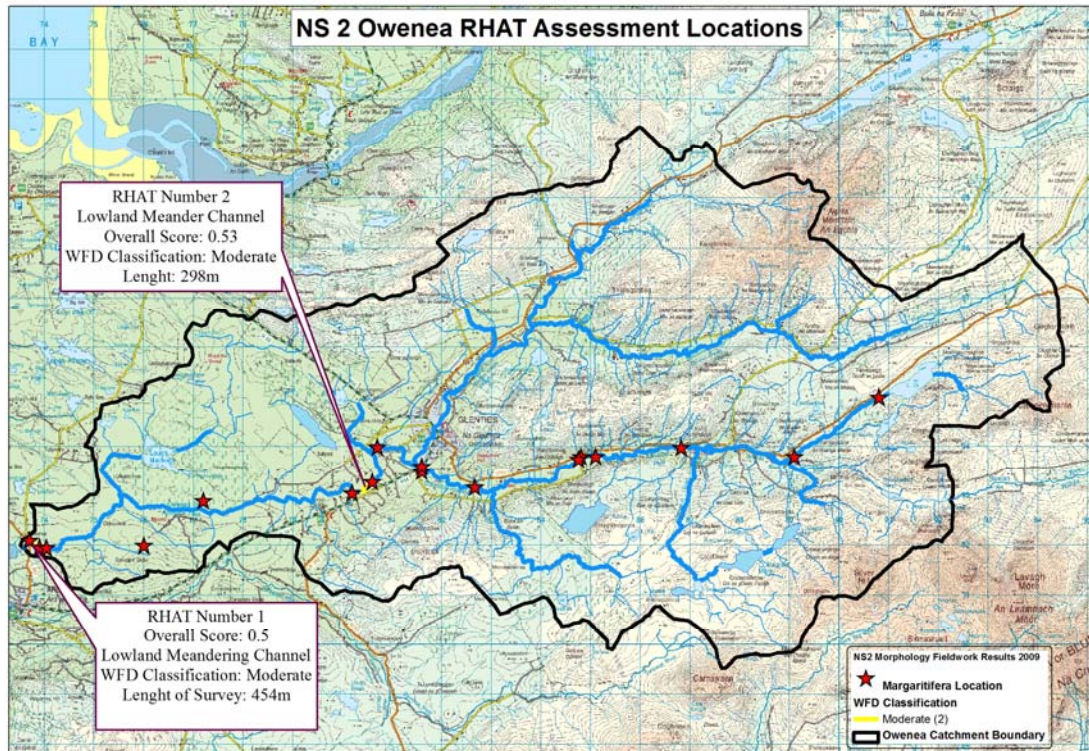
**Figure 3.1 Morphology RHAT Assessment Locations**

(The RHAT numbering system corresponds to the site code which may mean they are not sequential where a RHAT was not carried out at a particular site)
