NS 2 FRESHWATER PEARL MUSSEL SUB-BASIN MANAGEMENT PLANS

REPORT ON MORPHOLOGICAL MONITORING AND CATCHMENT WALKOVER RISK ASSESSMENTS IN THE OWENRIFF CATCHMENT

September 2009

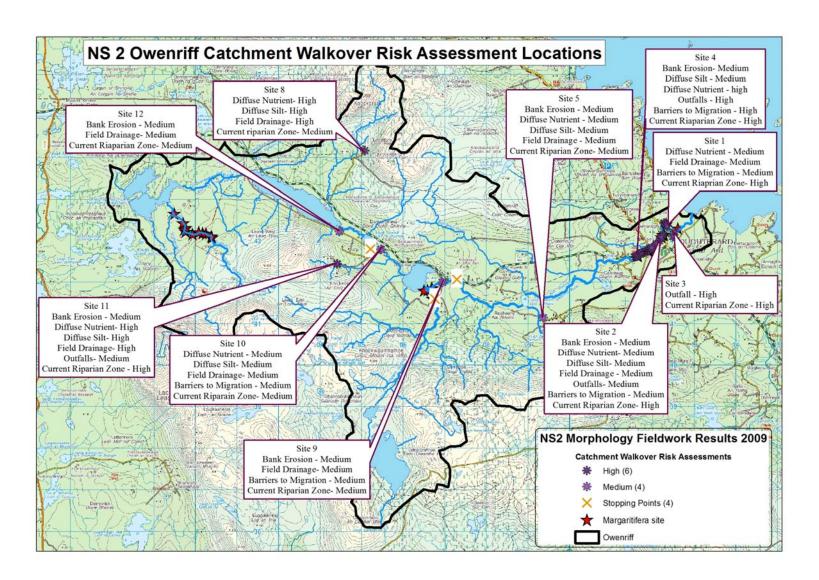
Figure 2 Location of Stopping points and Catchment Walkover Risk Assessments

A total of fourteen sites were surveyed in the Owenriff sub-basin catchment, with a risk assessment carried out at ten of these sites (four stopping points). **Figure 2** outlines the stopping point locations in addition to the High to Low Risk Assessment from the Catchment Walkover Risk Assessments. Six high risk sites were recorded out of the ten that were assessed. The remaining four were all recorded as medium risk; meaning no low risk sites were recorded within this catchment.

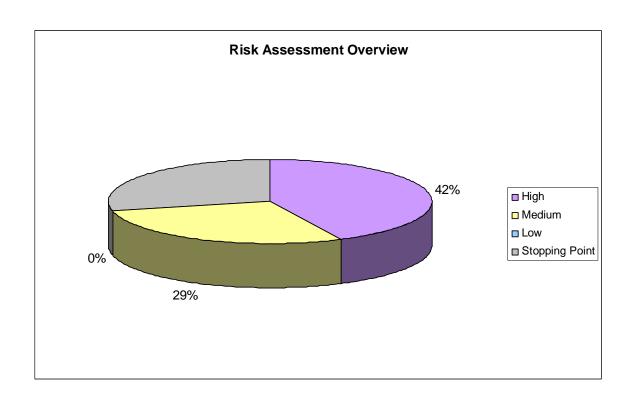
Figure 3 Risk Assessment Overview

Where one or any of these aspects is found to be the cause of significant impact to the riparian zone, or the channel along the stretch then this category may be assigned a high risk score. **Figure 3** outlines the percentage number of sites at High, Medium or Low risk. Locations where pressures were evident in the field which were not highlighted through the desk based assessment were also noted as stopping points. These points were not selected prior to fieldwork, they were opportunistic as the catchment drive through was taking place. The pie chart in Figure 3 indicates the percentage of stopping points also.

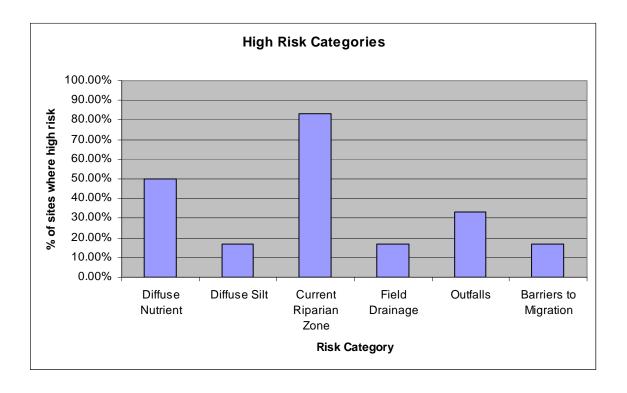
Figure 4 Breakdown of High Risk Categories

The break-down of pressure categories identified as high risk are outlined in Figure 4

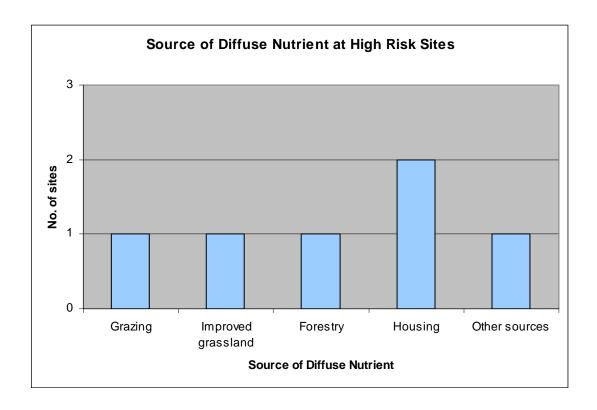
Urbanisation on the banks of the river often removing natural buffer leaving some tree-line but not sufficient to deal with pressures from such an urbanized area.

Figure 5 source of diffuse nutrient pressure at high risk sites
